SWEDISH? S

Unsigned clock o

TRIP-FRAME

of uncertain origin

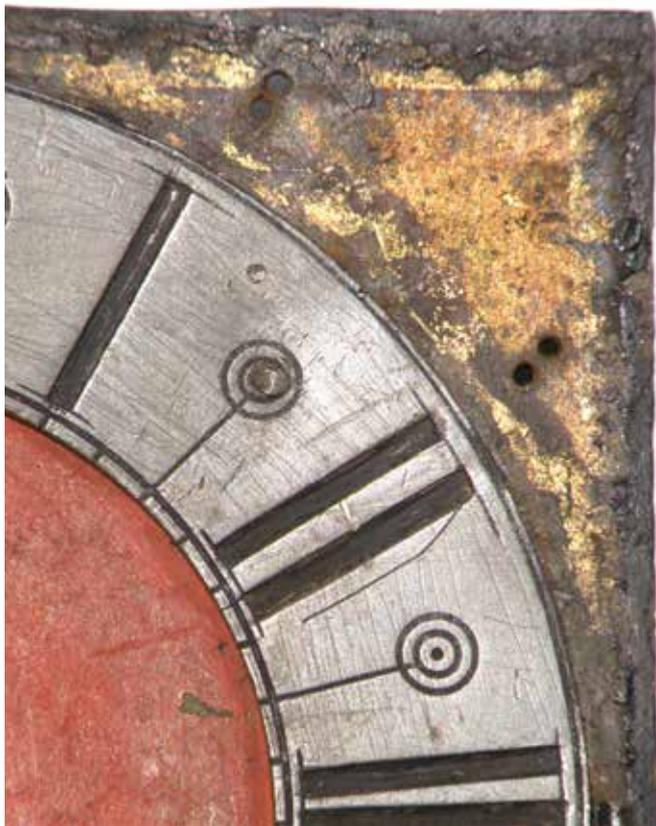
Figure 3. Gilding on the dial plate under the spandrels.

spandrels revealed traces of gilding underneath them, **figure 3**, so this was restored using gilt wax of a matching colour. Removal of the paint on the spandrels showed that it had been masking faces engraved on sun discs radiating beams of light, **figure**

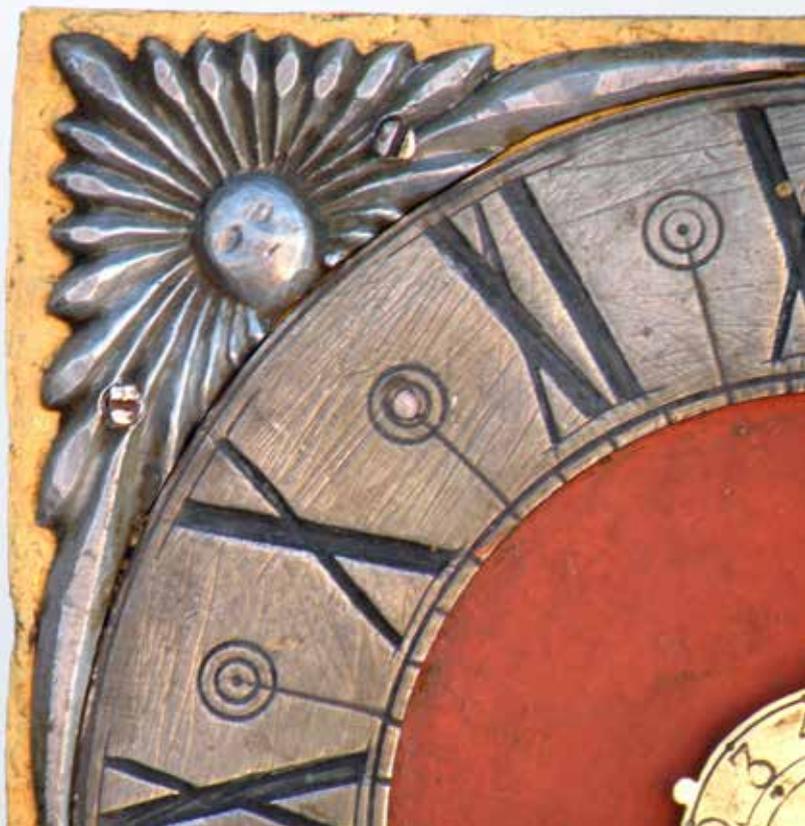
Figure 4. A restored dial corner.

Cleaning the spandrels and re-gilding the corners resulted in quite a bright and cheerful dial, with the sun shining from each corner, **figure 4**. The polished iron hour hand is of an attractive shape with two of the cut-outs in the shape of hearts, **figure 7**, while the engraved brass alarm-

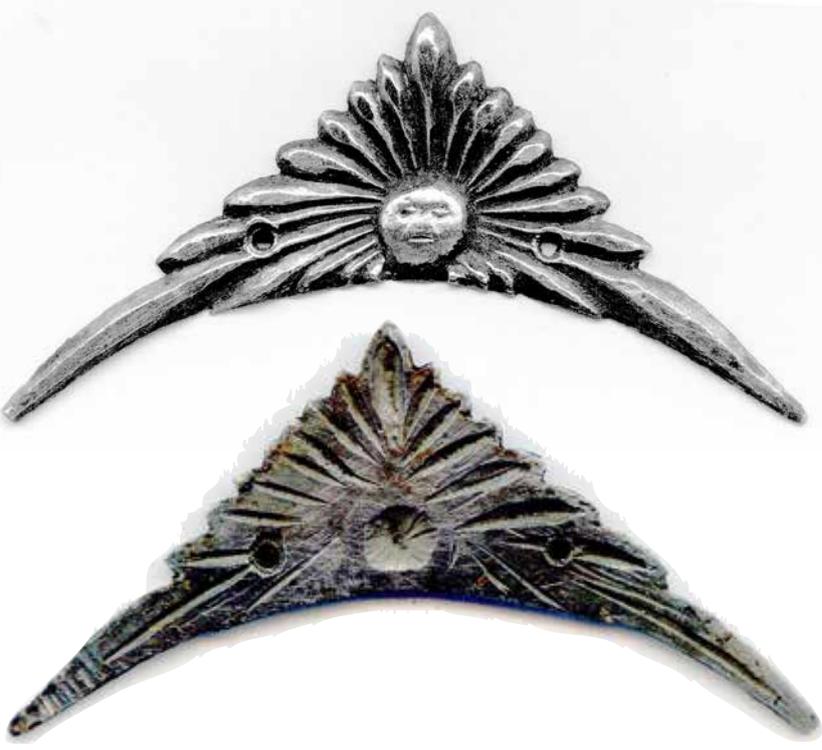
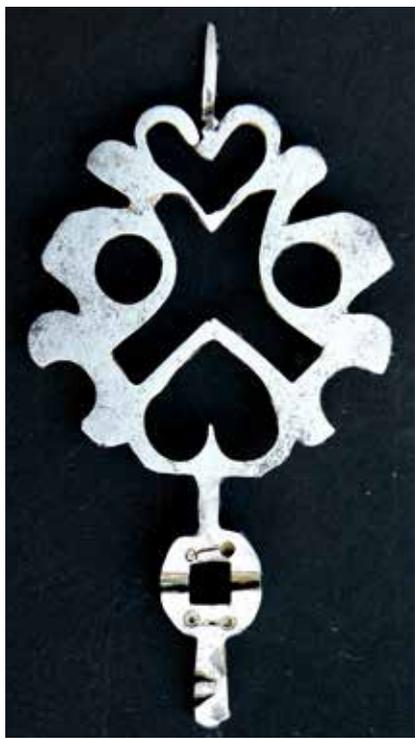
5. The rear of the spandrels, **figure 6**, showed that the casting has a hollow back and was made using a two-part mould. The molten pewter was poured into a closed mould, not simply poured into an open mould, as brass spandrels appear to have been.

Figures 5 and 6. Front and rear of the pewter spandrels.

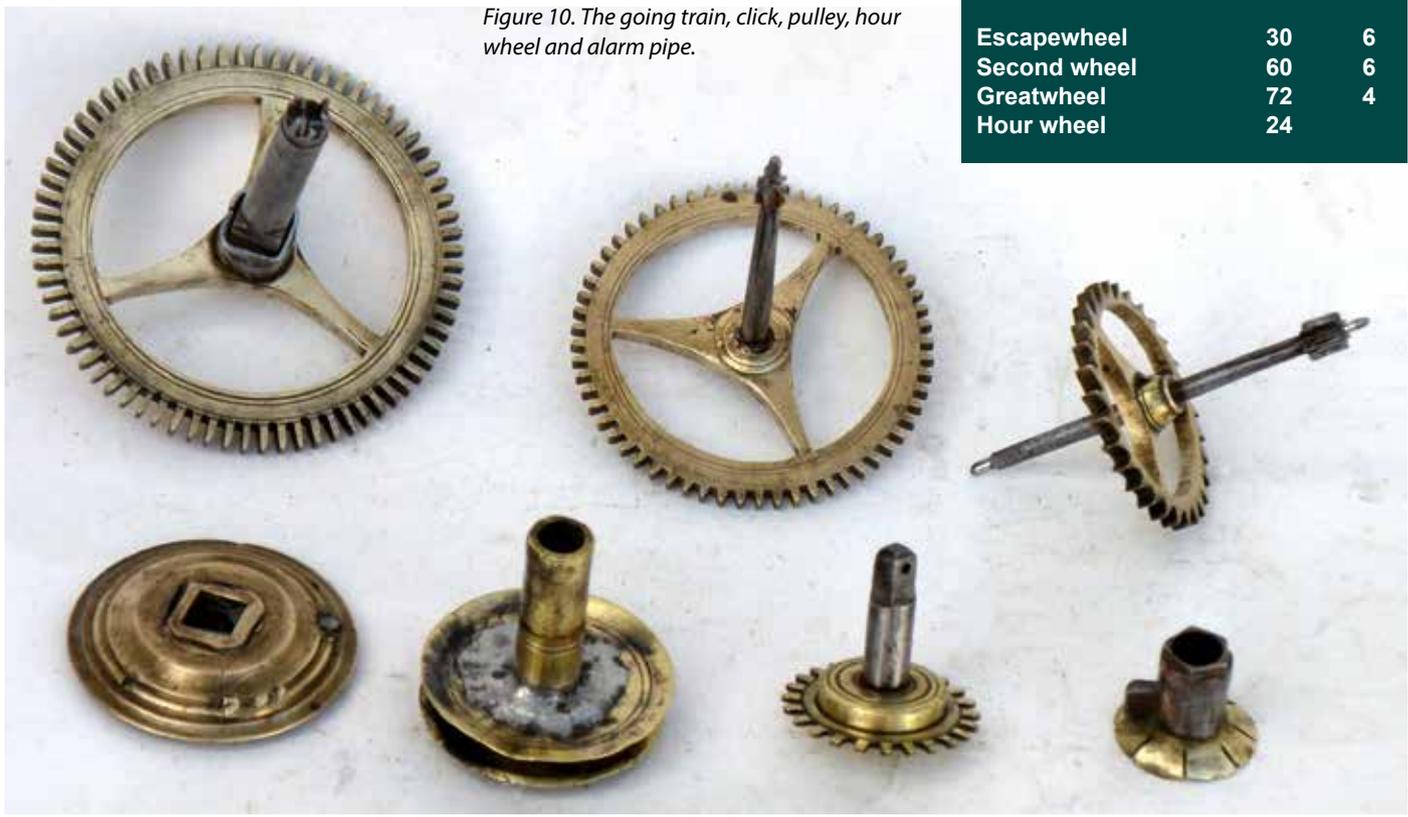
The brass wheels have three crossings and are quite conventional, apart from the construction of the pulley and click. One very unusual, and as yet unexplained, feature is a wooden collar on the greatwheel arbor, which appears in some of the pictures, but not others. **Figure 10** shows the three train wheels at the top, the click and rope pulley below with the hour wheel and alarm pipe to their right.

Figure 10. The going train, click, pulley, hour wheel and alarm pipe.

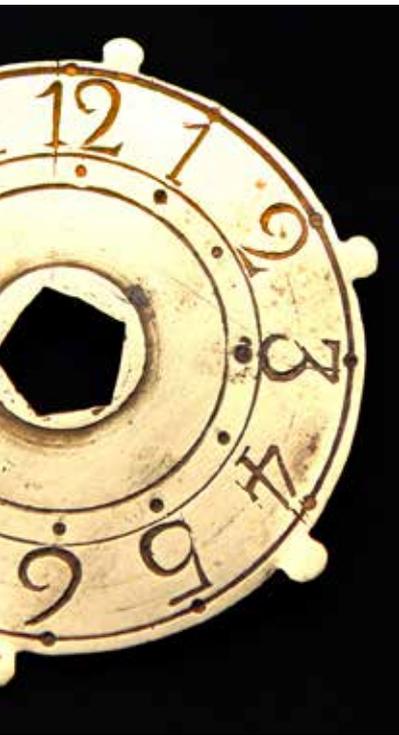
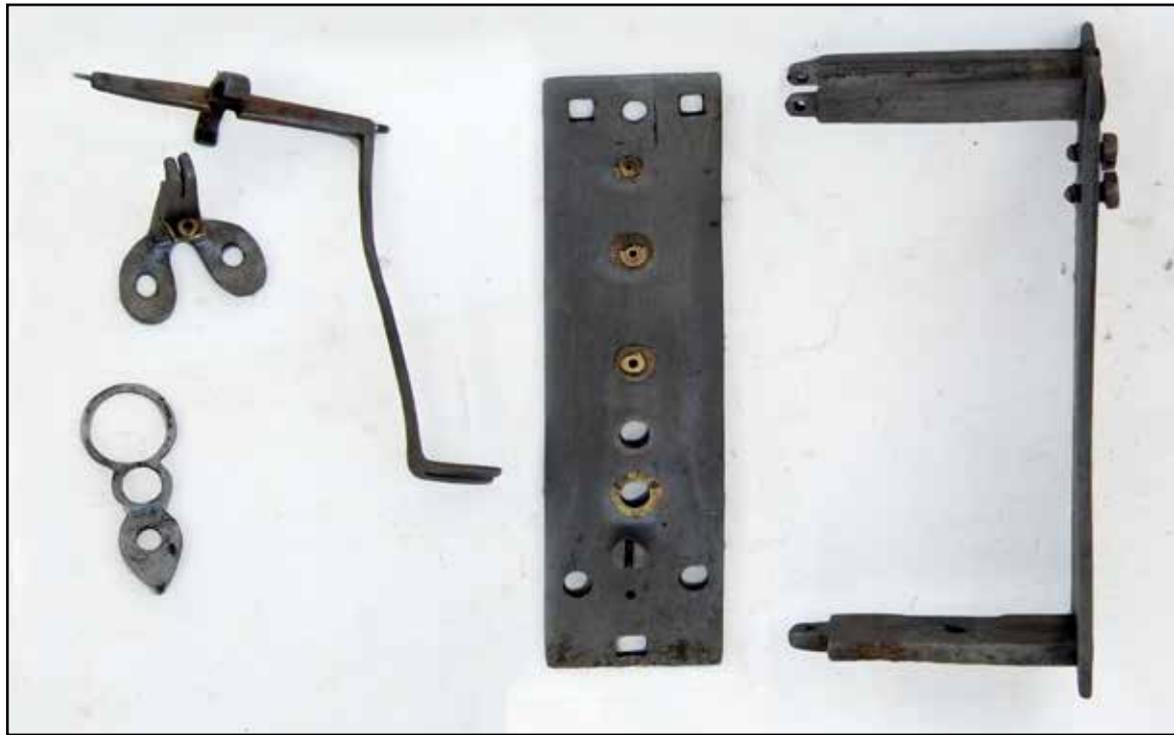
The simple iron strip-frame movement is only $5\frac{3}{16}$ in tall, $1\frac{3}{8}$ in wide and $2\frac{1}{8}$ in deep (132mm by 38mm by 55mm). It has quite a different construction to strip frames from Germany, which have vertical movement bars united by horizontal bars at the top and bottom. These are a development of, or at least an alternative to, posted-frame clocks. In contrast this one has two vertical bars united by two rectangular iron pillars at the top and a single broader one at the bottom (**figure 9**), riveted at the rear and held with taper pins at the front.

Figure 9. The movement 'plates', anchor, backcock and support for the hour wheel.

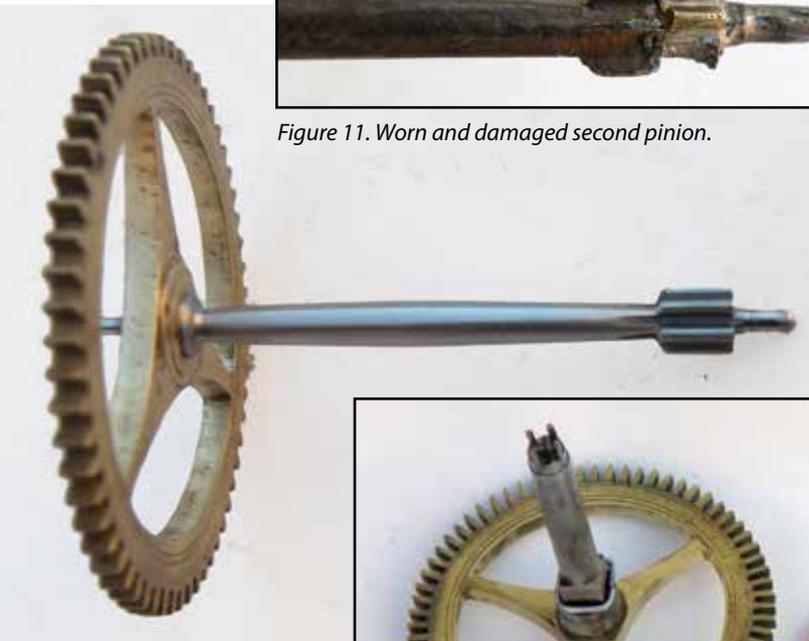
Figure 12 (above). Second wheel with replaced arbor and pinion.

an hexagonal bore with just a small rim left on the arbor to act like a collet. The arbor swelled out in the centre and the replacement was finished to an identical profile using a graver, **figure 12.**
