# A TRIO OF FRENCH

## 3. Cherubs and roses

# CH IRON CLOCKS

by John Robey, UK

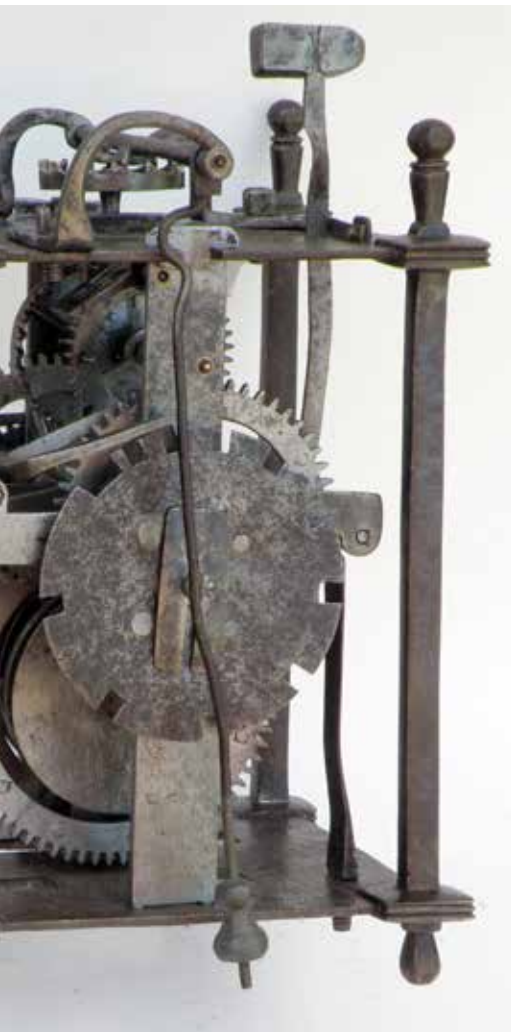
Figure 7. Rear of the movement with the replaced iron countwheel.

The starwheel or ratch for letting off the strike (included in **figure 15**) has 24 points rather than the more usual 12, indicating that not only does the clock strike every hour, but it sounds the half-hours as well. As received the countwheel was made of copper, which was clearly a later modification. I wondered why it had been necessary to change the countwheel, as they do not wear out and even if the narrow raised section at two o'clock had

The countwheel could have been taken off and the teeth on the gear reshaped, but this would probably have affected the depthing with the pinion, which then might have needed replacing. Instead it was decided to leave well alone and not run the striking train. I suspect that a previous owner had also tried to solve the same problem by replacing the countwheel with a poor one, but made of copper.

At this stage the replacement countwheel had ended up in a sorry state, so another one was made, this time paying extra special care to get the divisions as accurate as possible. But the results were no better, so I did what should have been done much sooner and inspected the teeth of the countwheel gear. While they were fairly evenly divided the same could not be said of their width and height, giving rise to uneven rotation of the countwheel. Adding half-hour striking means that the drive to the countwheel has to be more precise than with only the hours strike, so while the variations in the teeth might have been accommodated in an hour-striking clock adding the extra strikes

broken off it is a relatively simple job to repair it. Replacing the countwheel with a more appropriate one cut from a scrap Birmingham iron dial eventually revealed the most likely reason why it had been replaced.

$+ 12 + 1 = 90$  divisions, with suitable modifications to the wheel counts. The new countwheel was carefully marked out into 90 parts, but instead of each notch being just one division wide it was of double width to take into account the extra strike at the half-hours. This was riveted to its gear wheel, but it was soon found that the detent was not falling into

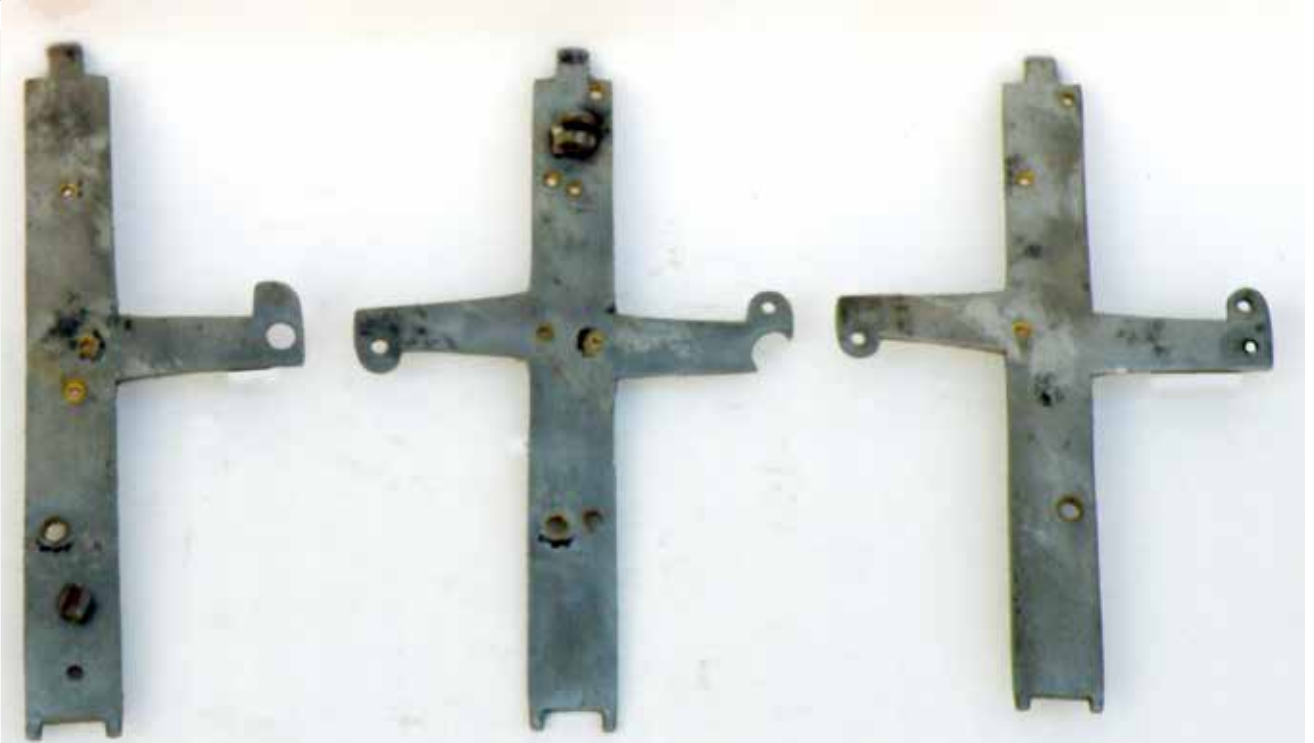
Figure 11. The very unusual movement bars.

This clock uses a very unusual variant of the English arrangement that has not been seen before, but other examples may exist. The central and rear bars are cruciform, while the front one has an arm only on the right. This means that the hammer arbor is only half the normal length and pivots on the left between the central and rear arms, the half-length arbor with the locking and countwheel detents pivots between the right-hand arms of the centre and rear bars. The lifting piece and the warning detent are on a long arbor that pivots between the right-hand front and rear arms, **figures 8 to 9**.

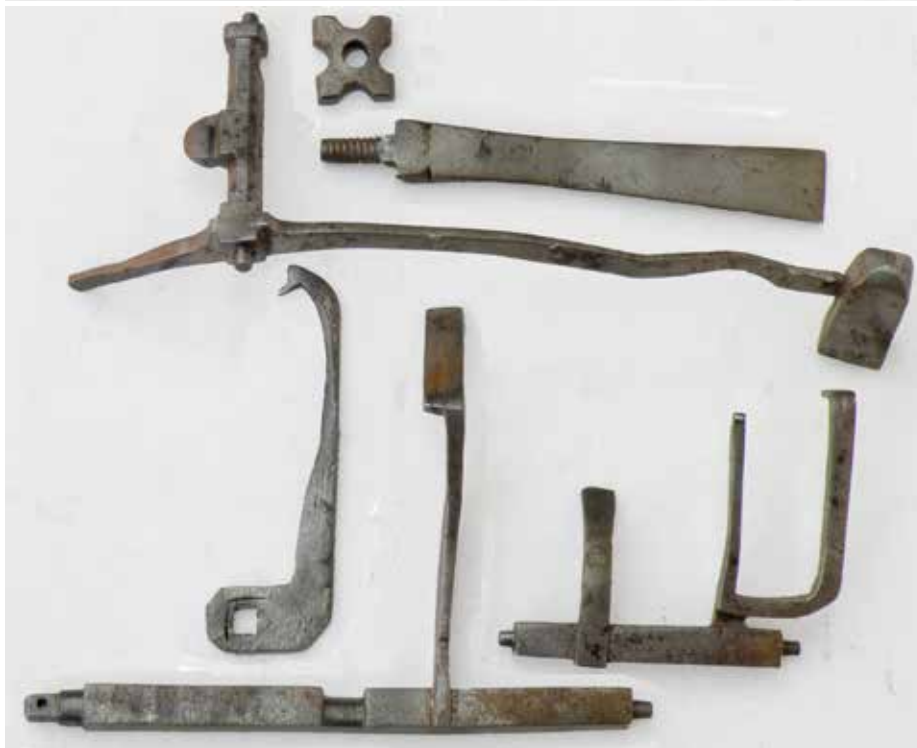
The levers and detents of the strike-work are shown in **figure 18** and the half-length arbors for the hammer and the locking detent, made possible by the very unusual arms on the central movement bar, can be seen. The hammer is of the type found on English 30-hour clocks, with the spring held with a decorative nut underneath the bottom plate. However, instead of the usual L-shaped stop there is a horizontal counter spring on the top plate, a method used on some English lantern clocks, especially from the West Country.

Figure 18. The hammer on a short arbor, hammer spring and nut, lifting piece, warning piece on a long arbor and the link, locking and countwheel detents on a short arbor.

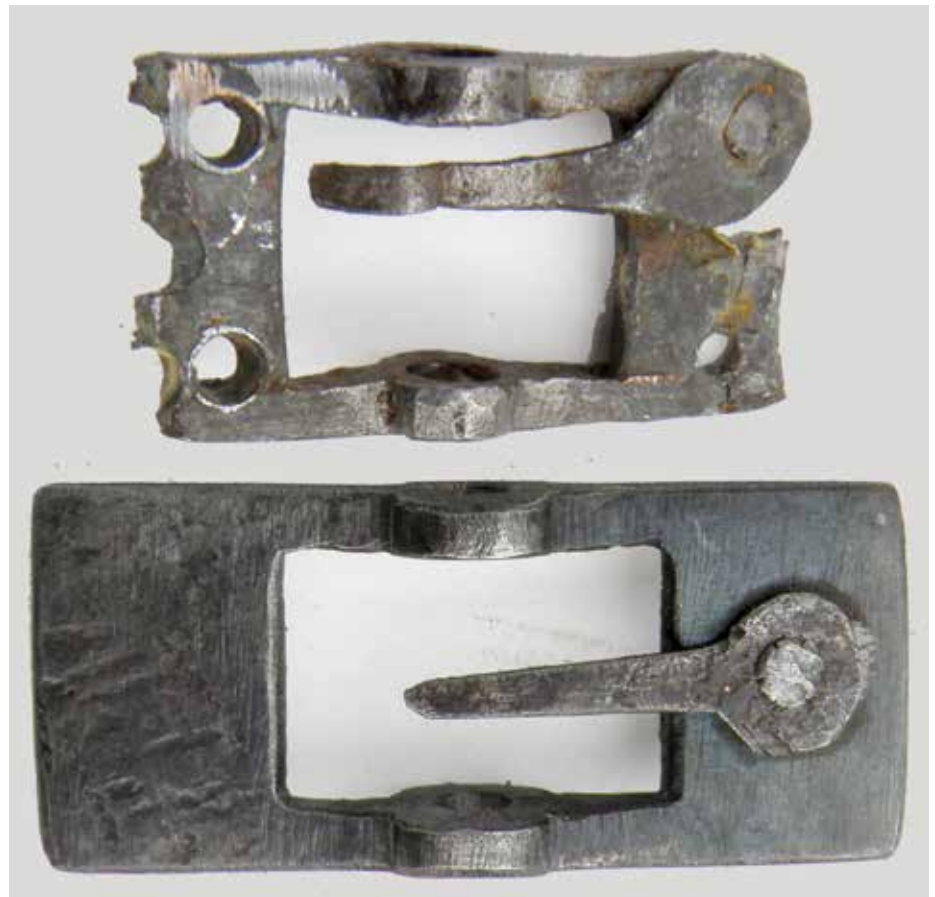
Figure 21. The damaged fly (top) and its replacement (bottom).

the fly, which had two lumps of lead riveted to it to slow it down, either because the friction spring was not holding it on to the arbor, or in a misguided and vain attempt to solve the countwheel problem. Perhaps it was thought that if striking was slower there would be a better chance of the detent dropping into the correct notch. Removing the lumps of lead left a sorry piece of iron with holes and parts broken off.

It was decided to make a new one and though the original would have been largely forged from wrought iron, this would have tested my skills to the limit, so it was made with a milling machine and files rather than a forge and hammer. A component like this is very awkward to hold so it was made from an over-long mild steel bar of rectangular cross-section. This enabled it to be clamped at each end directly to the table of the milling machine. Two wide slots were milled across the centre and then a central strip was cut slightly lower. This was repeated on the other side, making sure that the raised sections where the arbor passed through lined up, **figure 19**. The central aperture was then cut out, the holes for the arbor drilled, **figure 20**, and then the ends used for clamping sawn off, leaving the embryonic fly over-long. After filing to shape it was reduced in length until it just cleared the aperture in the top plate. A friction 'spring' was filed from mild steel, hammer hardened (there is no need to use hardened and tempered spring steel) and riveted in place. After chemically patinating the final result was a good copy of the original, **figure 21**. As an historical record the original damaged fly was retained and tied to a rear finial.
