Iron Crossings and Brass Rims

— and a Thwarted Passing Strike

John A. Robey

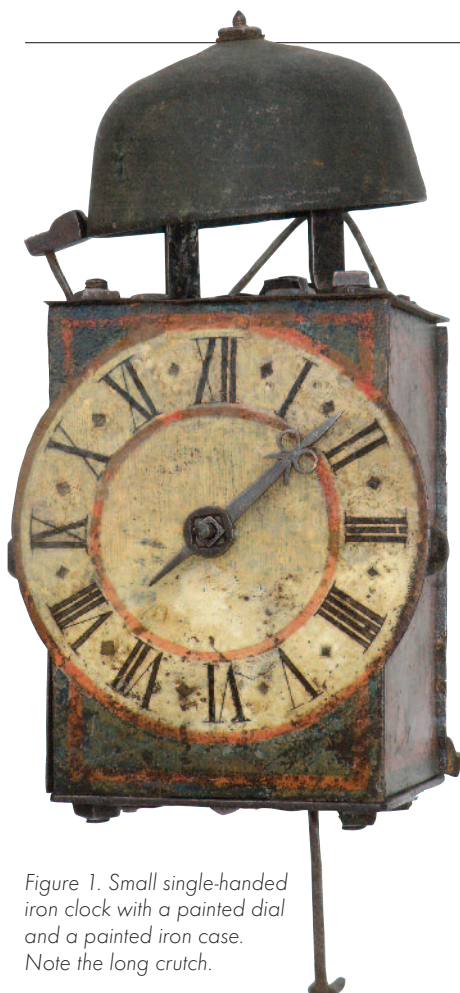
Figure 1. Small single-handed iron clock with a painted dial and a painted iron case. Note the long crutch.

In mainland Europe, a common type of country-made clock was similar to that shown, **Figure 1**, with a painted dial (which had been used for at least

While these wall clocks can have dials up to 12" wide,³ they are usually much smaller, typically about 7 or 8", but this one is particularly small, the one-piece dial being only 4" (102mm) wide by 6" (150mm) tall, the chapter ring extending a further 1/2" (15mm) at each side. The areas above and below the chapter ring are painted a dark bluish-green colour framed by a red line, with the iron side doors similarly decorated. The Roman hour numerals sit between two red circles, with the centre being a plain off-white colour. There was never an alarm. Two tabs at the bottom of the dial sit in slots in the movement bottom plate, while two tabs at the top are held in slots in the top cover, **Figure 2**. On this cover is fixed a two-armed bell-strap and the pendulum backcock, which is riveted to it. The long crutch extends about 3" (75mm) below the bottom plate.

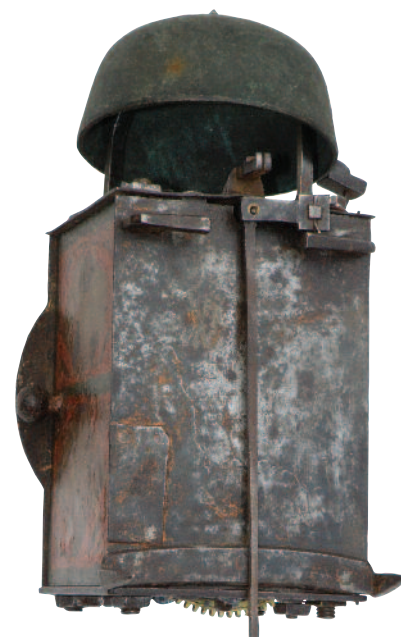
Figure 3. Rear of the case showing the separate cocks for the pendulum and rear pallet arbor pivot, the supports for the hanging hoop and spikes.

The rear cover, **Figure 3**, is held in a similar manner to the dial and has a bar with spikes to hold it off the wall. Instead of the usual hoop (which is typically much smaller than on an English lantern clock) there are two L-shaped pieces around which a hanging hoop can be hooked. An advantage is that the clock can be made to sit vertically on a wall that is out of plumb, but it has not been seen on other clocks. The side doors, **Figure 4**, have iron pull knobs, but no turnbuckles or catches and are a simple push-fit behind the dial. Due to the large wheels (see later) the left-hand door has a slot for the hammer and a shaped cover.

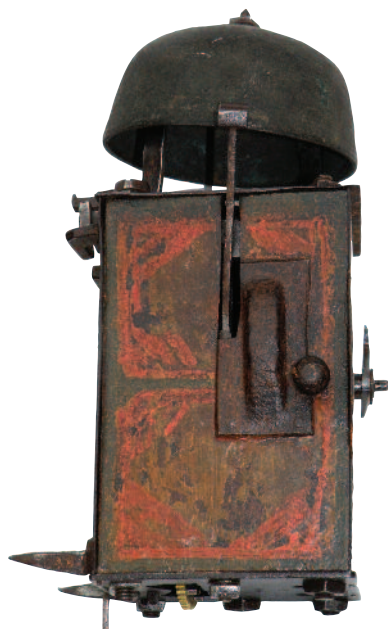
Figure 4. Left-hand door with a slot for the hammer and a shaped cover for the large going second wheel.

Figure 11. Consequently, to allow the left-hand door to shut there is a clearance aperture covered by a shaped cover, **Figure 4**. In addition, the front of the horizontal hammer arbor would block the going second wheel, so it is of reduced length, **Figure 15**, and its front end pivots in an iron bracket hanging down from the top plate, **Figures 7 and 9**.

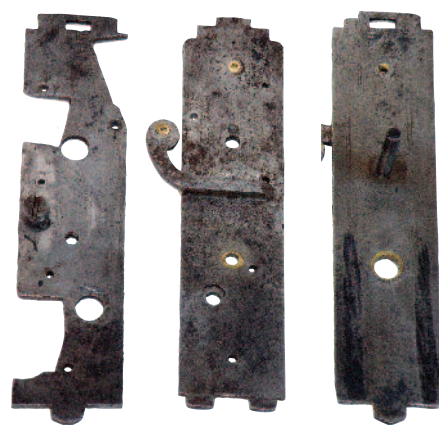
Figure 11. The iron movement bars. The second wheel of the going train pivots in an extension riveted to the front and centre bars.

The iron movement bars, **Figure 11**, have either one or two tabs at their lower ends that sit in slots, in a similar manner to the pins on English posted-frame clocks, with the central bar held with a wedge. Slots at the top of the front and rear bars sit over tenons filed into the edges of the plate. This is the Germanic method and is normally also used at the lower end of the bars, especially on clocks from southern Germany.

one has another on the right-hand side, **Figure 11**. A third cut-out at the lower left with a couple of small holes are at present unexplained, as are a large hole towards the top and a screw hole in the centre. The latter also fits the pivot post of the countwheel, which may have been its original, but incorrect, position.

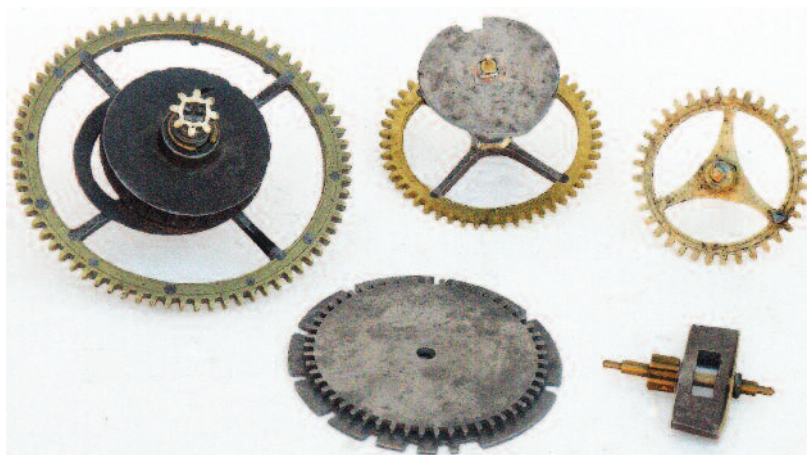
Figure 13. The striking train with composite iron and brass greatwheel and second wheel.

The wheels of the going and striking trains are shown in **Figure 12** and **13**. Winding of both trains is by the usual Germanic type of vee-pulley with serrated sides that grip a hard rope. Provided there are counterweights, this system is quite reliable and is not so prone to filling the movement with fluff from a soft rope and spikes. There are separate weights and counterweights for each train, not a Huygens loop, which is primarily found on English and Dutch clocks and on only some French posted-frame clocks.

The counts of the striking train are:

Fly	6
Locking wheel	36 — 5
2nd wheel	50 — 6
Greatwheel	72 — 8
(12 hammer pins)	
Countwheel	52

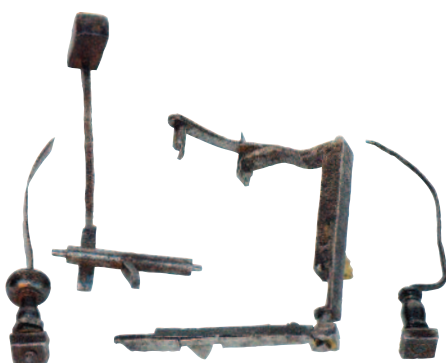
Figure 15. The hammer and spring (left) and the strikework arbor and its return spring.
