LIEGE ALARM

by John R

CONVERSION

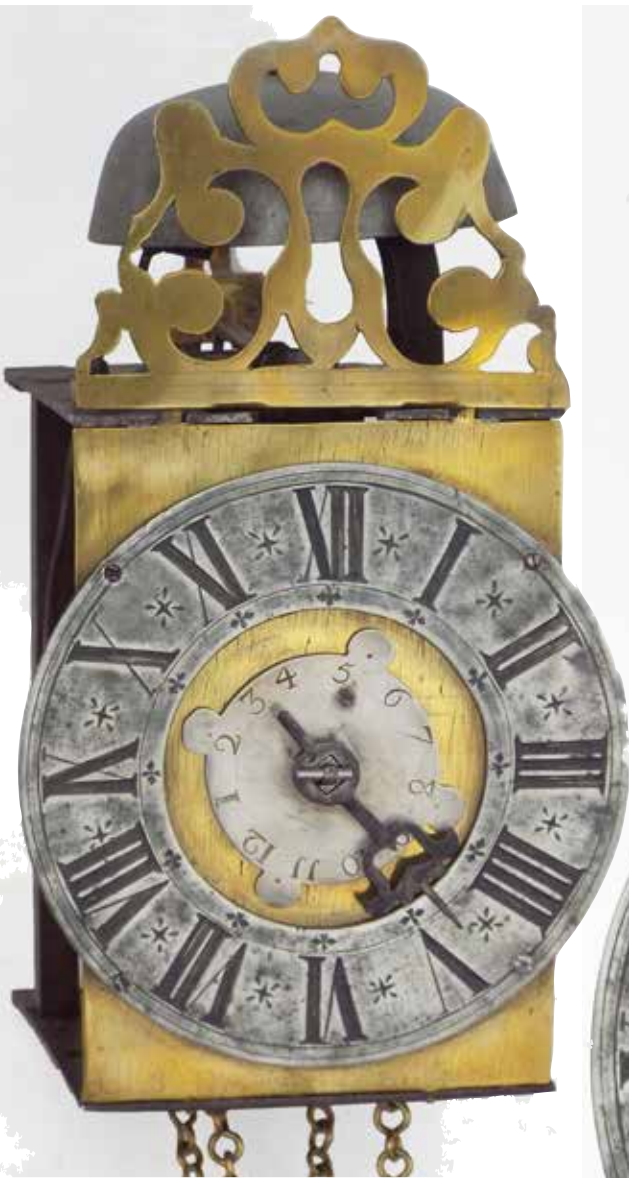
Figure 1. Liège alarm, with a brass dial, brass fret and a pewter chapter ring.

Which brings us to the subject of this article, shown in **figure 1**. It is a small short-duration rural clock with a thin brass dial and fret, a pewter chapter ring, a single iron hand, and brass wheels, in a simple iron frame with square corner pillars and no finials or feet. It is clearly not English, and like most country-made

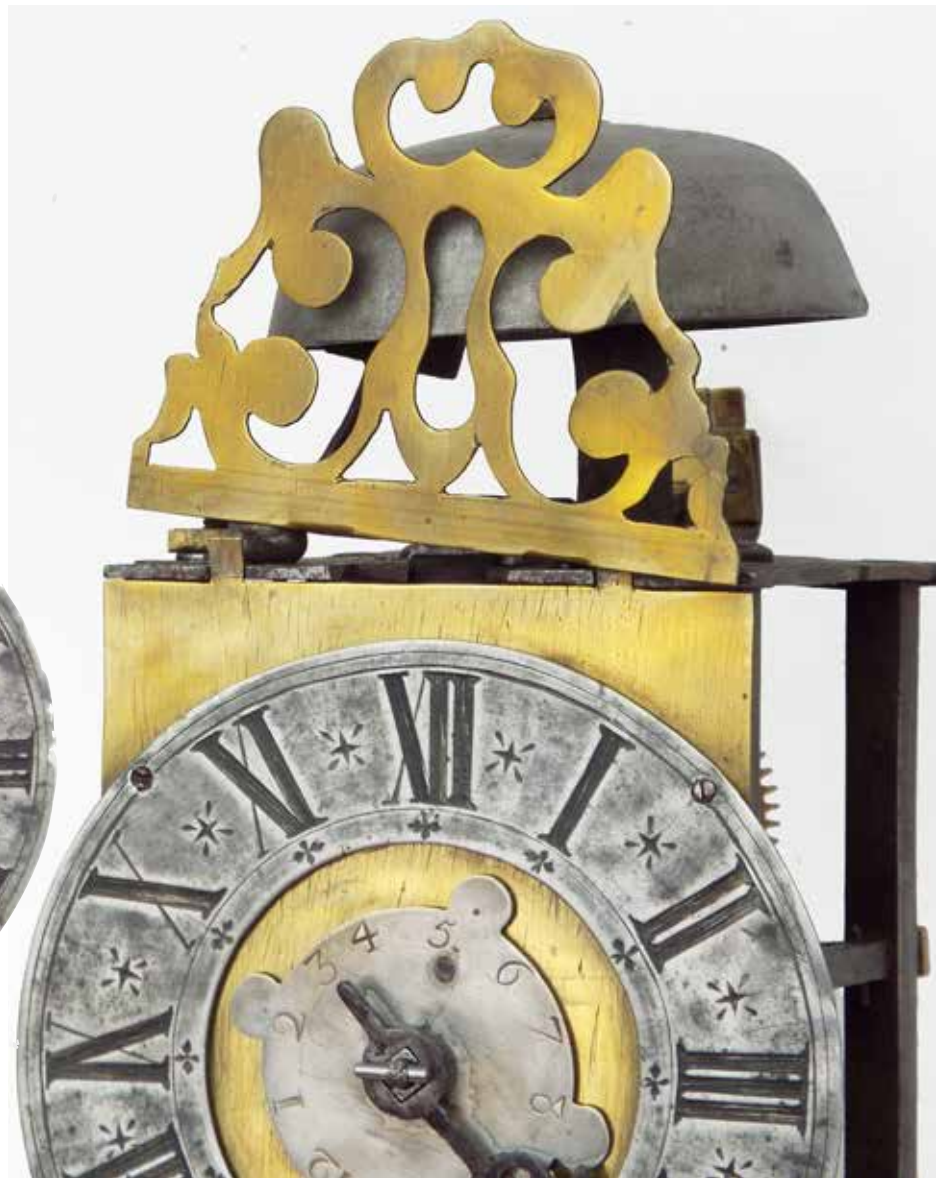
Figure 2. Tabs at the top of the dial held by the thin fret.

The thin rectangular brass dial sheet is 5½in (140mm) tall by 4in (102mm) wide, with a pewter chapter ring 5in (127mm) diameter fixed to it by four screws. Two small tabs at the bottom of the dial sit in holes in the plate, while larger tabs sit in locating recesses in the top plate and are held by the thin and relatively tall sheet-brass fret, **figure 2**. This simple and neat method is only practical with dials and frets that are thin. A more obtrusive variant of the same method holds the dial by two tabs on the fret sitting in front of the dial, **figure 3**.

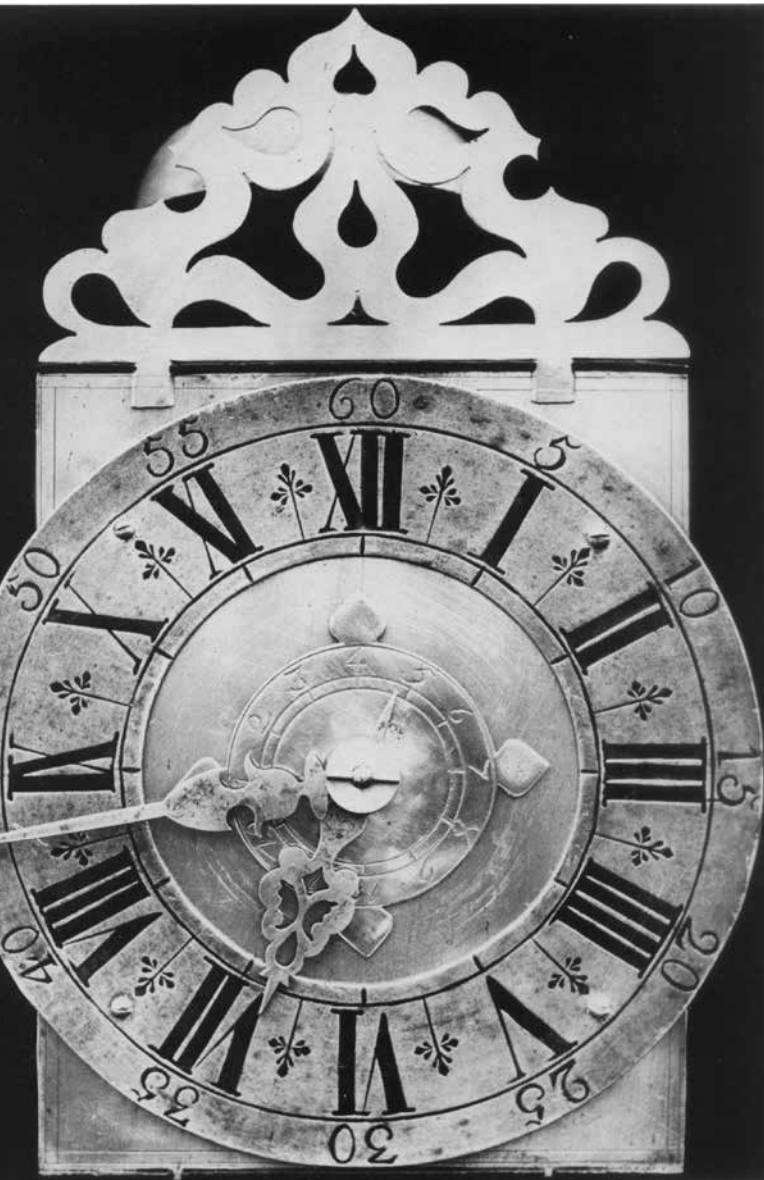
Figure 3. Tabs on the fret holding the dial of a two-handed Liège clock (from *KLOKKEN KUKBOEK* by W F J Hana, 1978).

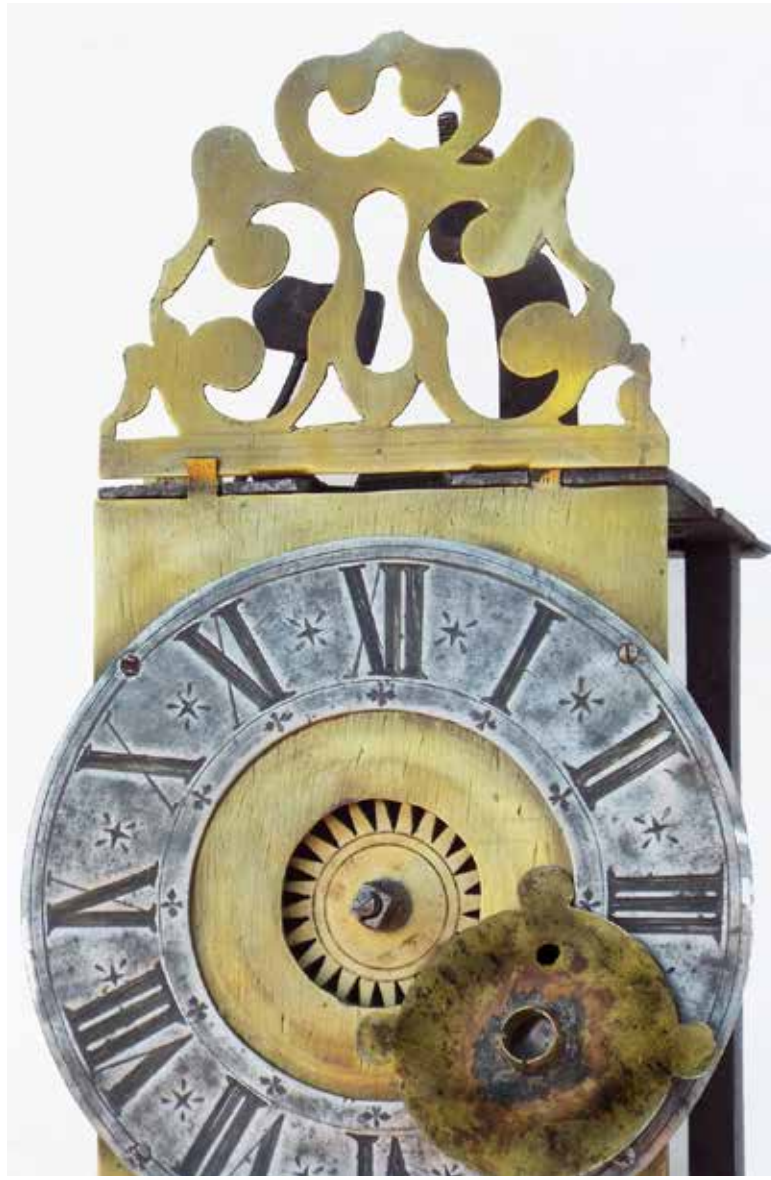
Figure 4. Cut-off pin on the back of the alarm disc and the large central hole in the dial.

The brass alarm-setting disc, which has been recently silvered, masks a large hole in the centre of the dial, **figure 4**. This was necessary as the pin (now cut off) to lift the alarm lever was on the back of the disc and its pipe was just a friction fit on the hand arbor. This arrangement is even simpler than that found on English alarms. The iron hand, **figure 5**, has a thick central boss and tapers towards the tips.

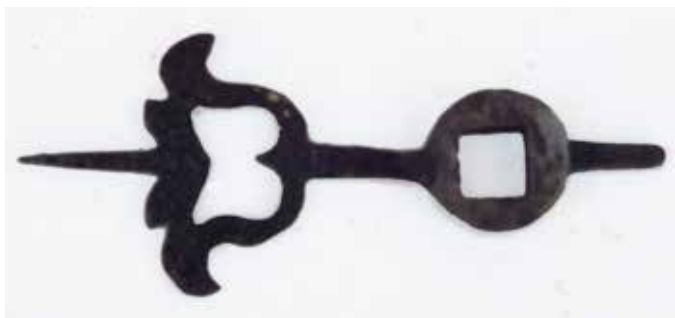
Figure 5 (above).
The simple iron hand.

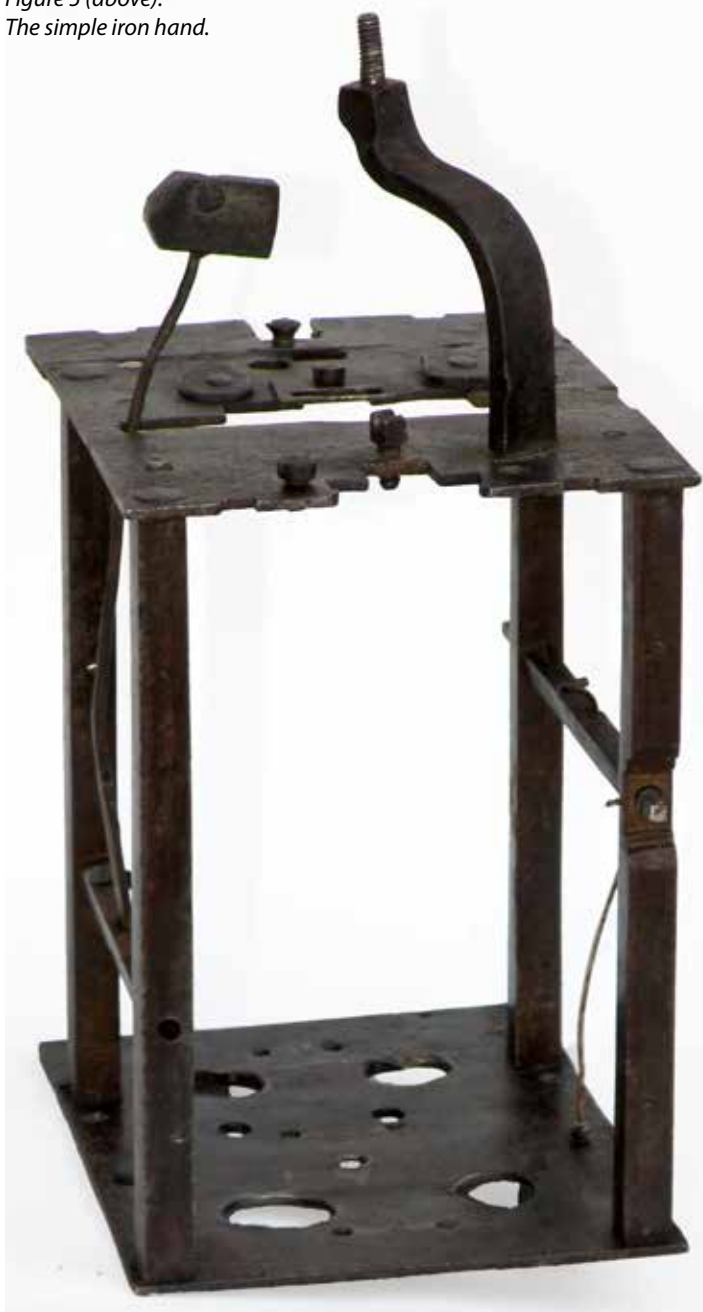
Figure 6 (left). The
iron frame with
riveted pillars.

The iron frame, **figure 6**, has thin square

pillars that are riveted flush with the plates, without finials or feet, as is typical of rural clocks made in the Liège area. The front and central movement bars are made of iron with inserted brass bushes, and the original rear bar would have been very similar. The movement bars are straight, **figure 7**, without the side arms found on English lantern and other posted-frame clocks. Empty holes in the plates indicate that there were once side doors, a rear cover and side frets, probably all made of painted iron, that were removed when the striking train was added.

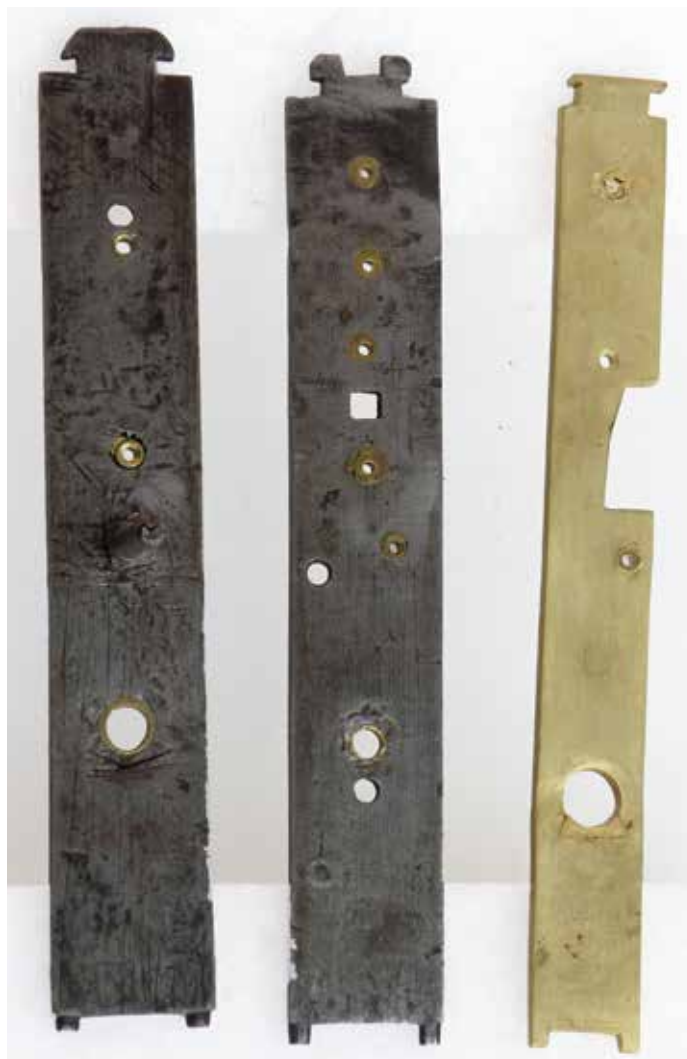
Figure 7 (above).
Original iron
movement bars
and the later
brass bar.

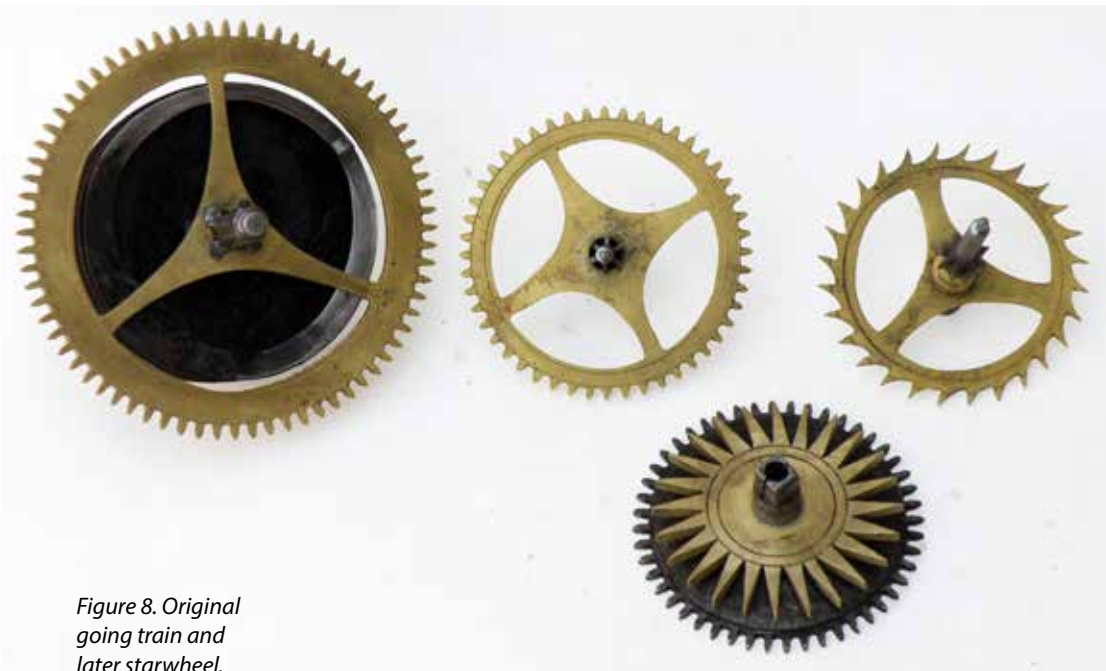
Figure 8. Original going train and later starwheel.

The wheels of the going train are relatively thin and made of brass, **figure 8**. The second wheel has four crossings, but the other two wheels have three crossings. A four-pronged pinion-of-report filed on the

Going train

escapewheel	28	8
2nd wheel	48	6
greatwheel	72	4
hour wheel	48	
beat = 0.90 seconds

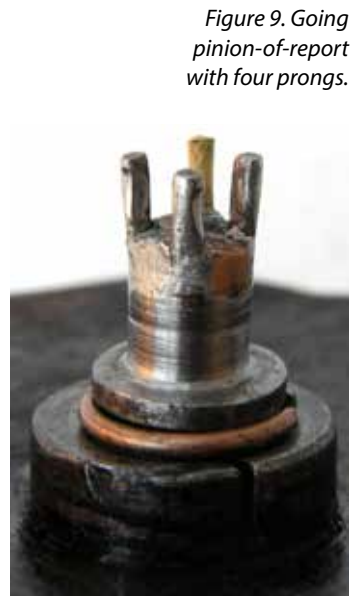
Figure 9. Going pinion-of-report with four prongs.

end of the greatwheel arbor drives the iron hour wheel (**figure 9**). The crownwheel for the alarm would have rotated on a post on the back of the central movement bar, with the verge pivoting between a small cock or potence on a rear bar, also made of iron, and the top plate. The alarm hammer at the top of the verge would have rattled inside the bell, which, like its bell stand is probably original.

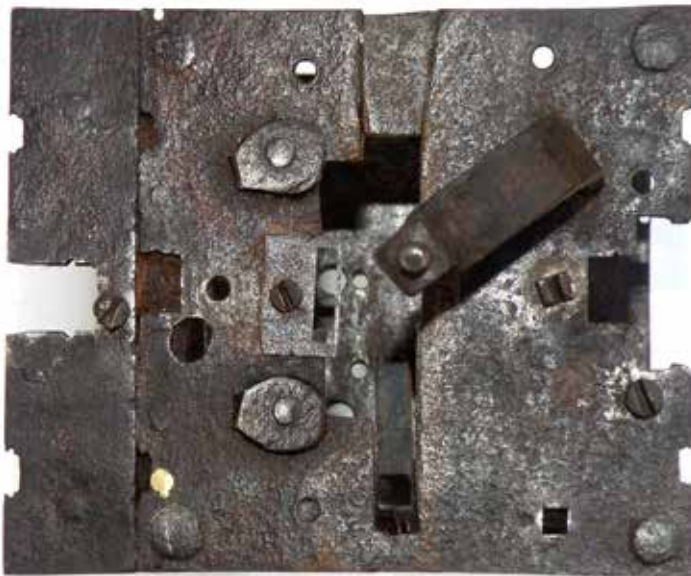
Figure 10. Top plate with rear extension.

riveting iron strips on to the top and bottom plates. Cutting a slot for the hammer weakened the top plate, so it had to have extra pieces added for support, **figure 10**.

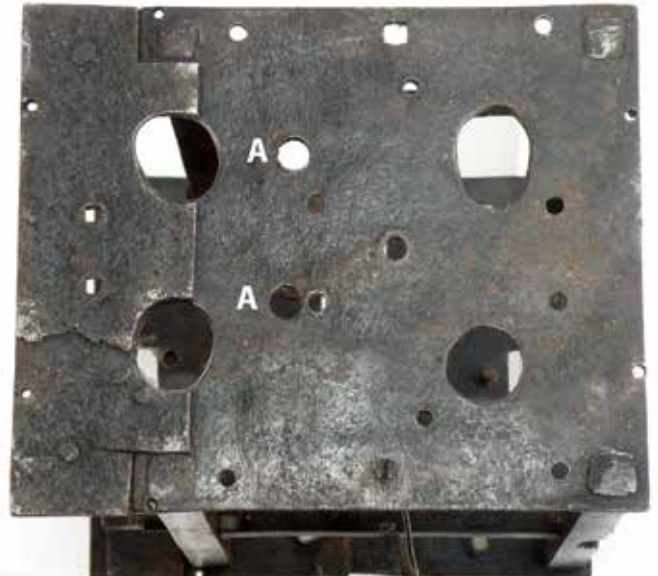
Figure 11. Extended bottom plate with two additional chain holes. The redundant holes for the alarm rope are marked 'A'.

The bottom plate was also extended and two new holes were cut to take a chain (there was probably a rope originally), leaving the now redundant smaller holes of the alarm rope, **figure 11**. The rear movement bar that held the alarm verge was replaced by a brass one, along with a striking train, **figure 12**, and the associated strikework, hammer, spring, and countwheel, **figure 14**. A starwheel with 24 points to let off the hour and half-hour strikes was fixed to the hour wheel. These additional wheels are considerably thicker

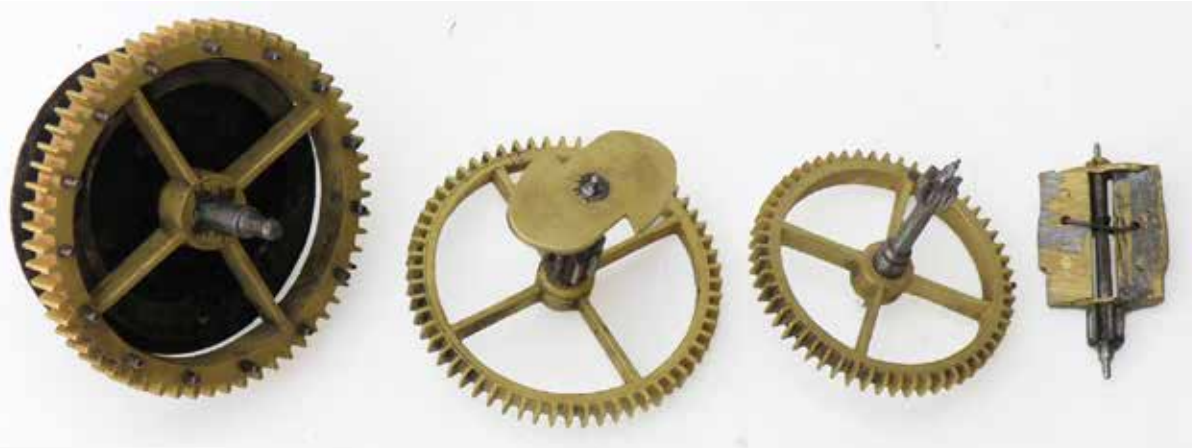
Figure 12 (above). Striking train from a Dutch clock.

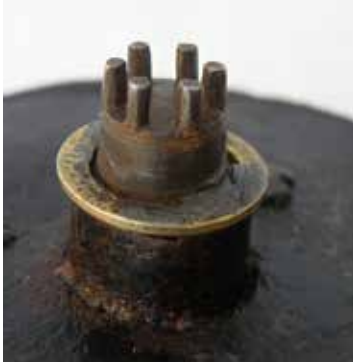
Figure 13 (left). Striking pinion-of-report with six prongs.

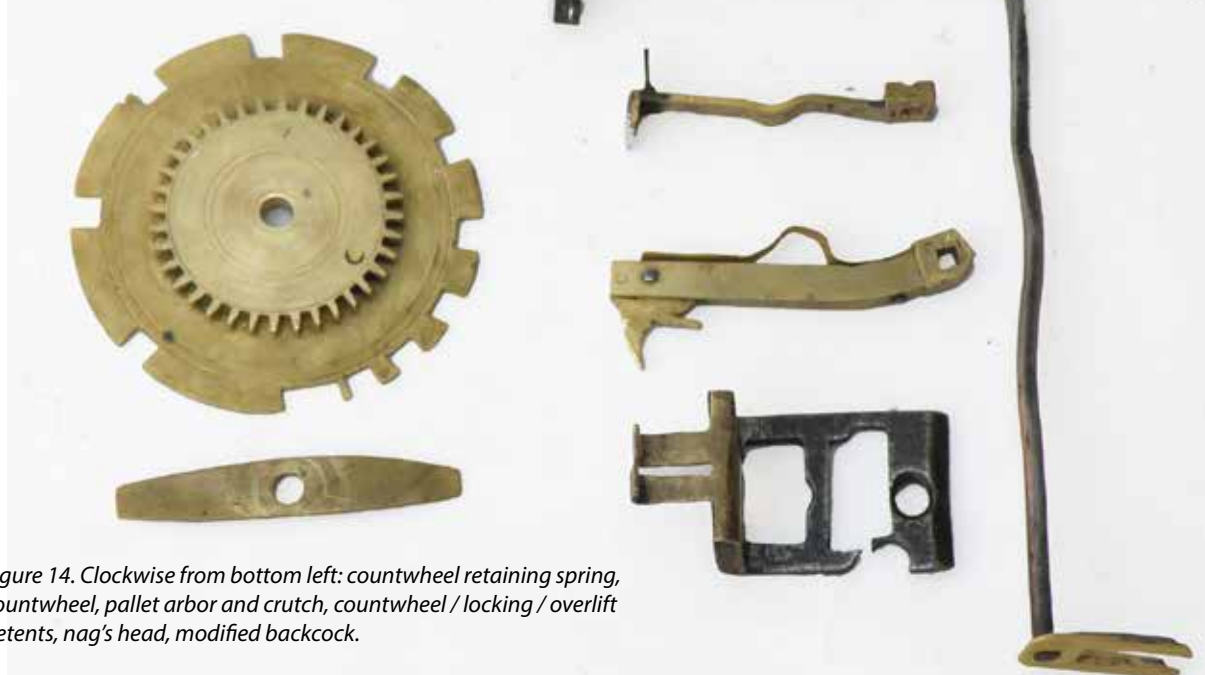
Figure 14. Clockwise from bottom left: countwheel retaining spring, countwheel, pallet arbor and crutch, countwheel / locking / overlift detents, nag's head, modified backcock.

Dutch weight-driven clocks continued to use the early nag's head system of striking, whereas warned striking was used from the start of domestic clockmaking in England. On this conversion the nag's head is squared on to the front of the single strikework arbor with the combined locking, overlift and countwheel detents squared on at the rear.

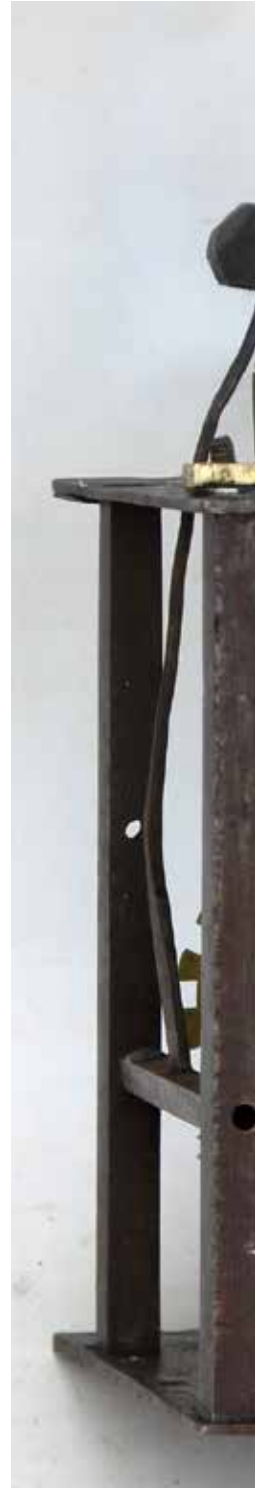
Figure 15 (left). Front of movement with the added starwheel and nag's head.

backcock was rather crudely modified so it could now sit over the top of the new rear bar and a longer pallet arbor was needed. The modified movement with its added striking train is shown in **figures 15 to 19**.

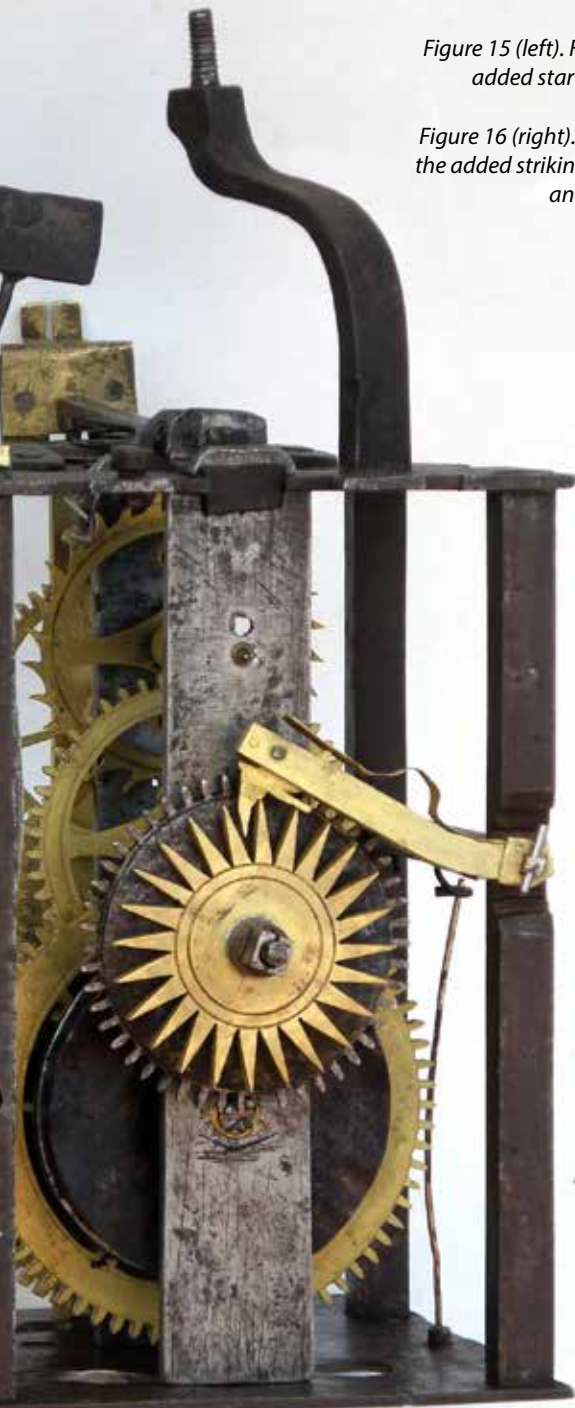
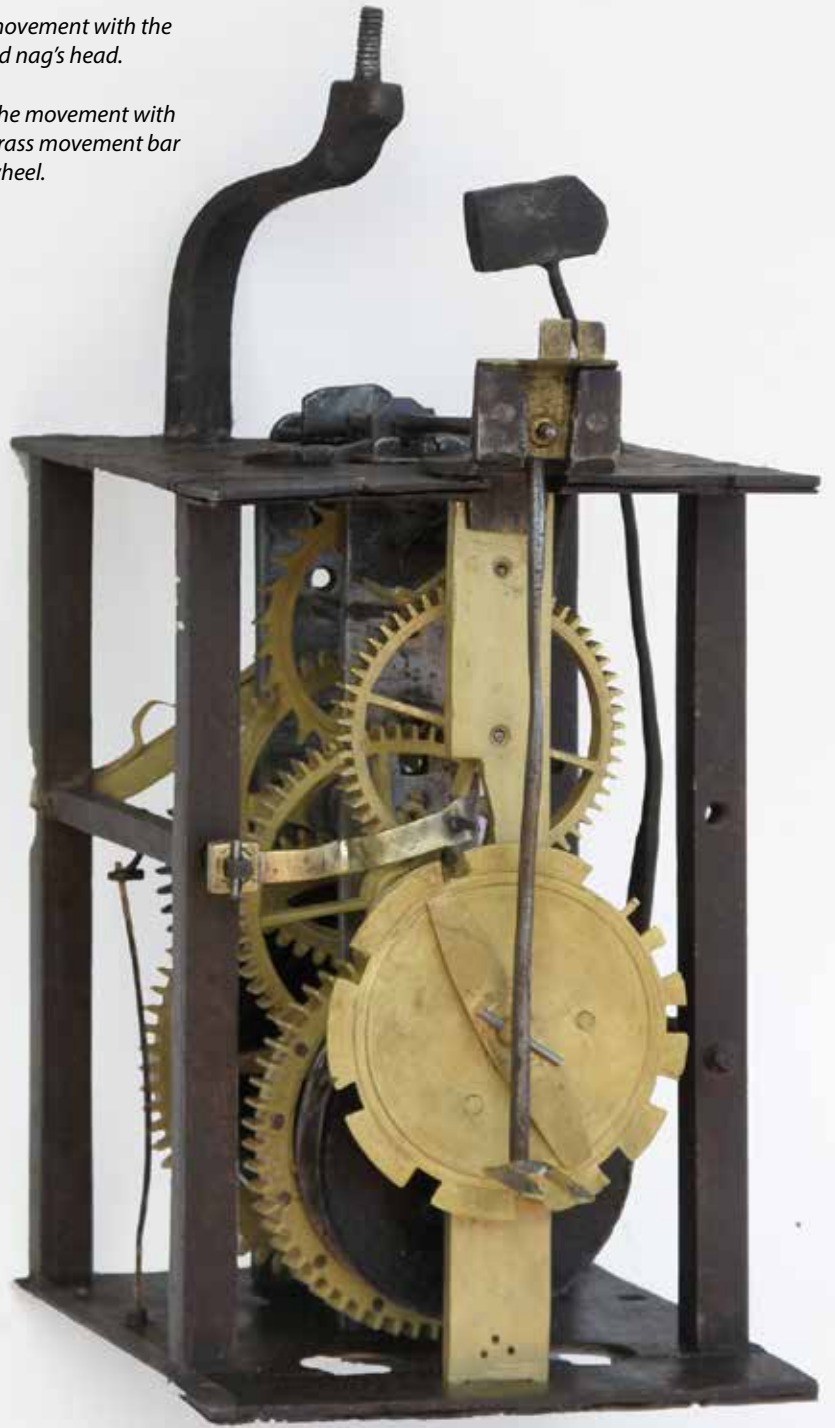
Figure 16 (right). Rear of the movement with the added striking train, brass movement bar and countwheel.

Figure 16. Rear of the movement with the added striking train, brass movement bar and countwheel.

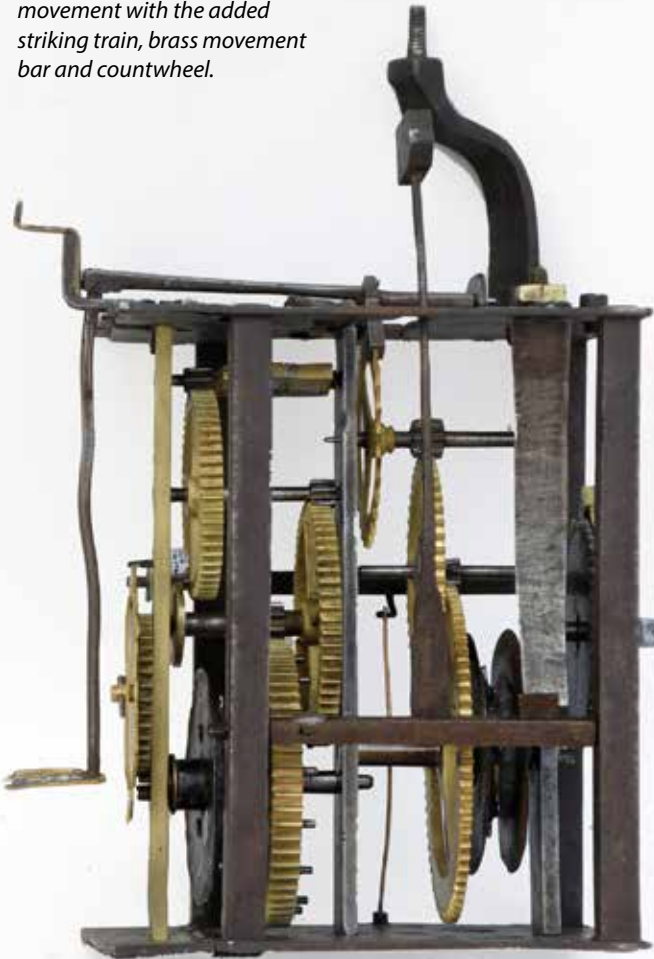
Figure 18. Right-hand side of the movement. Note the thicker wheels of the later striking train.

than those of the original going train, as can be seen in the side views of the movement, **figures 17** and **18**, and they have four parallel crossings. They were from an eighteenth or nineteenth century Dutch *Stoelklok* or *Staartklok* movement, probably made in Friesland, Groningen or Drente.
