THE ADAM

Part 1: The dial

by John F

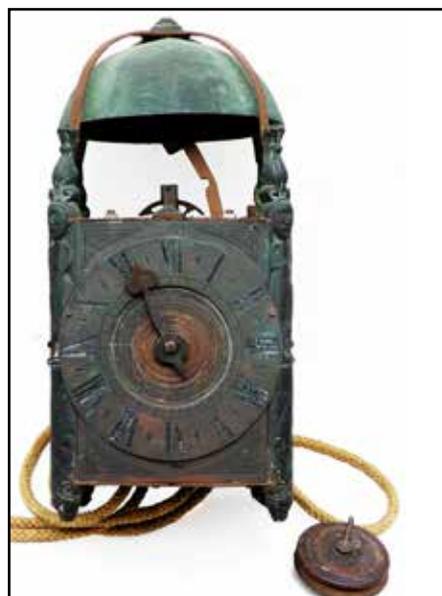
Figure 3. The clock as received.

had a very tarnished chapter ring, a very poor hand and a single side fret, all recent, **figure 3**.

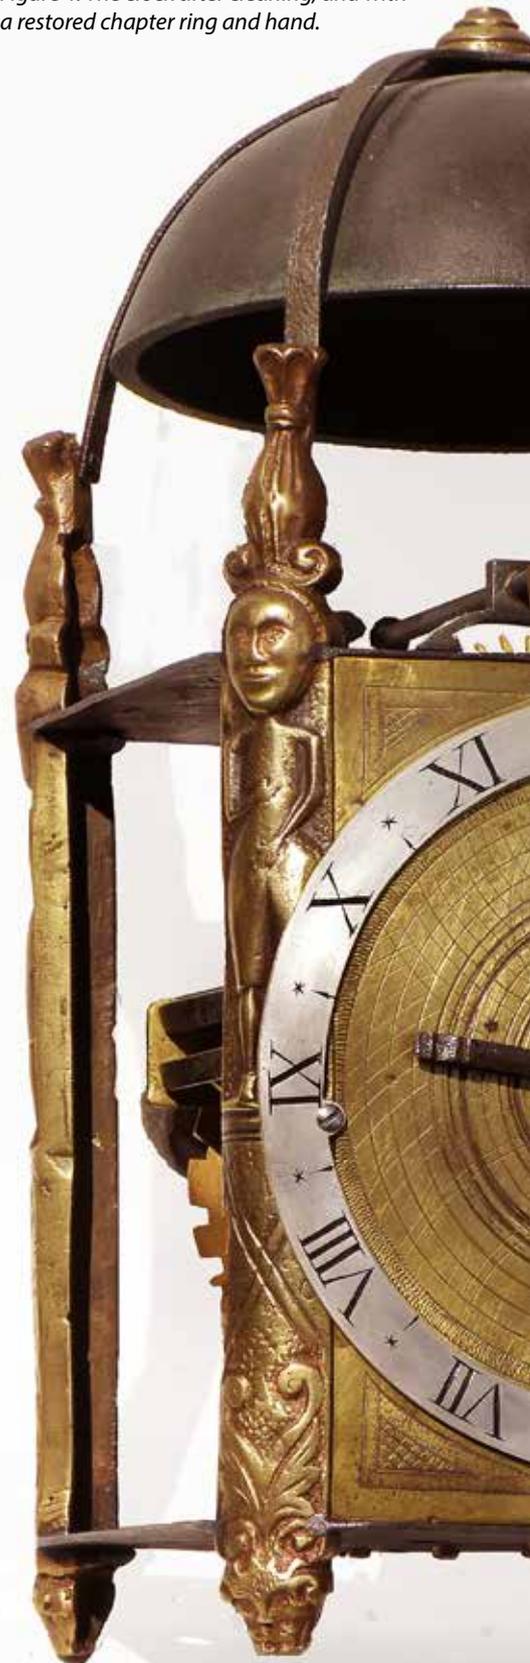
Figure 4. The clock after cleaning, and with a restored chapter ring and hand.

When the chapter ring was removed it could be seen that the size of the original chapter ring was delineated by wiggles decoration. This type of simple engraving was done by 'walking' a broad graver across the surface of the brass, and is usually associated with clocks made by the Quaker clockmakers of North Oxfordshire in the first half of the eighteenth century, but this clock is almost a century earlier.

The original chapter ring would have been only 1/2in (12.7mm) wide, much narrower than on any other known English lantern clock, so a replacement was made to suit. The relatively recent hand was replaced by one made from a piece of old wrought iron in a simple early style. After the pillars had been cleaned to reveal the details of the cast-brass figure on each corner, the clock

looked as shown in **figure 4**.

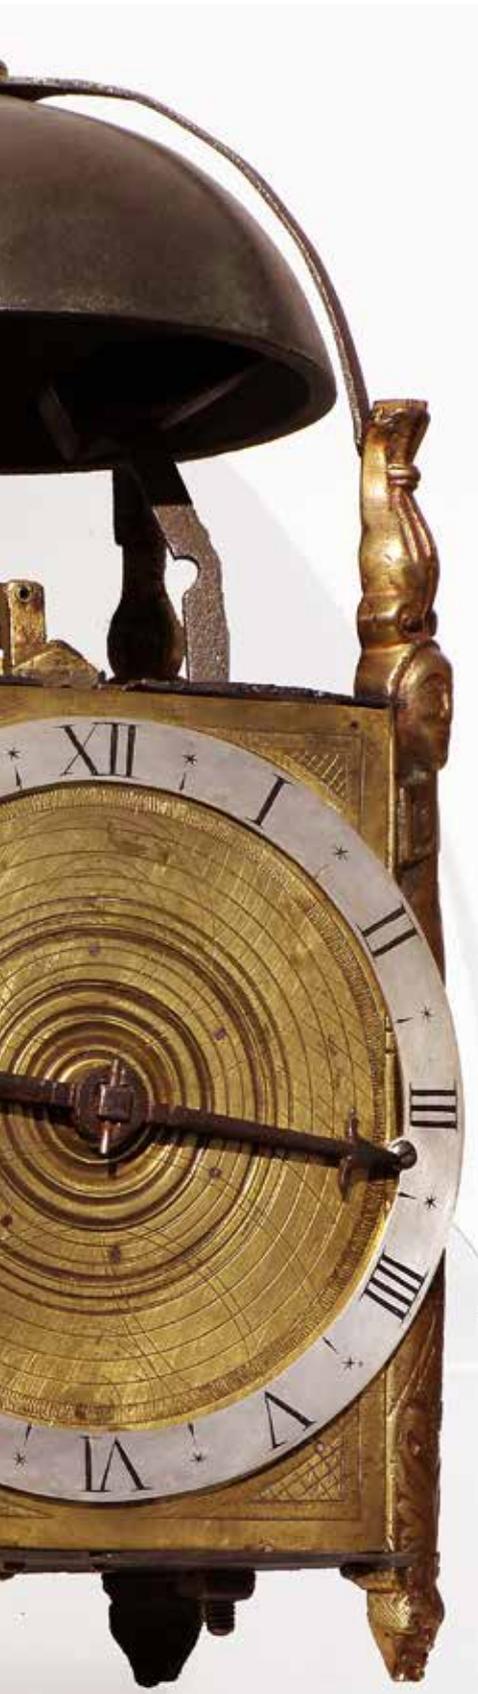
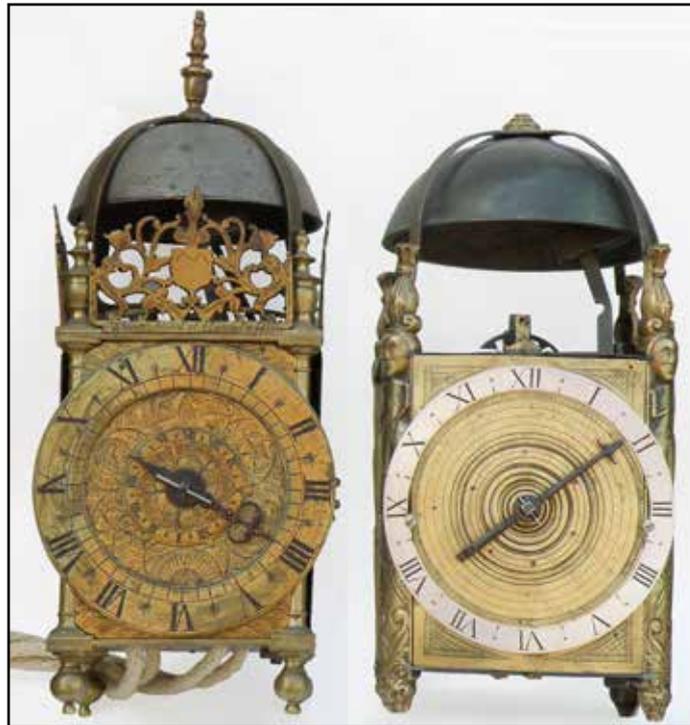
Figure 2. The restored Adam clock (right) compared to a mid seventeenth-century London lantern clock.

The Adam clock is shown after restoration in **figure 2**, next to a standard London lantern clock of about 1650, so that its uniqueness can be appreciated. The clock as sold on eBay

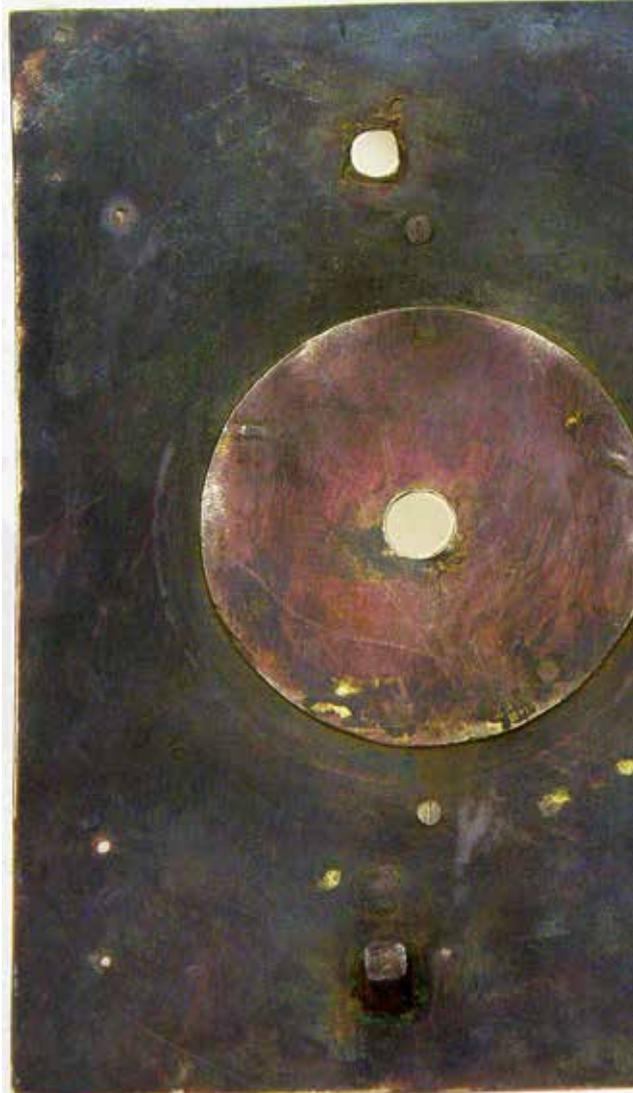
Figure 6. Rear of the dial with the insertion of a thicker central section.

The centre is a disc of thicker brass soldered in place, **figure 6**, the join coinciding with one of the heavily scribed circles. This separate piece does not perform any practical purpose, and it is likely that the circles were scribed so deeply that they cut through the thin sheet and a repair was made by adding a thicker central section. Both this disc and the thinner main part of the dial appear to be re-used pieces of

The rear of the dial has signs of a few plugged holes, which are a further indication that it was a re-used piece of brass. A new chapter ring was made from an old scrap brass dial to fit the space between the wiggework, and engraved with squat Roman hour numerals of the type found on early

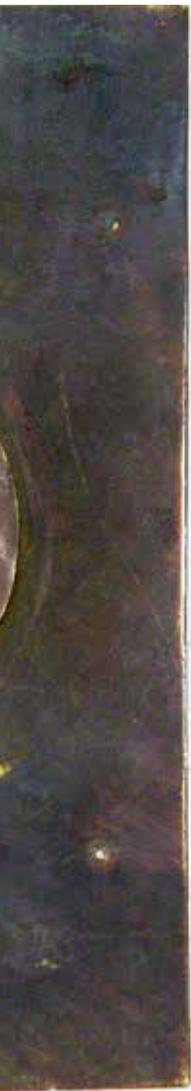
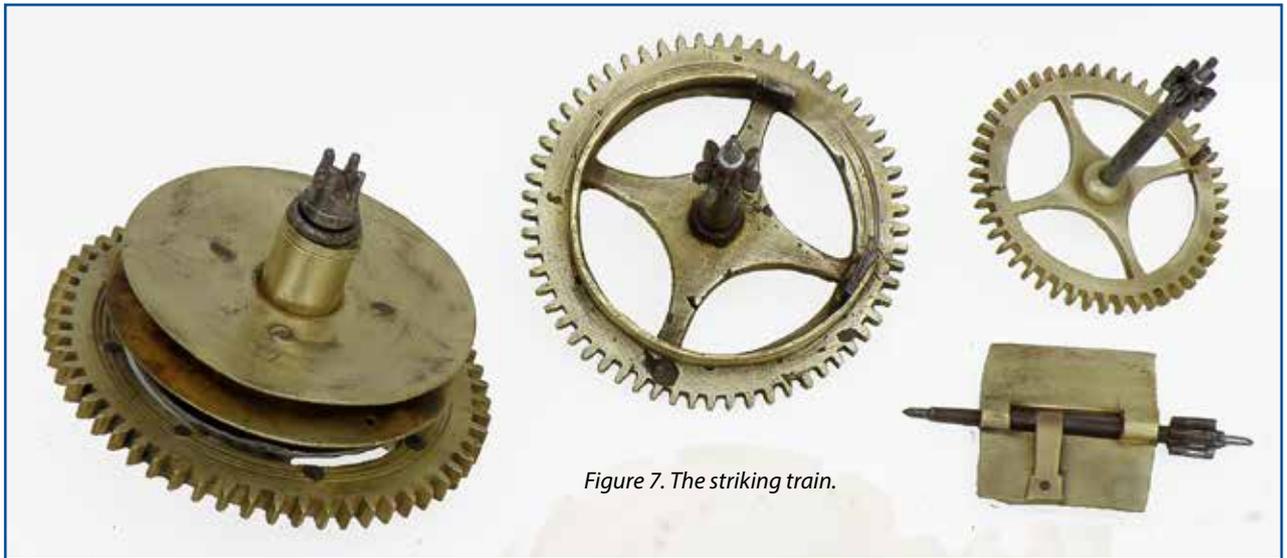
Figure 7. The striking train.

Like most early lantern clocks the going train has been altered, but the striking train is relatively unchanged, so it is described first. Although the fly and the warn wheel have had their arbors and pinions replaced due to excessive wear, the striking train remains

essentially as it was when first made, **figure 7**, with the usual four-pronged pinion-of-report filed on the end of the great wheel arbor. The fly is a later lighter version and the aperture in the iron top plate has been enlarged to accommodate it. The hoop-wheel arbor is steeply tapered and has a turned ring near the wheel, which is fitted directly to the arbor without a separate

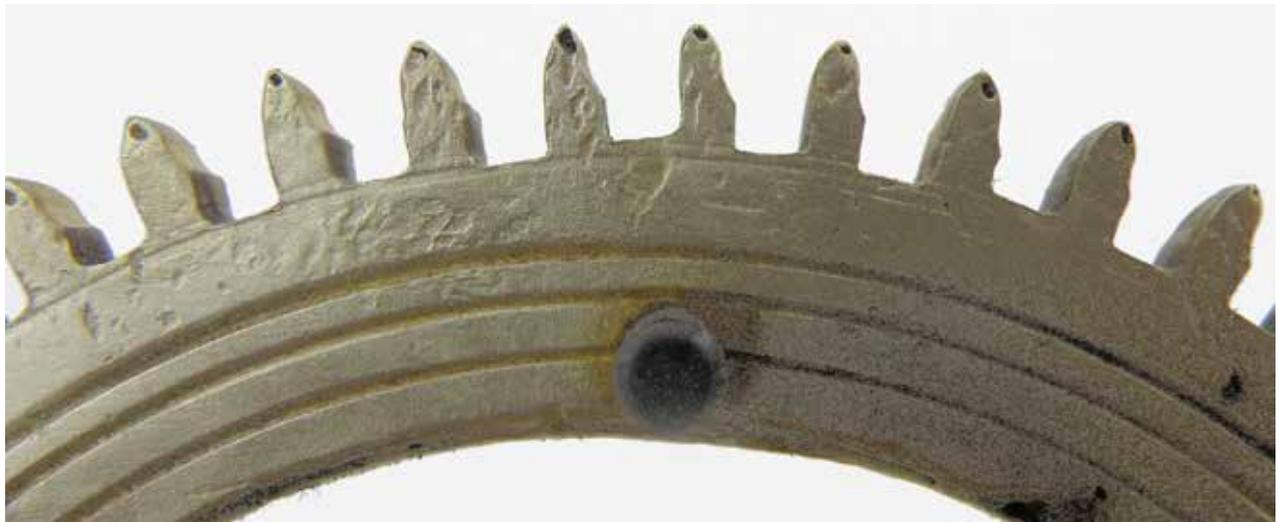
Figure 8. Teeth of the striking great wheel show considerable wear, and punch marks indicating they were cut and rounded by hand.

Punch marks on the tips of the teeth of the hoop wheel and the great wheel show that they were marked out using a dividing plate, before being slit by hand and rounded with a file, **figure 8**. The wheel counts for the striking train are

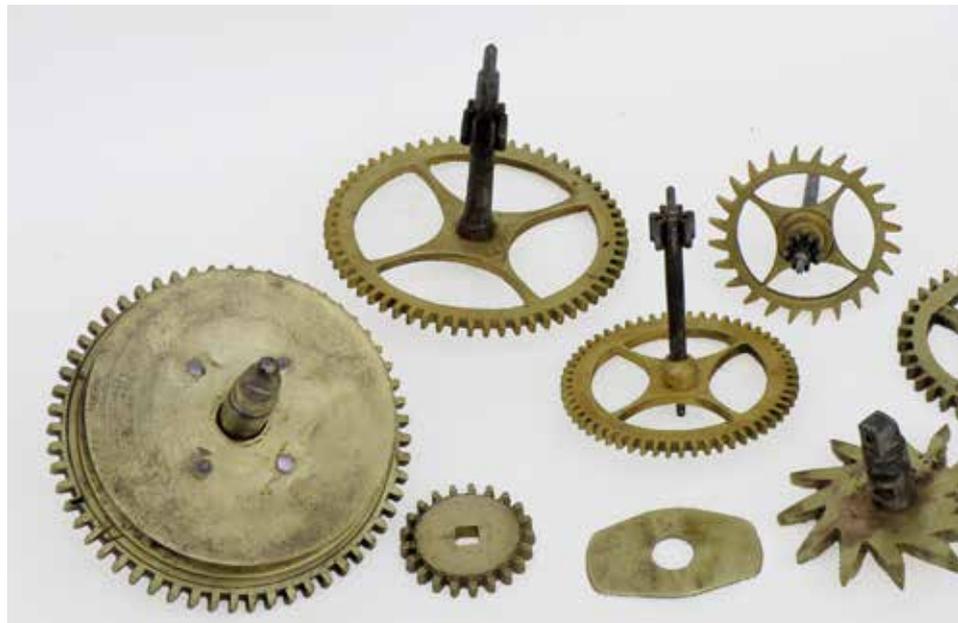
Figure 10. The four wheels of the going train after conversion to long pendulum and anchor escapement, together with the starwheel and later pinion-of-report and hour wheel.

Normally, when converted from a short to a long pendulum the contrate wheel was simply replaced by an escape wheel with radial teeth and new pallets for an anchor escapement fitted. This clock was converted by replacing the contrate wheel with a third wheel and adding an escape wheel at the top of the train. Hence it now has a going train of four wheels instead of the usual three, **figure 10**. This allowed the use of higher-count pinions and a slower running train, which in turn meant that the motionwork could be altered

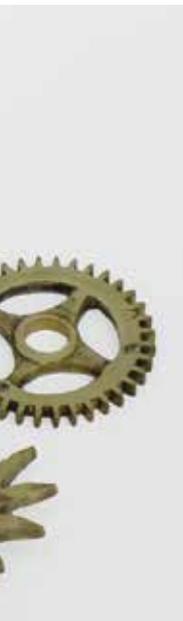
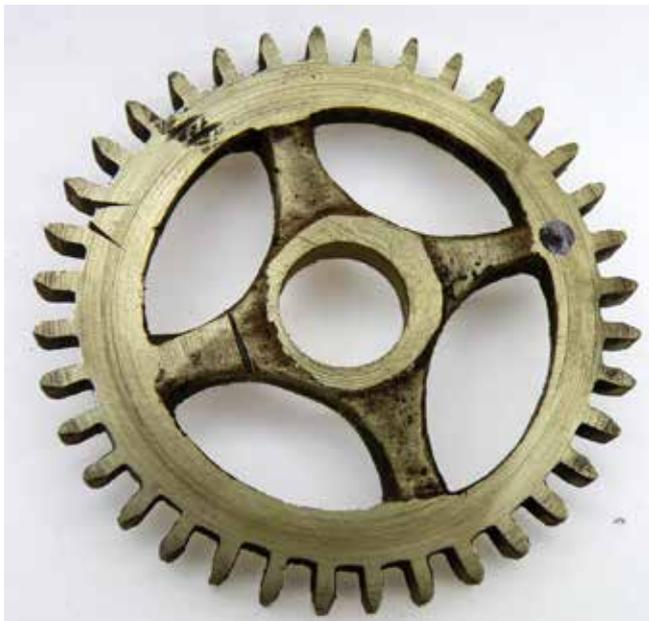
Figure 11. The hour wheel with alignment marks (left). An iron pin filed flush indicates its former use as a reverse minute-wheel, possibly from a small turret clock. The crossings are of an unusual section for a clock.

The original pinion-of-report, which would have been four pins filed into the end of the great wheel arbor (identical to the striking pinion-of-report), was sawn off and a new stub end with a square brazed in position. To this was fitted a larger brass 'pinion' of 21 teeth meshing with a new hour wheel of 36 teeth. The replacement hour wheel is marked with dots on the tips of the teeth, indicating that it was cut by hand, and not with a wheel-cutting engine.

The crossings of this wheel are thinner in section than either the centre or rim of the wheel, and are unlike the

wheels normally seen on domestic clocks. The rim has the remains of a substantial iron pin which has been filed flush, as well as two registration marks filed either side of a tooth, **figure 11**. It is too large for a normal domestic clock, but may have been the reverse minute-wheel from a small turret clock. The present going train is given in the panel on page 30, which gives 54.8 beats / minute and a pendulum of 46.8in, about 7in longer than on a seconds-beating longcase clock.

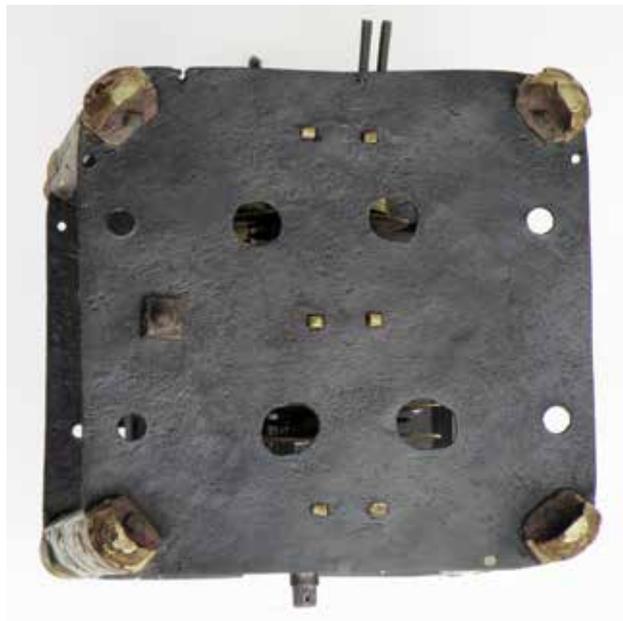
Figure 12. The iron bottom plate with two extra holes at each side where the ends of the two ropes were attached to double the duration by using pulleys for the weights and counterweights.

clocks. Originally each train would have been powered by its own weight and counterweight. The running time could be doubled by simply fixing all the free ends to the bottom plate and adding pulleys for both the weights and counterweights, which had to be double the size.

On this clock four holes were drilled in the bottom plate through which the ropes could be threaded and held with a knot, **figure 12**. This may even have been done when newly made, there is no way of telling, except that it was before being converted to a single weight and a Huygens loop.

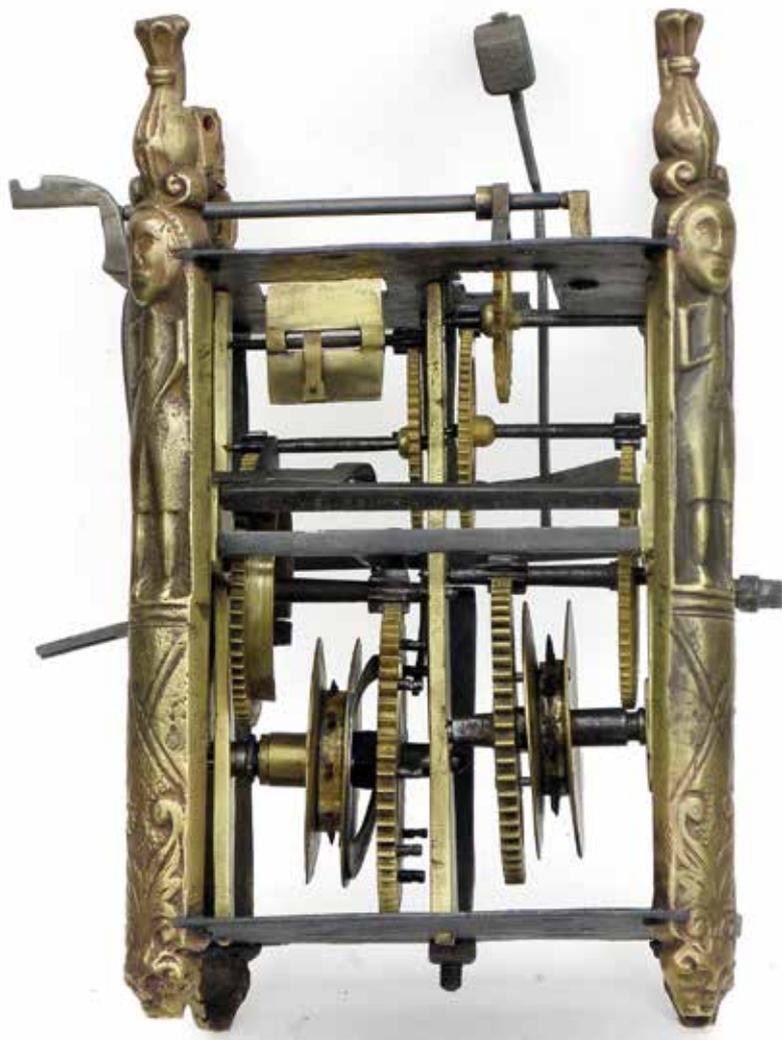
Figure 16. Movement from the left. The winding click on the going great wheel was removed during conversion to Huygens loop.

Originally there were winding clicks on both great wheels, but the one on the going train was removed when the clock was converted to operate with a single weight. There has been no attempt to reverse the direction of rotation of either of the trains, so when converted to Huygens loop the ropes would have crossed.

The complete movement is illustrated in figures 13 to 16, which show the typical English style of cruciform front and rear movement bars.
