John A. Robey

English lantern clocks with an original balance

Antiquarian Horology, Volume 41, No. 2 (June 2020), pp. 177–196

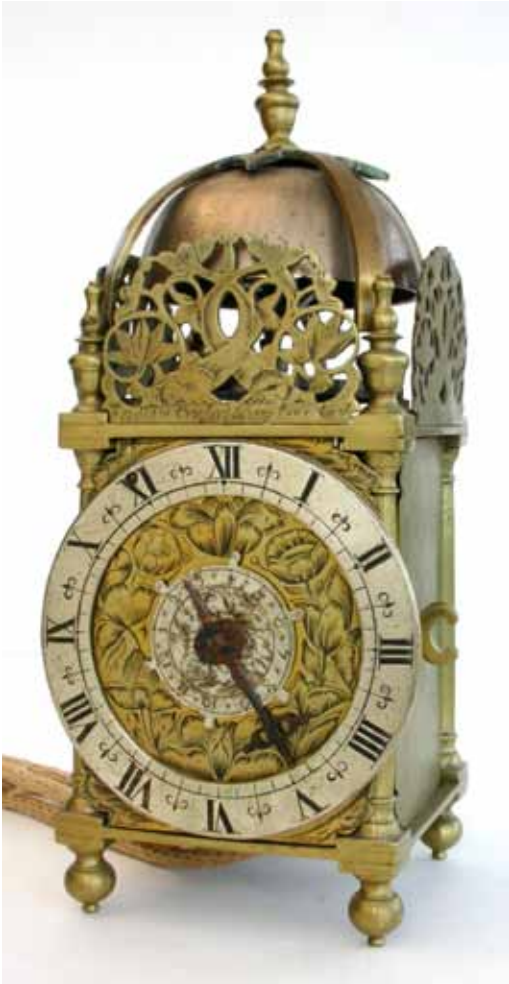
Fig. 1. A small lantern clock by Matthew Crockford, London, 1670, reconverted back to balance. (Photo: private collection)

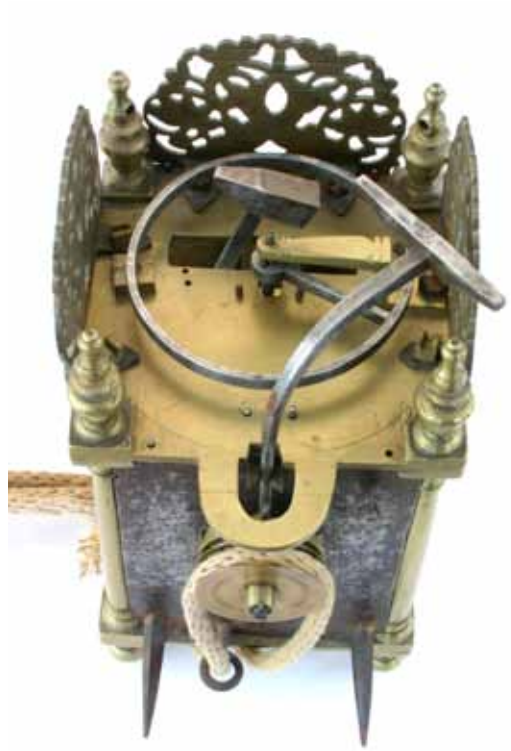
Fig. 2. Reconverted Crockford clock with an incorrect iron balance and a reinstated alarm. There is no aperture for the fly as it is below the top plate, which has an integral hoop. (Photo: private collection)

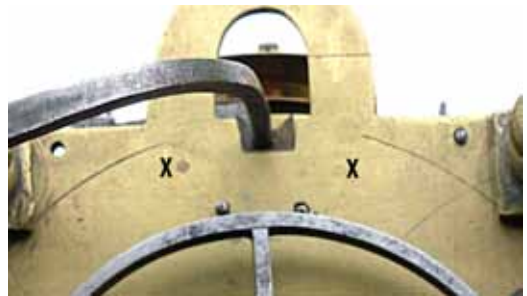
Fig. 3. Detail of the top plate of the Crockford clock, showing plugged holes (marked X) for a former pendulum back cock, the right-hand one being barely visible. The scribed circle was partly erased when the plugs were levelled. (Photo: private collection)

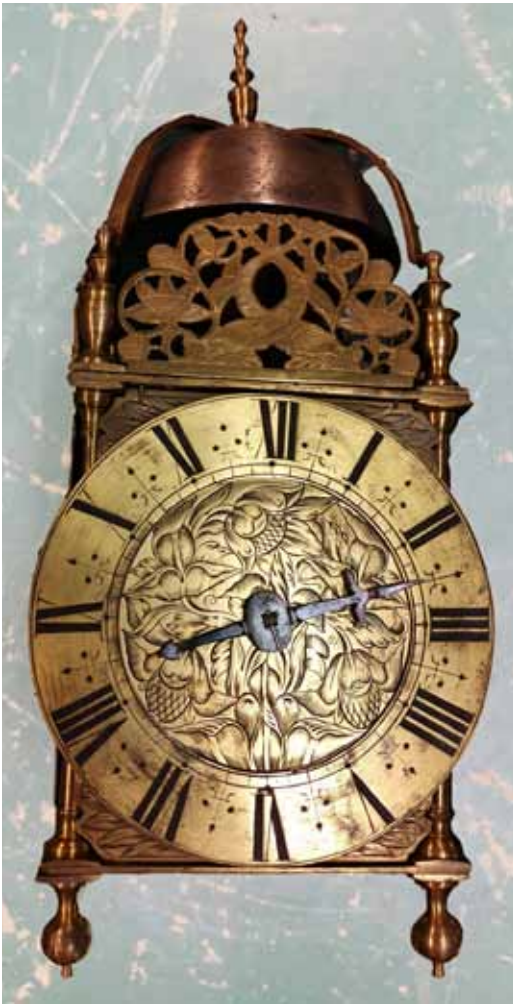
Fig. 5. Clock 1, anonymous lantern clock. (© Trustees of the British Museum)

British Museum, Reg. No. 1888, 1201, 145. George White, *English Lantern Clocks*, pp. 192–3, regards this as having an apparently original balance. Though the iron-topped balance cock suggests a later repair, and the pillars, finials and feet appear to have been over-zealously cleaned with abrasives and not accurately reassembled. From photographs taken by Oliver Cooke, Curator of Horology, the balance and escapement appear to be original (Figs 5–7). He also reports that the pinions and pallets show significant wear.

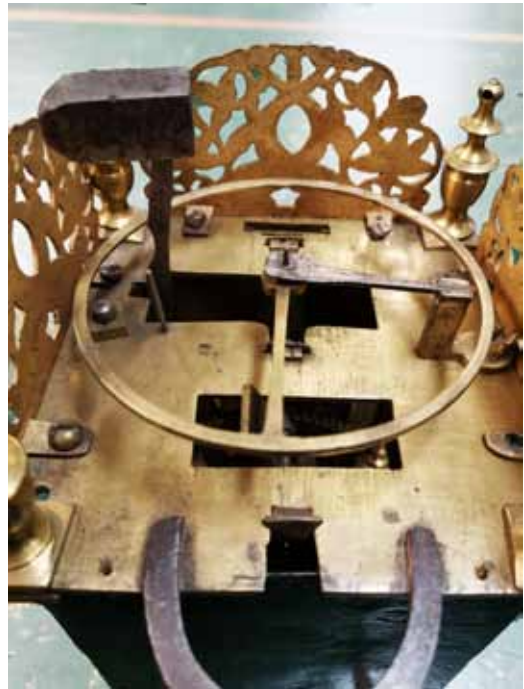
Fig. 6. Clock 1, top view showing the balance and repaired top cock. (© Trustees of the British Museum)

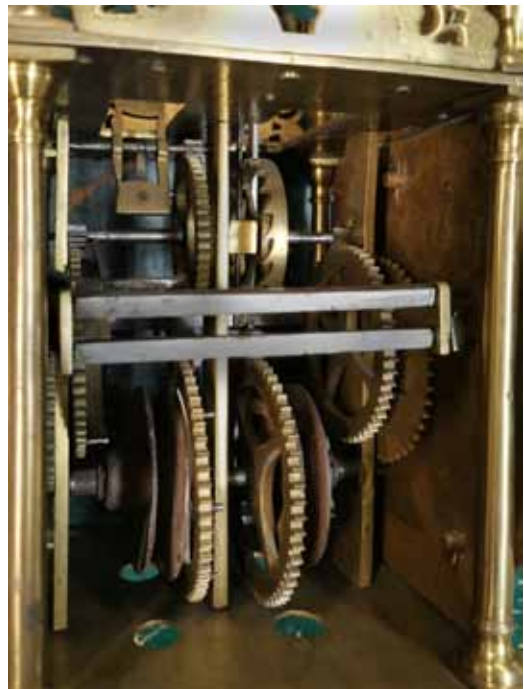
Fig. 7. Clock 1, movement. (© Trustees of the British Museum)

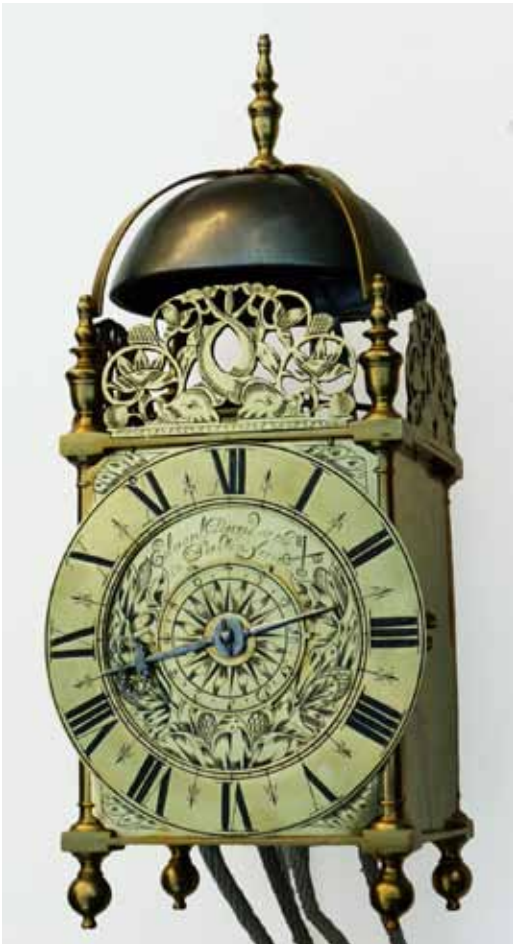
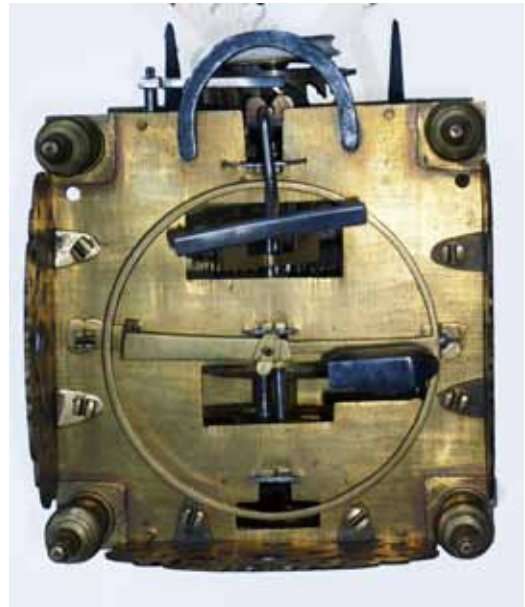
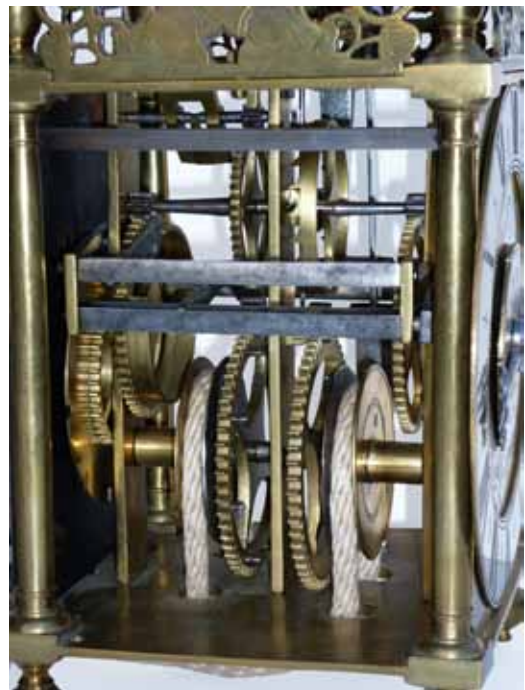
Fig. 8. Clock 2, Edward Norris. (Photo: Brian Loomes)

Fig. 9. Unaltered top plate of the Norris clock with its original balance and alarm. (Photo: Brian Loomes)

Fig. 10. Movement of the Norris clock. (Photo: Brian Loomes)

George White, *English Lantern Clocks*, pp. 190–1, 210 states: ‘Evidence suggests that the escapement is more likely to be original than a reproduction ... though the adjustable pivot hole on the top cock is probably not an original feature.’ The top plate has not been modified and the balance appears to be original (Figs 8–10).

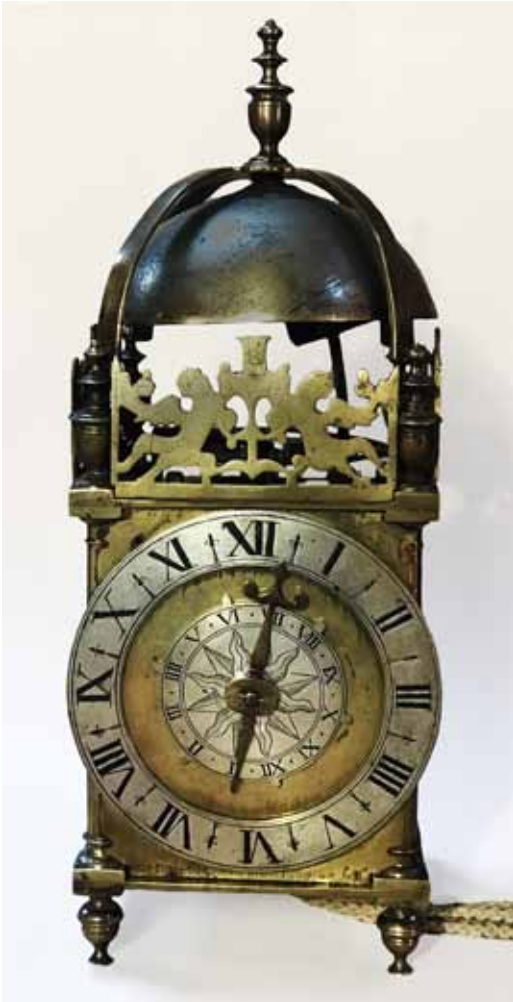
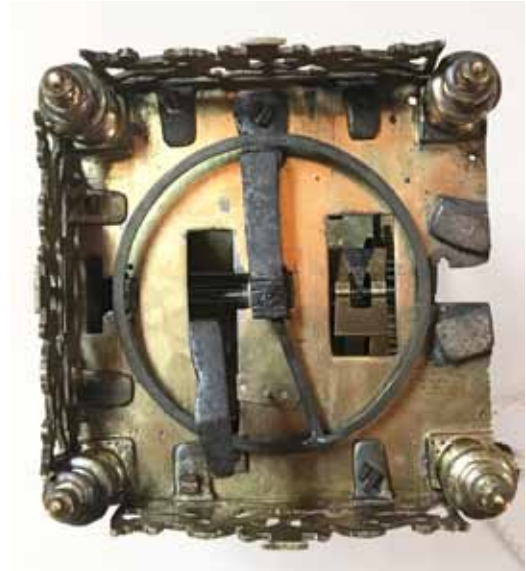
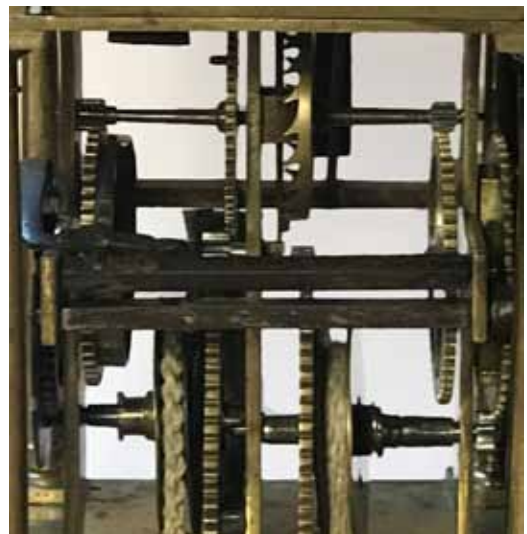
Fig. 11. Clock 3, John Pennocke, with a restored alarm-setting disc. (Photo: W. F. Bruce, courtesy of J. Nye)

Fig. 12. The tarnished brass balance of the Pennocke clock with an original iron top cock. (Photo: W. F. Bruce, courtesy of J. Nye)

Fig. 13. The escapement of the Pennocke clock. (Photo: W. F. Bruce, courtesy of J. Nye)

Lantern clock (Figs 11–13) with a very unusual balance cock made of iron, apparently original. See Loomes, *Lantern Clocks & Their Makers*, p. 81. Regarded by John Hooper as the only surviving pre-Civil War (Period One) lantern clock retaining its original balance escapement, and confirmed by W. F. Bruce, who has recently serviced it. Though the alarm has been removed and the hoop cut, this may have been when fitted into a case or on a shallow bracket (see ‘Evidence for an original balance’).

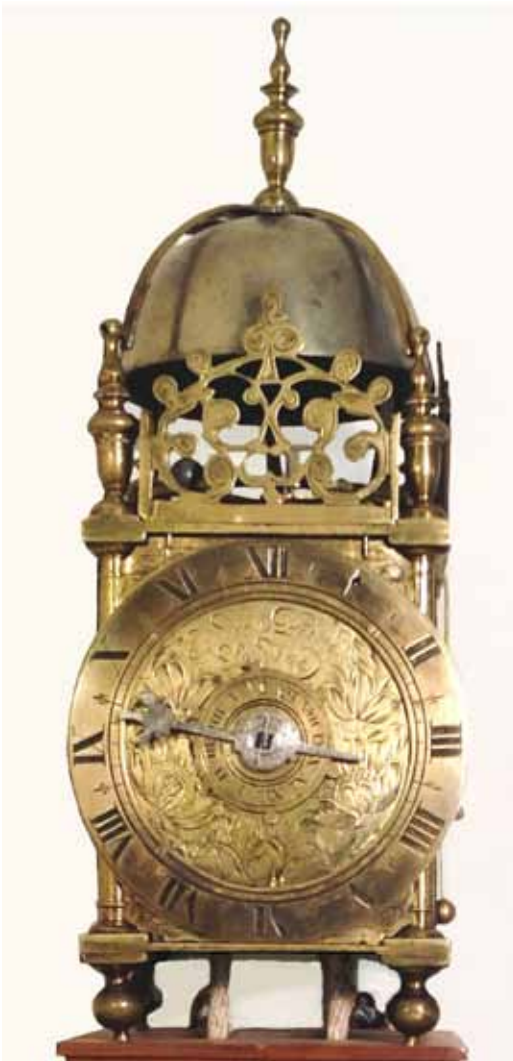
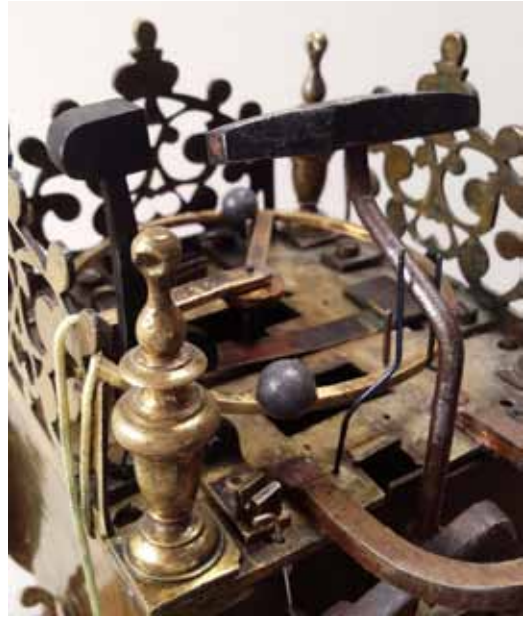
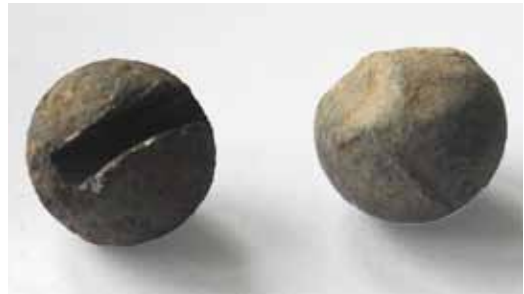
Fig. 14. Clock 4, Andrew Prime, a small striking clock with an alarm. (Photo: B. Calver)

Fig. 15. Unaltered top plate of the Prime clock. The original balance has two lead balls, one original, the other a replica. (Photo: B. Calver)

Fig. 16. The original Prime slotted balance weight (left) compared to a Civil War musket ball (right). (Photo: B. Calver)

A small three-quarter size lantern clock with an alarm. Though the frets are of an earlier style than the dial, the top plate, on which the hammer pivots and its spring is fixed, has not been altered and the crownwheel has undercut teeth. The unexplained empty hole near the hoop does not appear to be part of an escapement conversion. A slotted sixteenth-century lead musket ball and a replica sit on the original balance (Figs 14–16). These were probably added to increase the balance’s inertia and hence recoil. This results in a larger restoring force, analogous to the gravitational force on a pendulum bob, at the expense of increased friction and wear, to improve performance. Two diametrically opposite punch marks on the balance indicate the position of the balls (see also Clock 7). The owner reports that the balls significantly reduce variations in timekeeping. Prior to its current owner it had been with the same family for many generations and unlikely to have been modified recently.

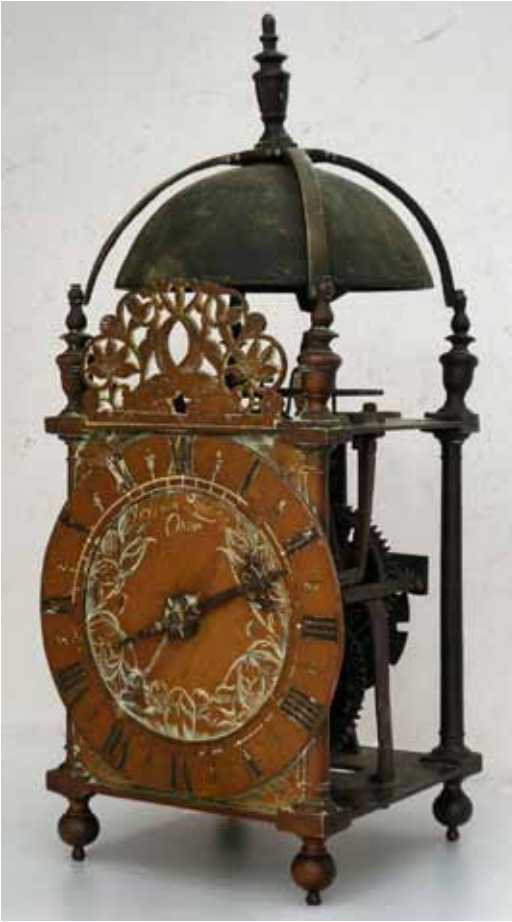
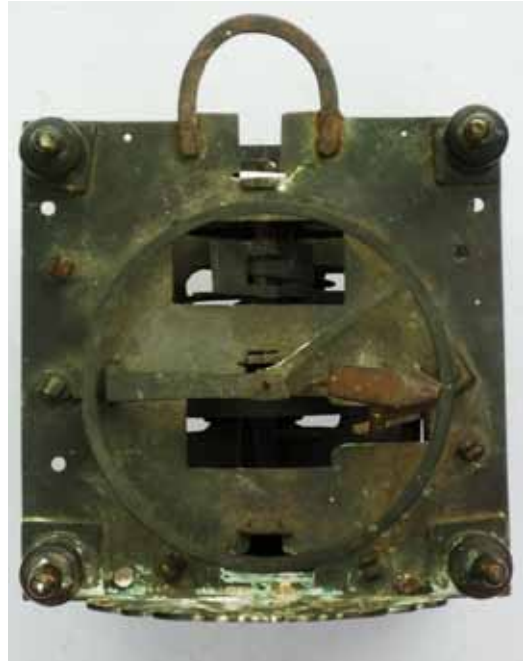
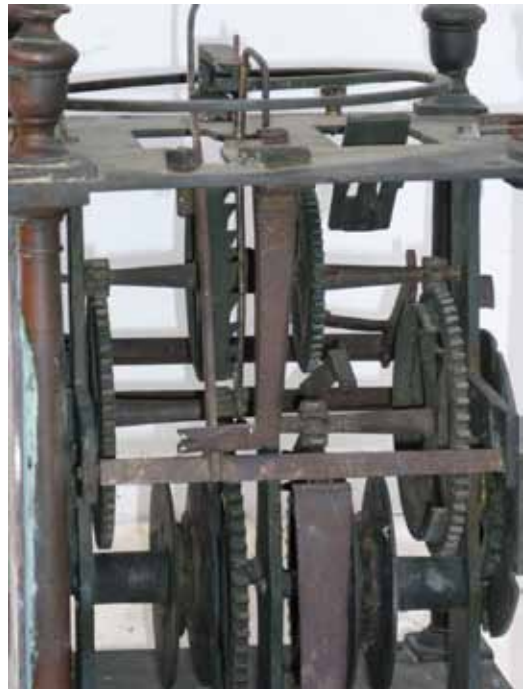
Fig. 17. Clock 5, John Quelch. Oxon. (Photo: Brian Loomes)

Fig. 18. Top plate of the Quelch clock. (Photo: Brian Loomes)

Fig. 19. Original balance and escapement of the Quelch clock. (Photo: Brian Loomes)

A London-made clock. Said to have been discovered relatively recently in a remote area of America, probably taken there shortly after it was made and then abandoned. Sold at Bonhams, London, July 2010. See Brian Loomes, ‘John Quelch of Oxford, An original balance-wheel lantern’, *Clocks*, October 2010, pp. 11–14. Though it is in a distressed condition with the rear cover and alarm lost, from the photographic evidence, there is a good chance that the balance and escapement are original (Figs 17–19).

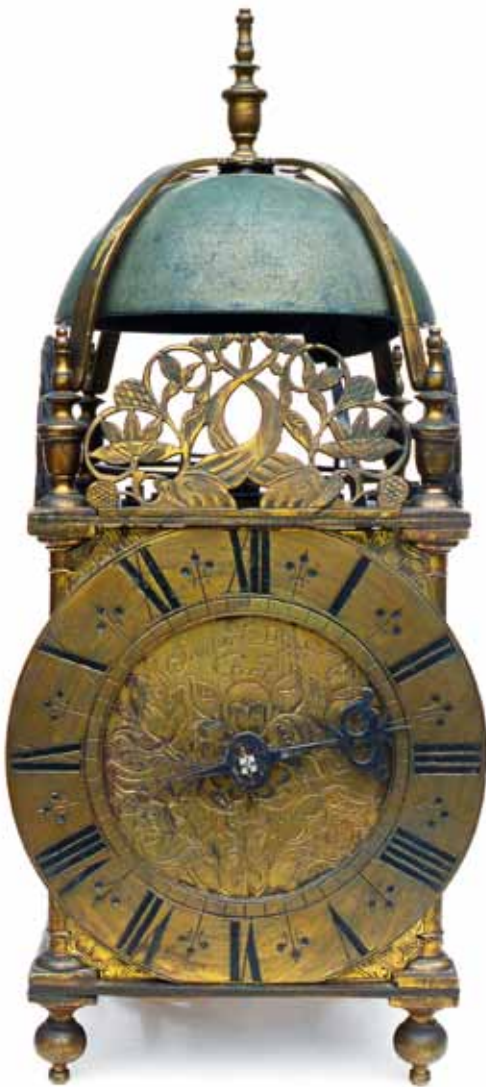
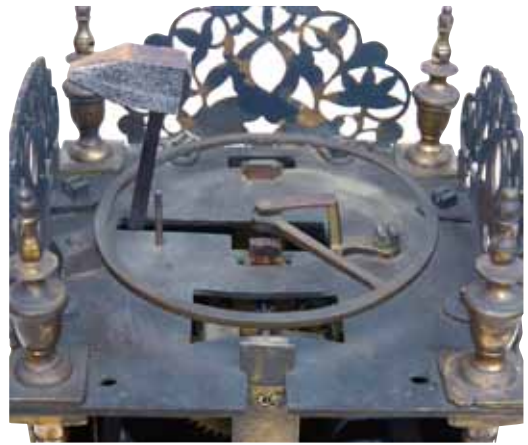
Fig. 20. Clock 6, Samuel Stretch. (Photo: J. Darken)

Fig. 21. Unaltered top plate and balance of the Stretch clock. Hanging hoop missing. (Photo: J. Darken)

This clock, which has been illustrated in several publications, has for a long time been accepted as having an original balance escapement (Figs 20–25). It has been regarded as likely to be original by John Hooper, Jeff Darken and George White. Recent images are included in Jeff Darken & Michael Hurst (eds), *Time & Place* (2007), pp. 52–3, and *Antiquarian Horology*, December 2003, pp. 608–11, Picture Gallery. The latter describes and illustrates the escapement in detail. The verge has been lowered to enable the crownwheel teeth to contact unworn areas of the pallets, and the crownwheel has been moved on its arbor, as well as being dished to compensate for wear.

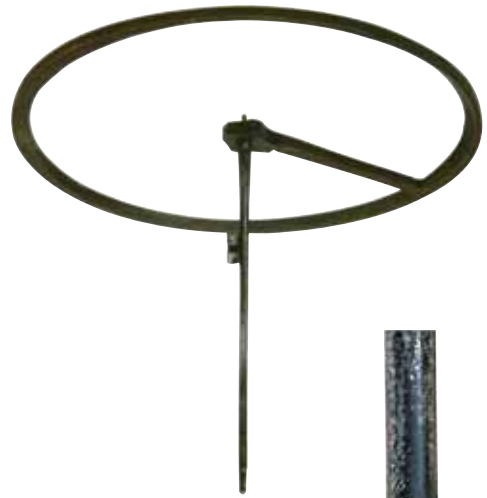
Fig. 22 (above). Stretch balance.

Fig. 23 (right). Lower pallet of Stretch clock, with two wear pits.

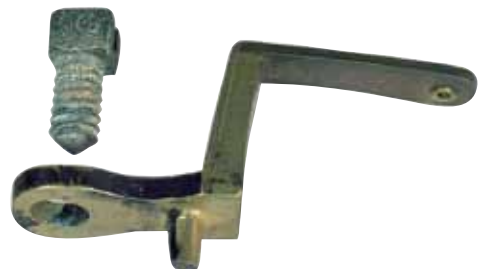
Fig. 24. Crownwheel with undercut teeth. (Photo: J. Darken)

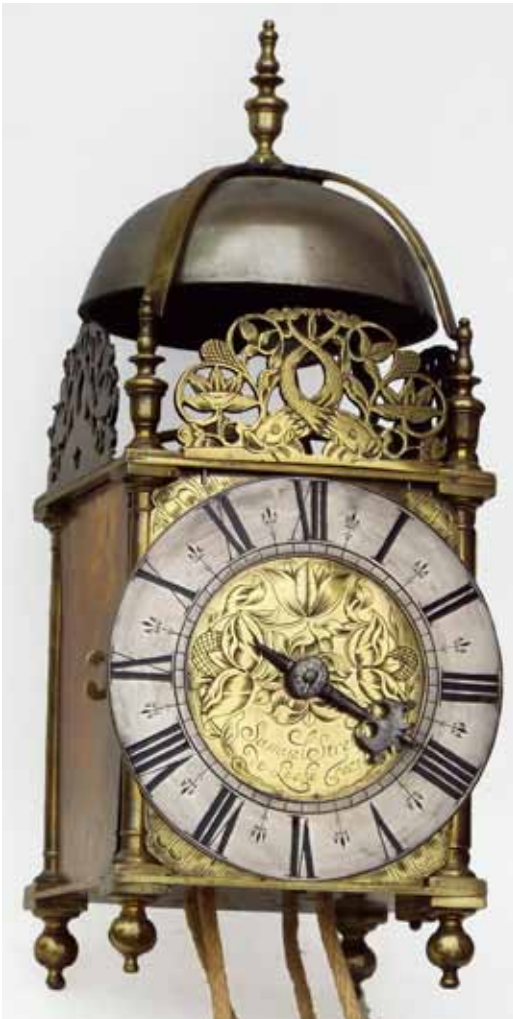
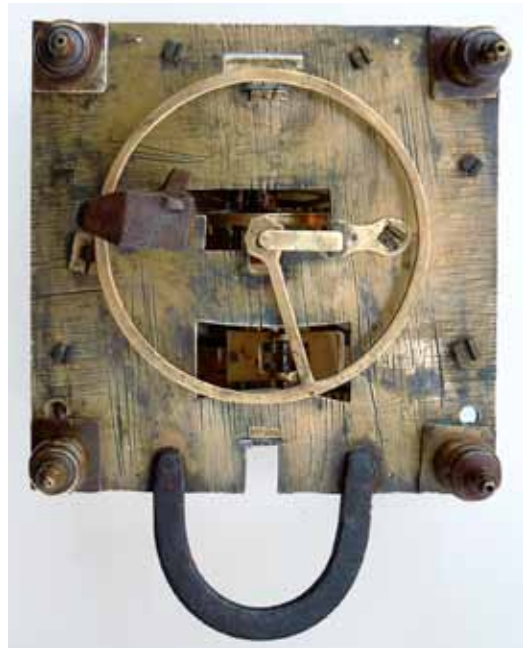
Fig. 26. Clock 7, Samuel Stretch de Leeke. (Photo: private collection)

Fig. 27. Samuel Stretch de Leeke with unaltered top plate and balance. The shape of the central boss indicates that the balance was probably cast with four arms to avoid distortion, three of them removed during finishing. (Photo: private collection)

While Clock 6 has been known for many years, by coincidence another completely original clock (apart from the doors and rear cover) by the same maker appeared in the Alan Wagstaff Collection, sold at Christie’s, London, December 2005 (Figs 26–34). See also Brian Loomes, *Lantern Clocks & Their Makers* (2008), pp. 284, 420–3. The top plate is unaltered and the crownwheel teeth are undercut by 15 degrees. Despite the pallets having been filed to remove wear pits, considerable wear has subsequently taken place, and the crownwheel has been dished to compensate. Filed marks on the balance probably indicate the position of former subsidiary lead balls to improve timekeeping.

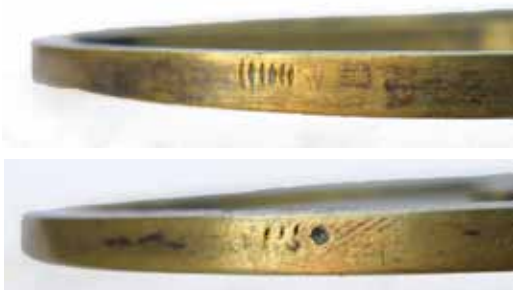
Figs 29-30. File marks on the Stretch de Leeke balance indicate the former position of lead weights. What appears to be a punch mark is a small casting fault. (Photo: private collection)

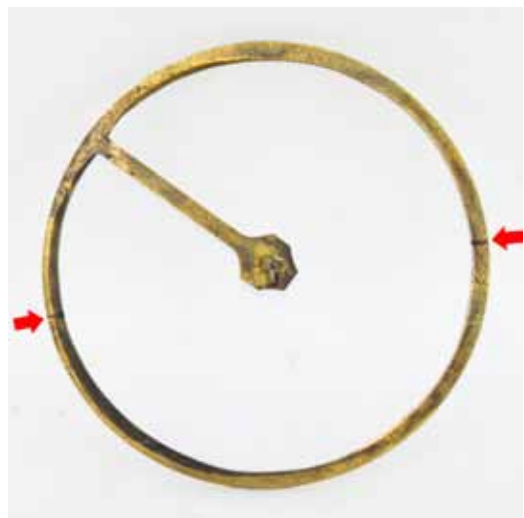
Fig. 28 Underside of the original Stretch de Leeke balance with the inner edge partly chamfered for poise. The arrows indicate the position of the marks shown in Figs 29-30. (Photo: private collection)

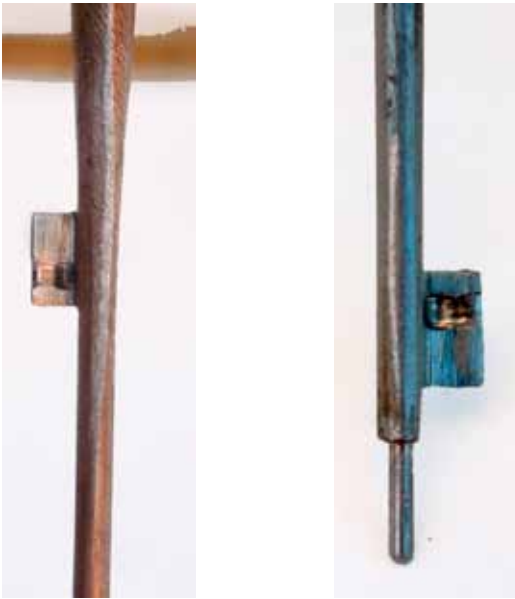
Figs 31-32. Wear on the Stretch de Leeke pallets. Note the shape of the top of the verge. (Photo: private collection)

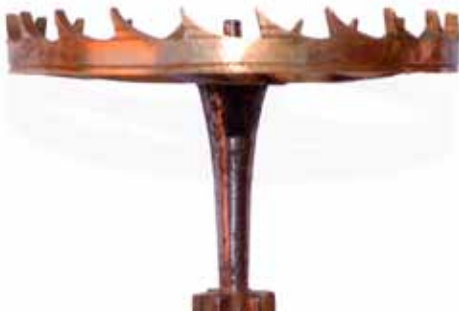
Fig. 34. Stretch de Leeke crownwheel with undercut teeth, and original steeply tapered arbor (Photo: private collection)

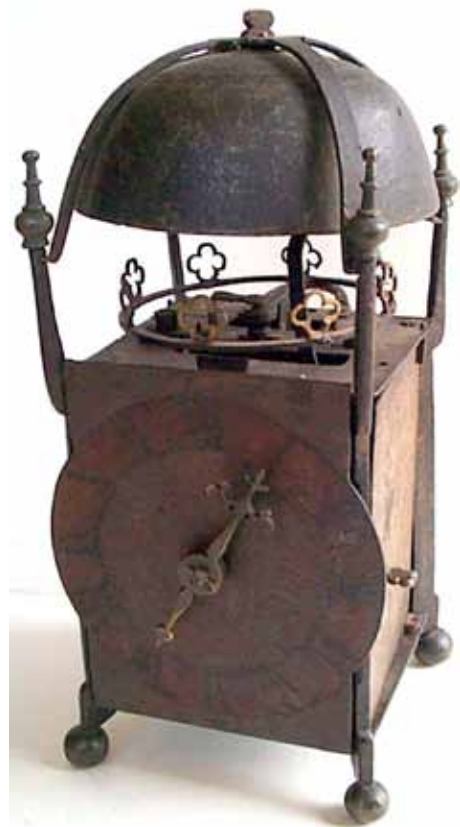
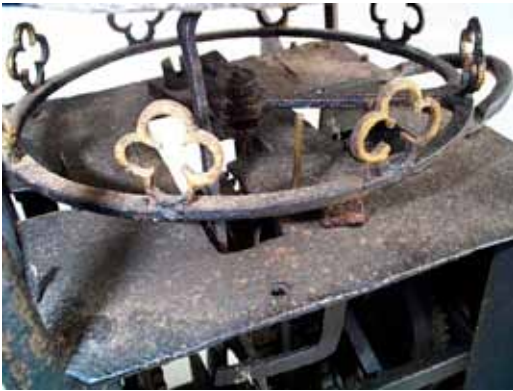
Fig. 35. Clock 8, anonymous English lantern clocks with an iron frame and balance. (Photo: J. Hooper)

Fig. 36. Detail of the balance of Clock 8 with cast-brass quatrefoil attachments. (Photo: J. Hooper)

Fig. 37. The movement of Clock 8. The crownwheel has undercut teeth and baluster-shaped crossings. (Photo: J. Hooper)

An English iron-framed lantern clock with brass wheels and an atypical iron balance with eight cast-brass quatrefoil attachments.⁷ Though an iron clock is known with a new

movement, including top and bottom plates, inserted into a Continental iron frame by William Holloway of Stroud in 1687,⁸ there is no evidence that the clock in Figs 35–37 was a similarly modified Continental clock. The author has made a detailed study of an identical clock (even with the same recesses in the front pillars for the chapter ring), redialed and converted to anchor escapement about 1710 by James Wright of Knowle, Warwickshire.⁹ While the frames might have been imported from France or Flanders, all the wheels, apart from the replaced escape-wheel, have the same counts as English balance lantern clocks, and the strike-work is identical to English practice. A series of unsigned mid-seventeenth century lantern clocks with similar iron frames has English dials and frets. There is no evidence that any of them are reused Continental clocks.¹⁰

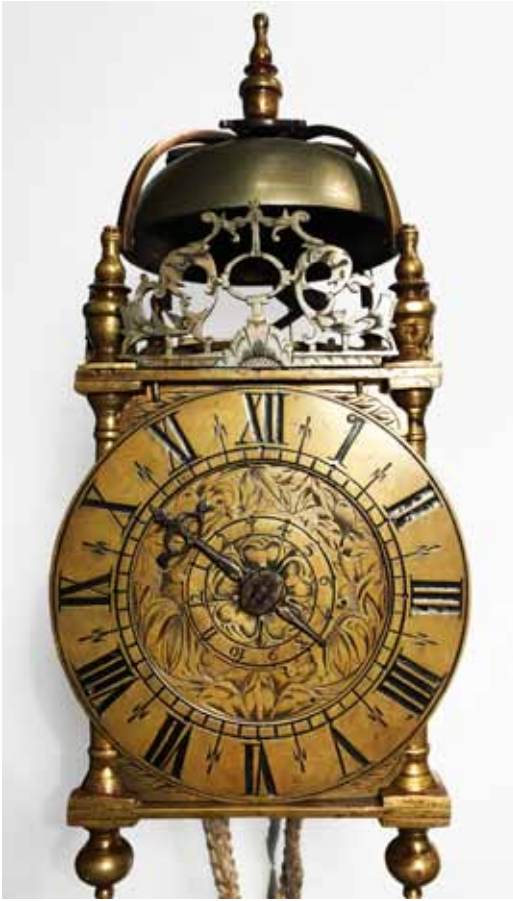
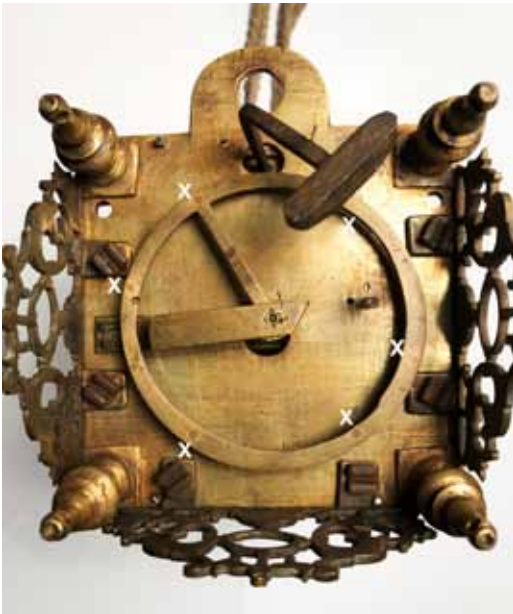
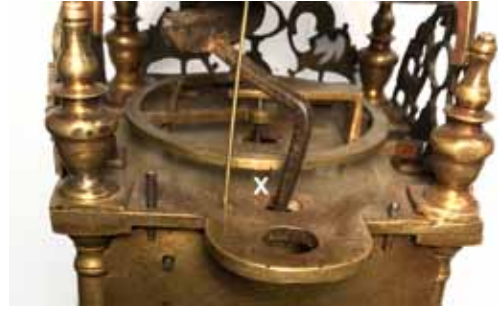
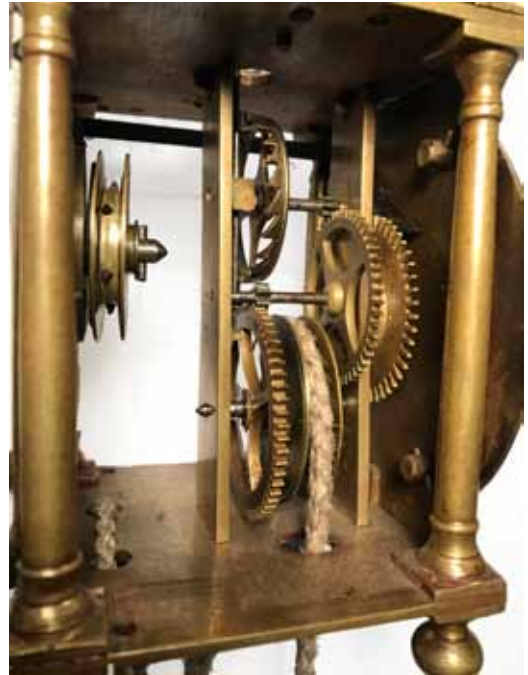
Fig. 38. Clock 9, anonymous miniature lantern alarm. (Photo: Nigel Raffety)

Fig. 40. The balance of Clock 9 with one of the plugged holes in the side of the rim marked by X. (Photo: Nigel Raffety)

Fig. 41. The escapement of Clock 9. (Photo: Nigel Raffety)

Fig. 39 (left). The top plate of Clock 9 with six plugged holes in the rim of the balance, marked by X. (Photo: Nigel Raffety)

A miniature timepiece alarm (Figs 38–41), only 9in (23cm) tall and 4in (10cm) wide. Unaltered top plate with an integral cast hoop and three holes for a banking pin, but no evidence of plugged holes.¹¹ The balance has six plugged holes that were probably for attaching small weights for either regulation or for increasing the inertia and reducing variations in rate. There are similar plugged holes in the side of the rim. Since the balance is so small, being only 2½in (62mm) diameter, like Clock 10 additional mass may have been needed to achieve a reasonable rate when the oil thickened, then the weights removed when no longer necessary once lubricants improved. Alternatively different sizes and numbers of weights may have been used to adjust the rate rather than only altering the driving weight.

The crownwheel is fitted to its arbor with a brass collet, rather than the usual method of fitting it directly onto a steeply tapered arbor, and is probably an eighteenth-century replacement. Subsequently the rim has had a new ring of teeth added without any undercut. There is good wear to the pallets.¹²

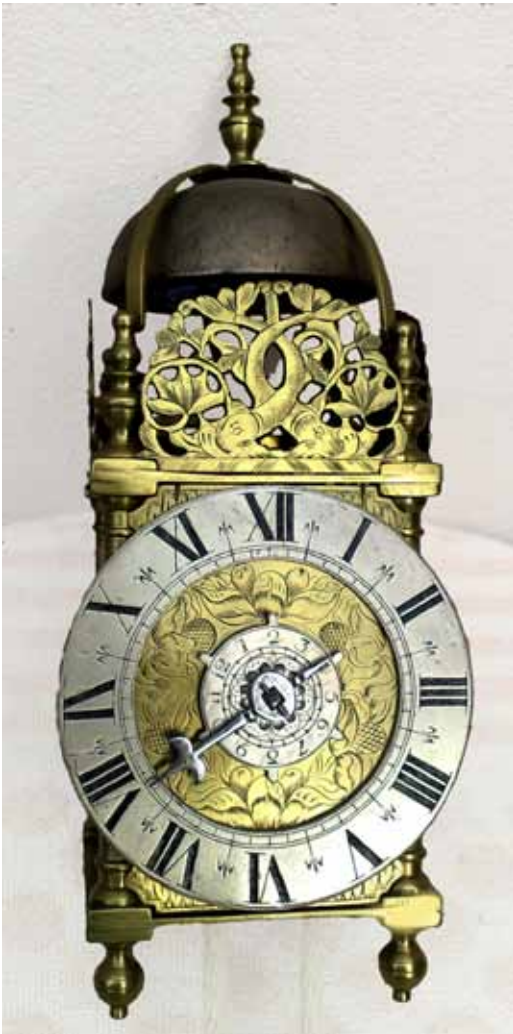
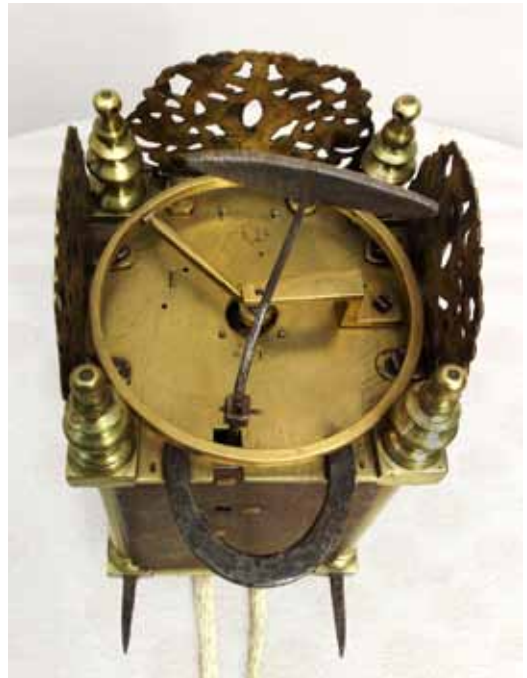
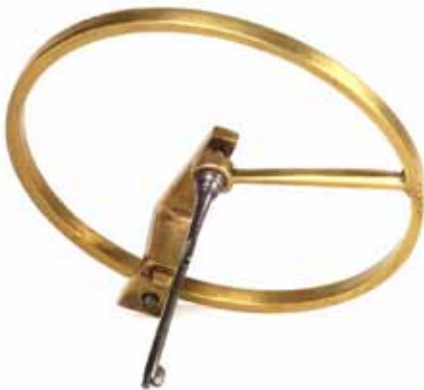
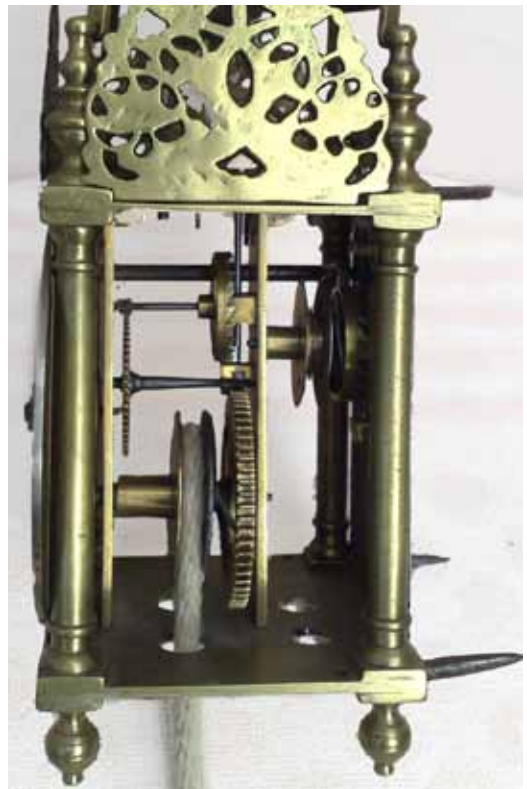
Fig. 42. Clock 10, anonymous miniature lantern alarm. (Photo: Martyn Pettifer)

Fig. 43. The unaltered top plate of Clock 10. (Photo: Martyn Pettifer)

Fig. 45. The balance, pallet staff and top cock of Clock 10. (Photo: Dreweatts)

Fig. 44. The escapement of Clock 10. (Photo: Martyn Pettifer)

A miniature timepiece alarm (Figs 42–45), 9½in (24cm) tall and 4in (10cm) wide. Similar to Clock 9, but with a larger balance, 3⅜in (86mm) diameter. Unaltered top plate, but the later crownwheel has no undercut to the 21 teeth, there is an integral collet and a parallel arbor. The top of the balance staff has uncharacteristic decorative turning where the balance is attached, so the pallets have also probably been replaced due to wear. Sold at Dreweatts, Newbury, September 2012.

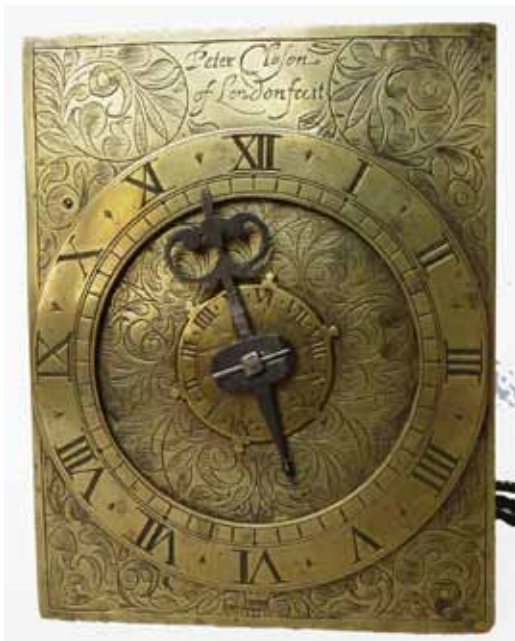
Fig. 46. Clock 11, timepiece alarm by Peter Closen. (Photo: private collection)

Fig. 47. Unaltered top plate of the Closen timepiece 11, the only holes are for the sturdy banking pins. Note the cut-off pins on the balance. (Photo: private collection)

Small timepiece alarm with a balance 2⅜in (71mm) diameter and plates 3⅞in (82mm) wide, 2⅜in (75mm) deep and 4⅞in (119mm) top to bottom (Figs 46–47). The balance has the remains of iron pins, probably for attaching washers of different thicknesses for rating, see also Clock 9. They are unlikely to have been for fixing musket balls of the type found on Clock 5, as they would foul the rear of the dial. While the illustrations of this clock in W. F. J. Hana, *English Lantern Clocks* (1979), p. 128, show no undercut to the crownwheel teeth and he states that the verge has ‘book’ pallets, which were used in the

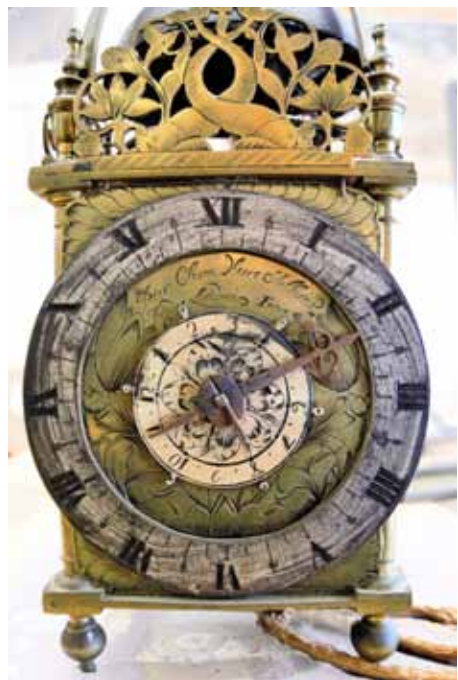
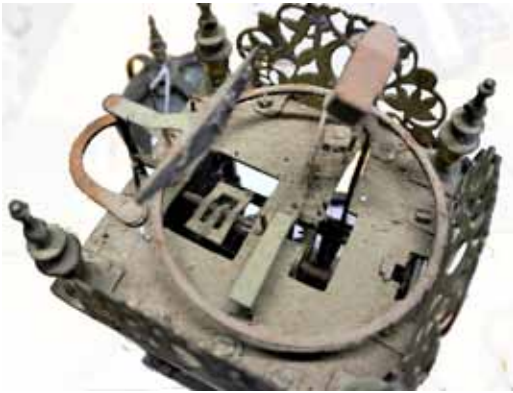
Fig 48. Clock 12, unrestored lantern clock with alarm by Peter Closen. (Photo: private collection courtesy of Brian Loomes)

Fig 49. Unaltered top plate and alarm of the Closon clock, though the iron balance is probably later. (Photo: private collection courtesy of Brian Loomes)

Fig. 50. Movement of the Closon clock. (Photo: private collection courtesy of Brian Loomes)

Based on photographic evidence, and bearing in mind that dust obscures any signs of possible blocked holes, this clock may not have been converted to pendulum, but the crownwheel and the iron balance do not appear to be original (Figs 48–50). Personal inspection may revise these conclusions. Until recently in New Zealand.

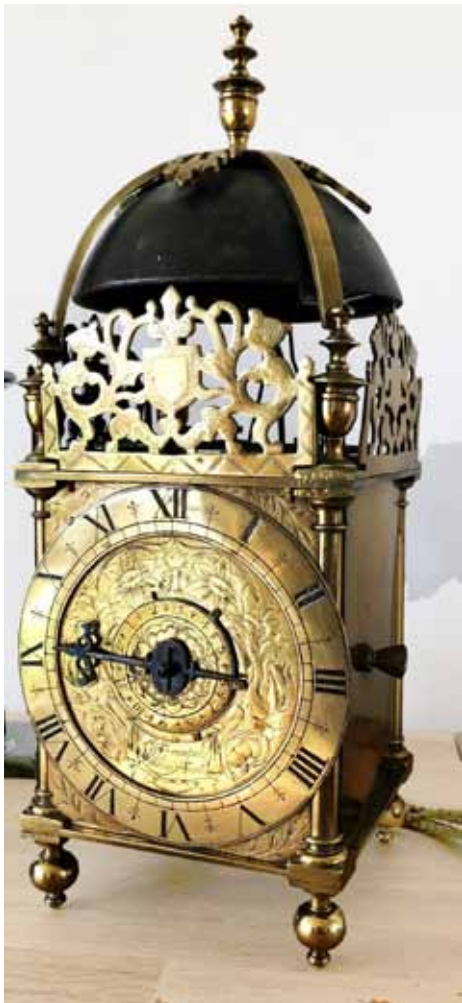
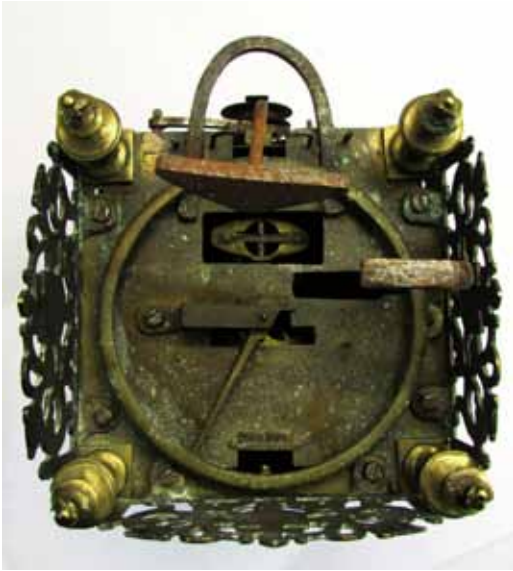
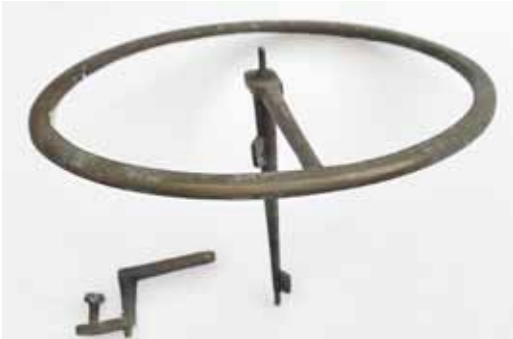
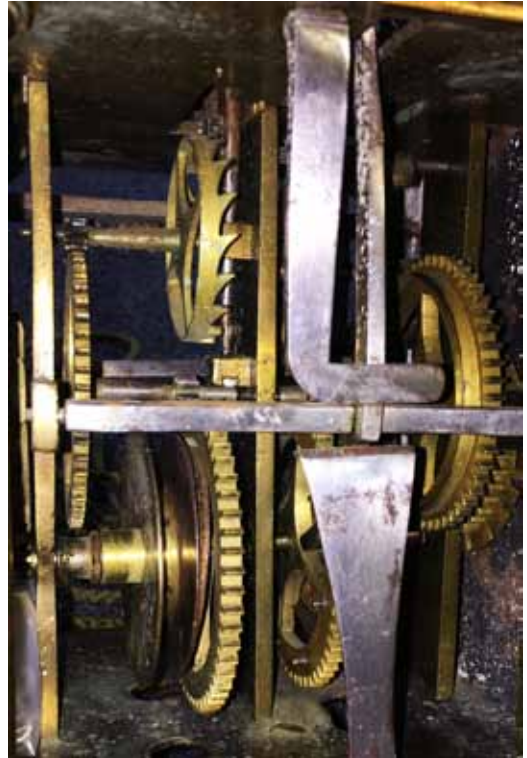
Fig. 51. Clock 13, lantern clock with alarm by A Fromanteel. (Photo: private collection courtesy of Brian Loomes)

Fig. 52. Unaltered top plate and alarm of the Fromanteel clock. (Photo private collection courtesy of Brian Loomes)

Fig. 53. The Fromanteel balance with rounded edges appears to be original, but the verge is overly sturdy with little pallet wear. (Photo: private collection courtesy of Brian Loomes)

Fig. 54. The Fromanteel crownwheel appears to be a replacement. (Photo: private collection courtesy of Brian Loomes)

Lantern clock with an alarm. See Hana, *English Lantern Clocks*, p. 61; Brian Loomes. ‘Our Famous Fromanteel’, *Clocks*, August 2018, pp. 9–11. Instead of the hammer sharing the same aperture in the top plate as the balance staff, it is set further back than usual in its own gap, and the plate has not been adapted to accommodate anchor pallets. Though the balance has atypical rounded edges, from the photographic evidence it appears to be original,

but the crownwheel and the untypical verge (whose pallets show little wear) have probably been replaced (Figs 51–54). Personal inspection may revise these conclusions.

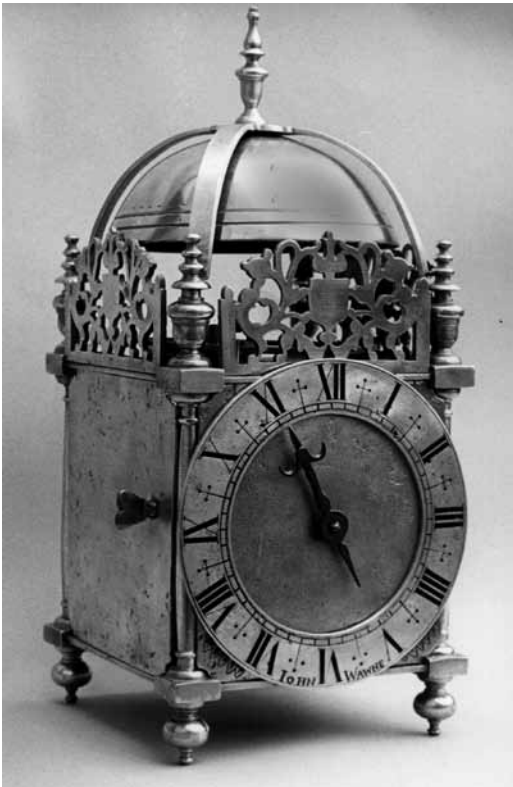
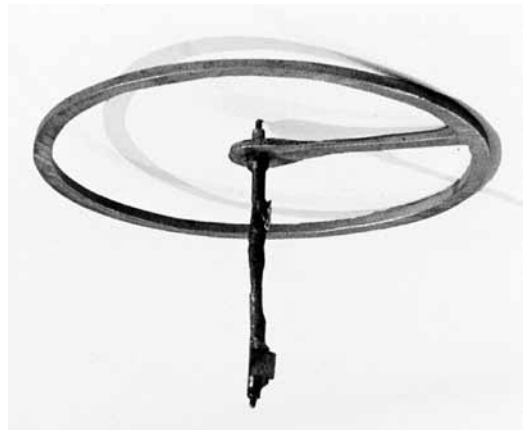
Fig. 55. Clock 14, lantern clock with a later dial signed 'John Wawne'. The pillars have integral finials and feet. (Photo: Martyn Pettifer)

Fig. 57. Movement of the Wawne clock. (Photo: Martyn Pettifer)

Fig. 56. Top plate of the Wawne clock. (Photo: Martyn Pettifer)

Fig. 58. Balance of the Wawne clock. (Photo: Martyn Pettifer)

On the photographic evidence the top plate appears to be unaltered, though the verge, balance, top cock and hoop are less convincing. The crownwheel does not have undercut teeth, the parallel arbors have collets and the fly is of a later type. (Figs 55–58). Probably an unconverted movement that

had lost its dial and balance, and later fitted with a cut-down eighteenth-century longcase or wall clock dial with the spurious name John Wawne, who was not born until 1733.¹³ Advertised in *Antiquarian Horology* June 1987, p. 647, and Summer 1988, p. 344. Sold by Sotheby’s, London, March 1995.
