The Horological Journal

Rescuing a Gothic Clock

Part 1 – *The Frame, Striking Train and Strike-Work*

John Robey

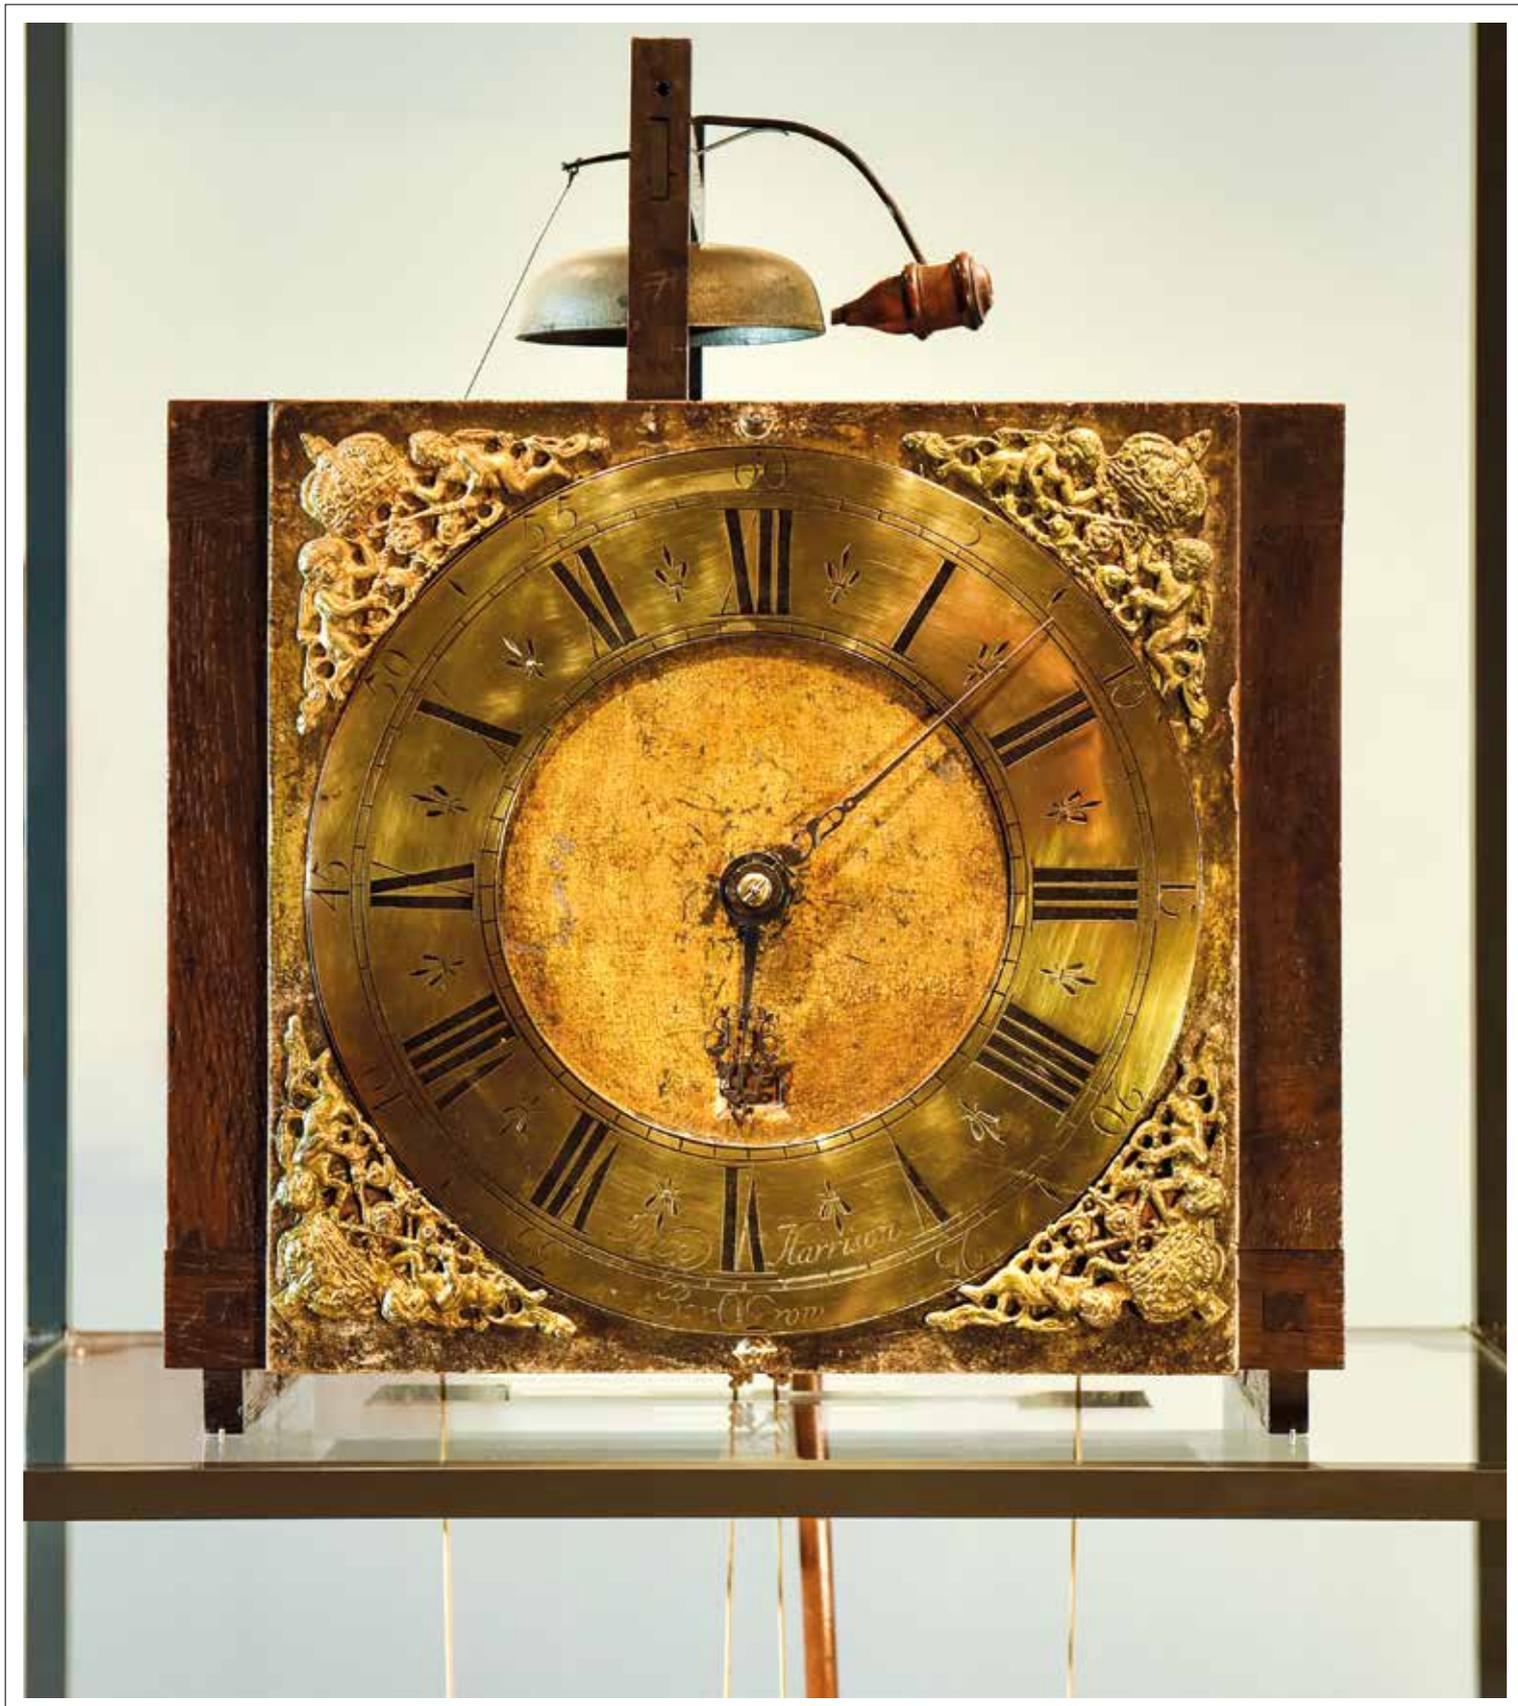
Figures 1 and 2. An early Gothic clock before and after 'restoration'. The escapement, balance, hour wheel, dial, hand, linials, hammer, bell and bell frame are all new. (Photos: Derek Pratt)

The title of this article has been deliberately chosen, as it is not about a simple restoration and definitely not conservation, but a sympathetic conversion of a much-altered movement into an attractive and working clock. Members of the conservation lobby, and those of a nervous disposition, might like to skip to another article. If presented with this clock the museum approach would be to leave it with all its additions and imperfections, but that was something that did not appeal to me. When the former curator of horology at a national museum was asked what they would do if they

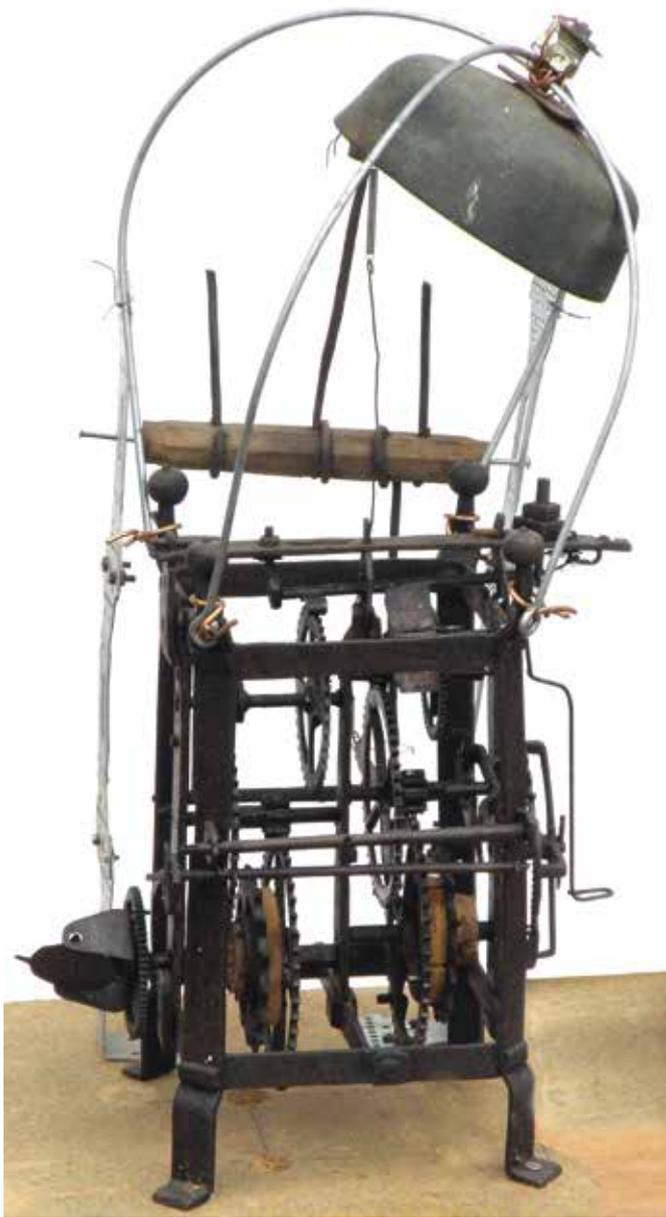
Figure 3. Movement as received with crude additions to use it as a small turret clock.

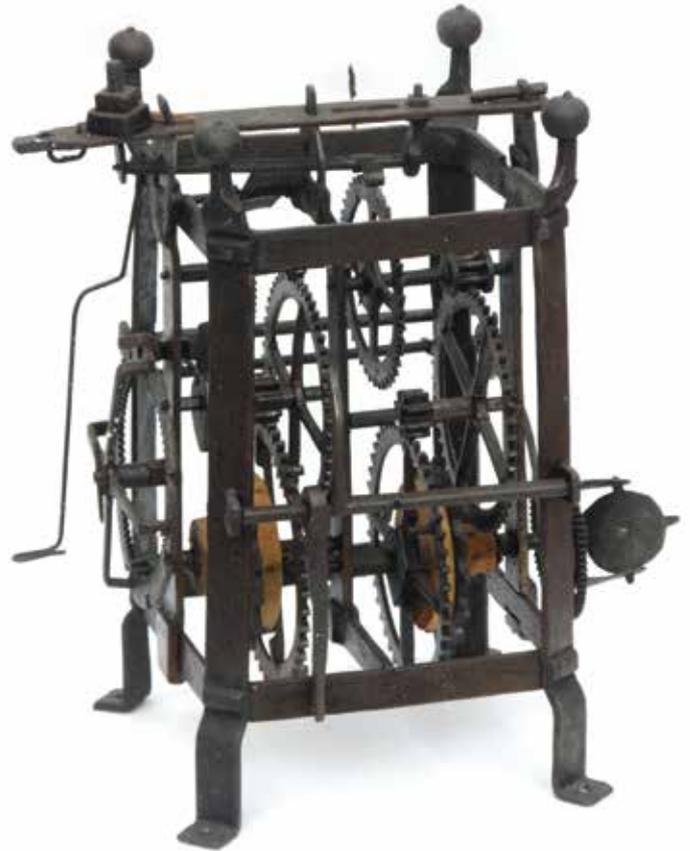
Figure 4. Most of the excrescences removed to show the conversion to anchor escapement and a crude universal joint for the leading-off work.

The first task was to remove all the recently added 'junk' so the extent of the alterations could be assessed, **Figure 4**. It should be noted that the following descriptions and photographs are not necessarily in the order in which the work was carried out. The main frame was found to be almost untouched, apart from extra supports for the added warning arbor, **Figure 5**. The balls on the ends of the finials appear to be separate and forced on and not forged integral with the pillars. The sub-frames are $5\frac{3}{4}$ in (146mm) square at the top and $6\frac{1}{16}$ in (154mm) square at the bottom, the pillars being 12in (305mm) tall. The three movement bars had been mutilated at the top and additional pieces riveted on to accommodate the arbor of the anchor escapement and an internal fly, **Figure 6**. These were removed and the tops reinstated by welding on mild steel pieces and filing them to shape. The dovetails at the bottom of the front and rear bars which hook on to the lower frame were intact, **Figure 7**. The brass bushes are later repairs and if not excessively worn they were left, but any that needed rebushing were replaced with mild steel. Though technically inferior, iron pivots running in iron holes are quite satisfactory on these and later iron clocks.

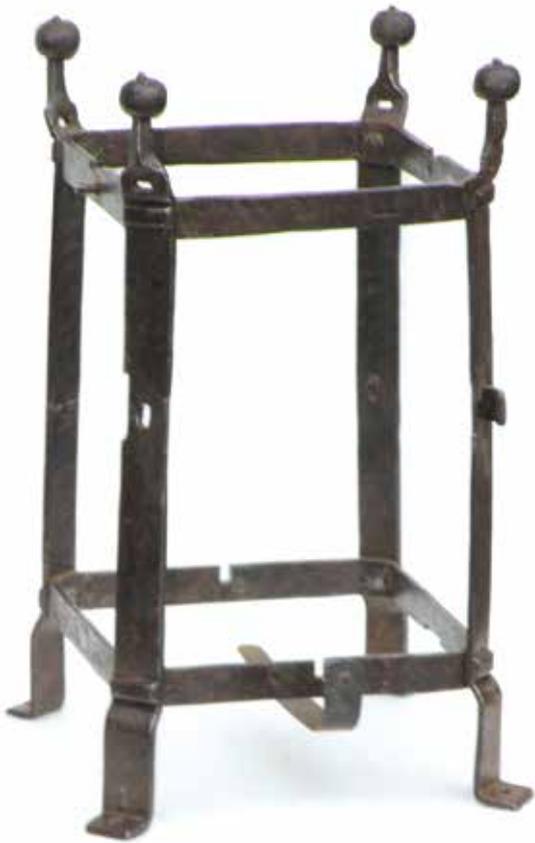
Figure 5. The riveted frame with the later supports for the warning arbor removed and the hammer spring reinstated. Note the holes for the ends of the bell frame.

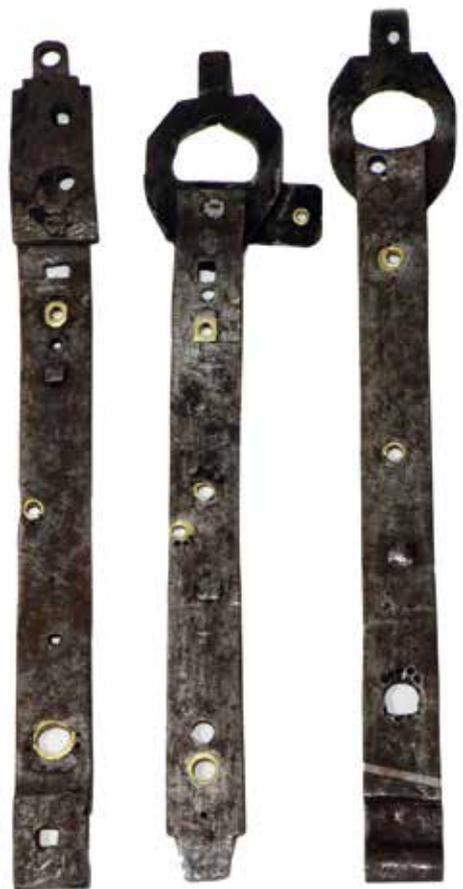
Figure 6. The movement bars with extensions riveted to the top when converted to anchor escapement and one on the central bar for an internal fly. The brass bushes are repairs. Note the holes where supports for the dial, and cocks for the crownwheel and balance were originally fitted.

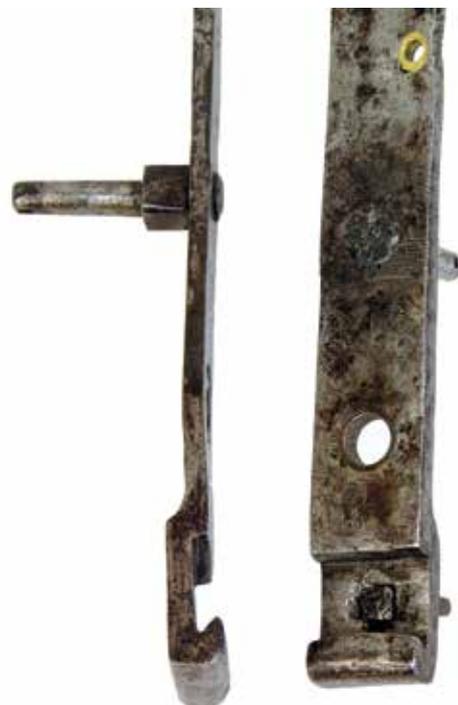
Figure 7. Dovetail hooks at the lower end of the rear (left) and front (right) movement bars. The rear bar has its original post for the countwheel, the front bar has a replaced post for the hour wheel and a support for the dial.

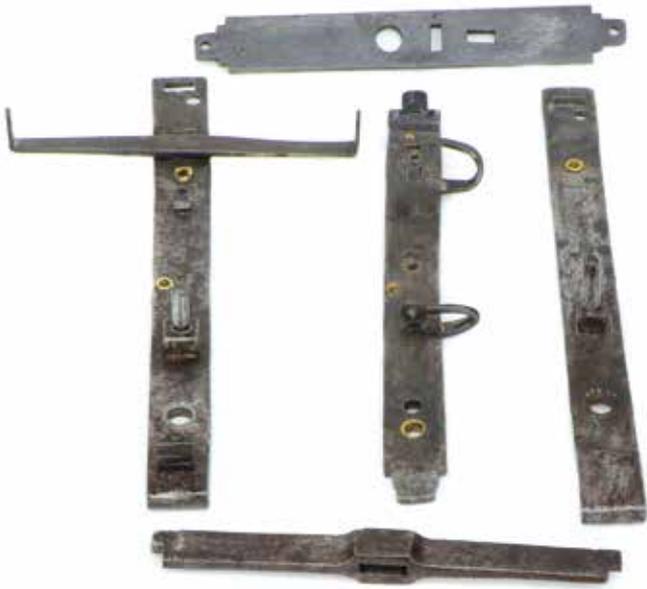
Figure 8. Restored movement bars and top and bottom cross bars.

The original top cross bar had been replaced with a thin strip during the conversion to anchor escapement, so a new one was made with tenons in the ends that fit into the existing slots in the front and rear bars and held with taper pins. A tenon on the central bar fits into a slot in the top bar (taper pin not necessary), while an original tapered tenon at the bottom fits into a mortice that had been forged into a thicker section of the lower cross bar. **Figure 8** shows all five removable bars after restoration, including the cocks for the crownwheel and balance (see Part 2) and the arm that holds the top of the dial.² The assembled frame and bars, including the top cock and gallows for the balance suspension (see Part 2) are shown in **Figure 9**.

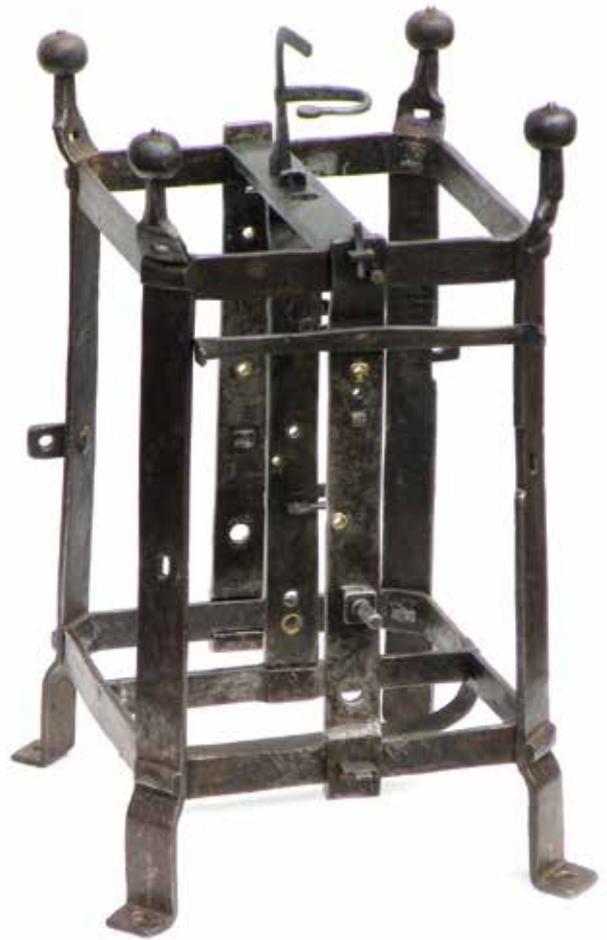
Figure 9. Assembled frame after restoration.

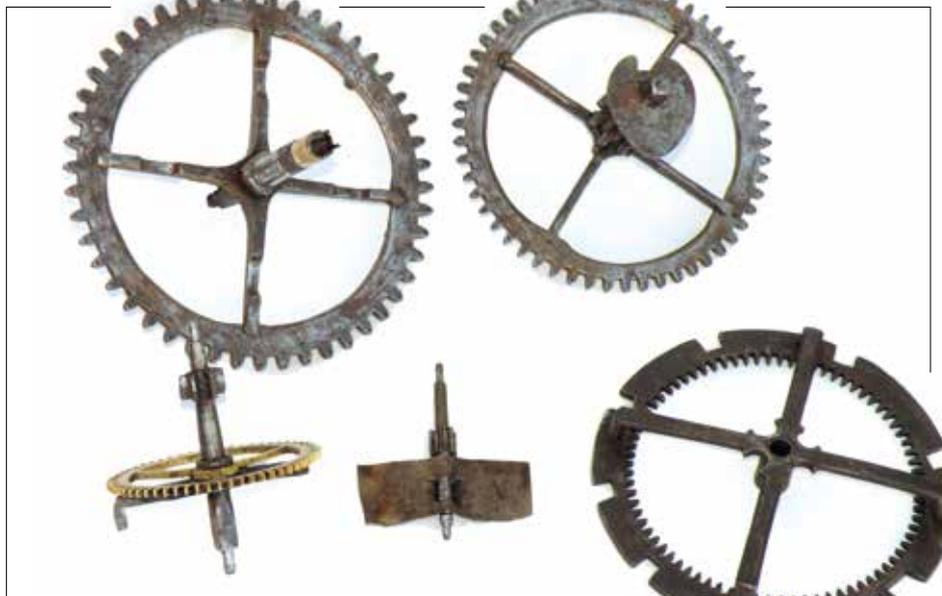
Figure 10. Striking train as found. Clockwise from top left: greatwheel, second wheel with single 'heart' overlift cam, countwheel with internal teeth, later fly, third arbor with locking arm and added brass warning wheel. Note the wear on the crossings of the greatwheel caused by the winding click.

Since the striking train and its associated levers was largely complete with more parts added than removed, this was tackled next. During conversion from nag's-head striking to warning the external fly had been removed, a brass warning wheel fixed to its arbor and a small internal fly added, **Figure 10**. The conversion to pendulum would have necessitated removal of the original external fly. The added parts were removed and the fly arbor extended to take a large two-bladed fly complete with a small ratchet wheel and click of the type often found on turret clocks. The striking train now consists of just two wheels: greatwheel and second wheel with a single-slot overlift cam with locking on an arm on the fly arbor.³ This arrangement of only two wheels plus an external fly is not uncommon on medium-to-large Gothic clocks. The wheel counts are:

Wheel Counts	
Fly	6
Overlift Wheel	54-8
Greatwheel (6 hammer pins)	48-6
Countwheel	78

The striking greatwheel is 4.8in (122mm) diameter. As is usual on Gothic clocks, the countwheel has internal teeth and outside slots for the detent to drop into. To give enough room for the pinion of report to mesh positively, the crossings of the countwheel have to be offset. This construction is only found on very early British turret clocks, not domestic clocks.

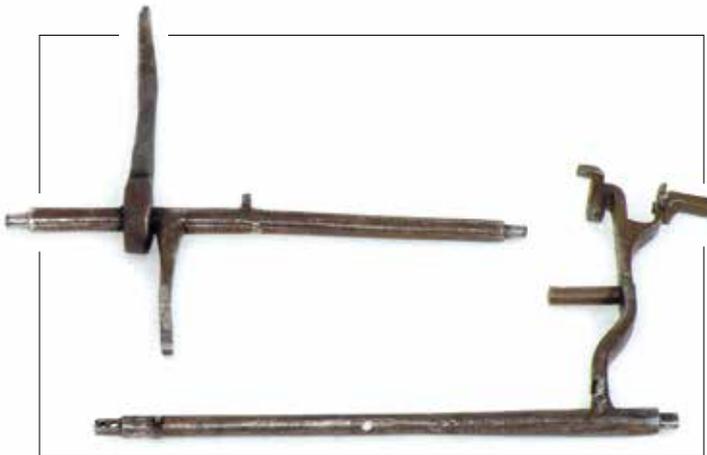
Figure 11. The strike-work as received, top: hammer arbor; bottom: arbor with striking detents, an added link and hole where the lifting piece with nag's head once fitted.

Figure 11 shows the strike work and hammer arbors as found. When striking had been converted to warning, the arm with the nag's head became redundant and had been removed, but a hole in the arbor indicated its former position. The arm and nag's head were reinstated. While on small clocks the flipping back of the nag's head is assisted by a small flat spring, on larger clocks such as this one gravity is sufficient. A short horizontal bar had been added to act as a link when the warning detent was lifted. Since this was now superfluous it was removed. The end of the striking detent, which is U-shaped to straddle the rear movement bar, is multi-functional. The lower edge on the left is lifted by the overlift cam, the bent-over piece locks against the arm on the fly arbor, while the extension on the right is the countwheel detent. The hammer had been replaced by an arm to operate an overhead hammer, presumably via a wire link, but the hammer tail and a short arm to link it to the hammer spring remained. A fragment of the original thin flat hammer spring remained riveted to the right-hand side of the lower frame. It would have passed underneath the movement and

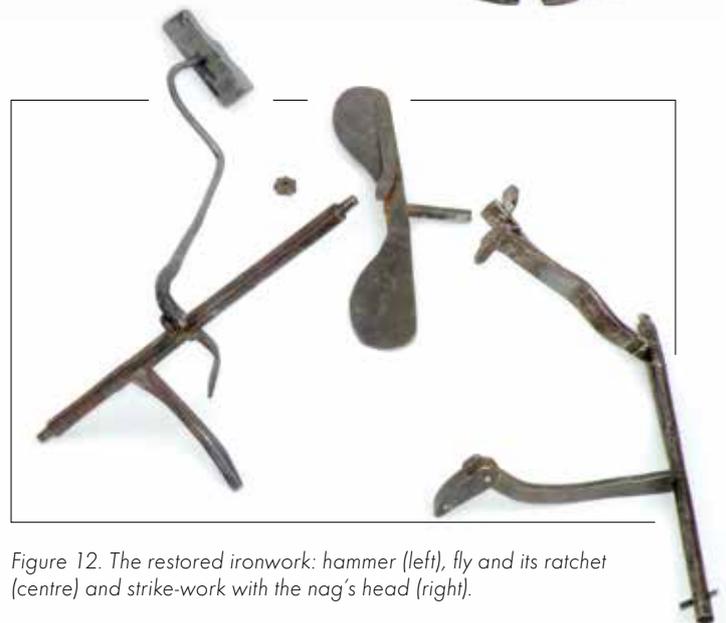
Figure 12. The restored ironwork: hammer (left), fly and its ratchet (centre) and strike-work with the nag's head (right).

connected to the hammer arbor by a wire link. This is the usual arrangement for hour-striking Gothic clocks and while a vertical twisting hammer shaft was commonly used on later Germanic iron clocks, it is rare on Gothic clocks and then usually associated with French/Flemish clocks. **Figure 12** shows the restored ironwork. Unlike English lantern and later 30-hour posted-frame clocks, Gothic clocks usually have no separate stop, the thin hammer shaft simply contacts the top of the frame to avoid the hammer jangling on the bell.
