# A TRIO OF FRENCH

## 3. Cherubs and roses

# CH IRON CLOCKS

by John Robey, UK

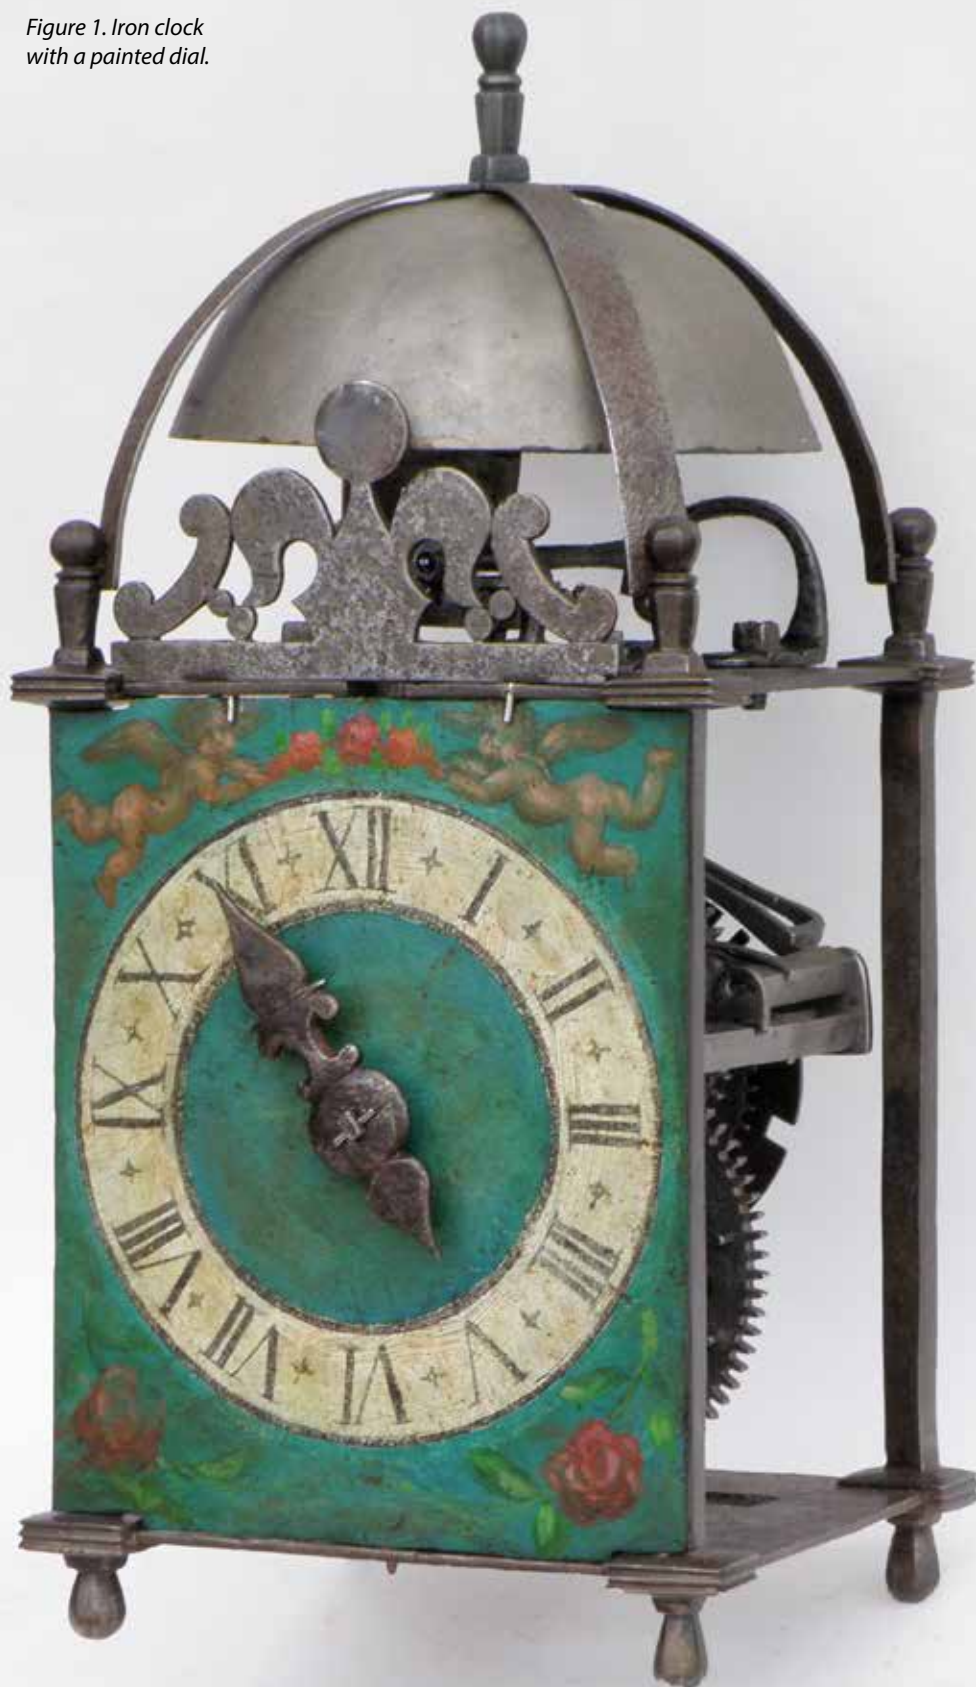
The third clock in this mini-series on early French clocks looks more like a lantern clock than the previous two, having a front fret, bell frame and decorative finials, **figure 1**—all made of iron—yet there are still many difference between it and an English brass lantern clock. Despite not having a hanging hoop or spikes it appears to be a stand-alone clock, not intended to be fitted in a tall case (as were many French so-called 'lantern clocks', especially from Normandy). It probably would have sat on a wall bracket made of either wood or wrought iron.

*Figure 1. Iron clock with a painted dial.*

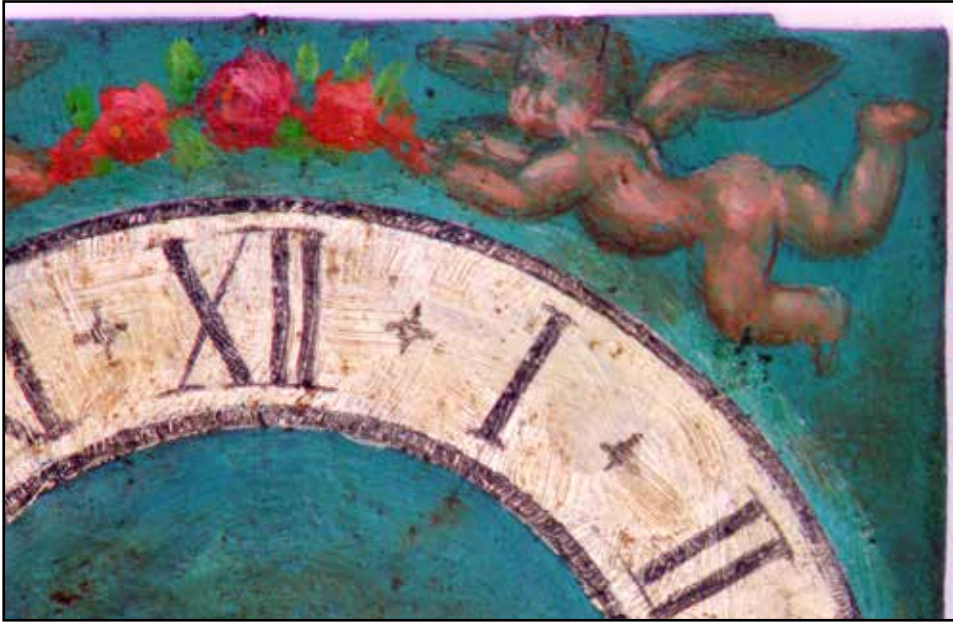
Figure 2. Cherubs in the top corners of the dial.

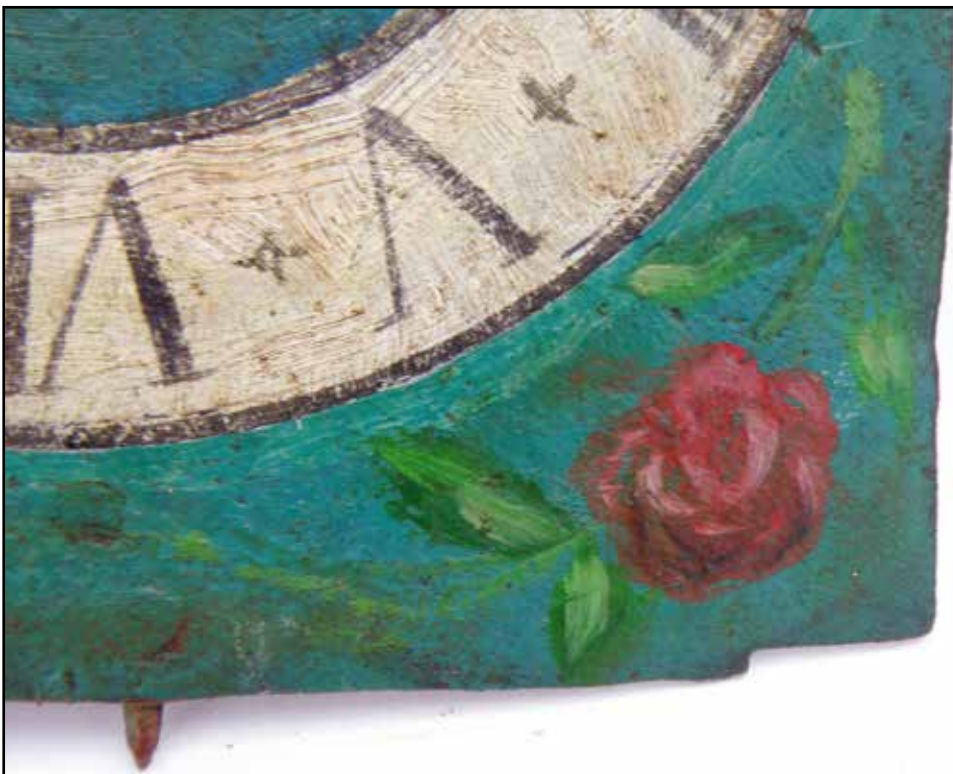
Figure 3. Roses in the lower corners.

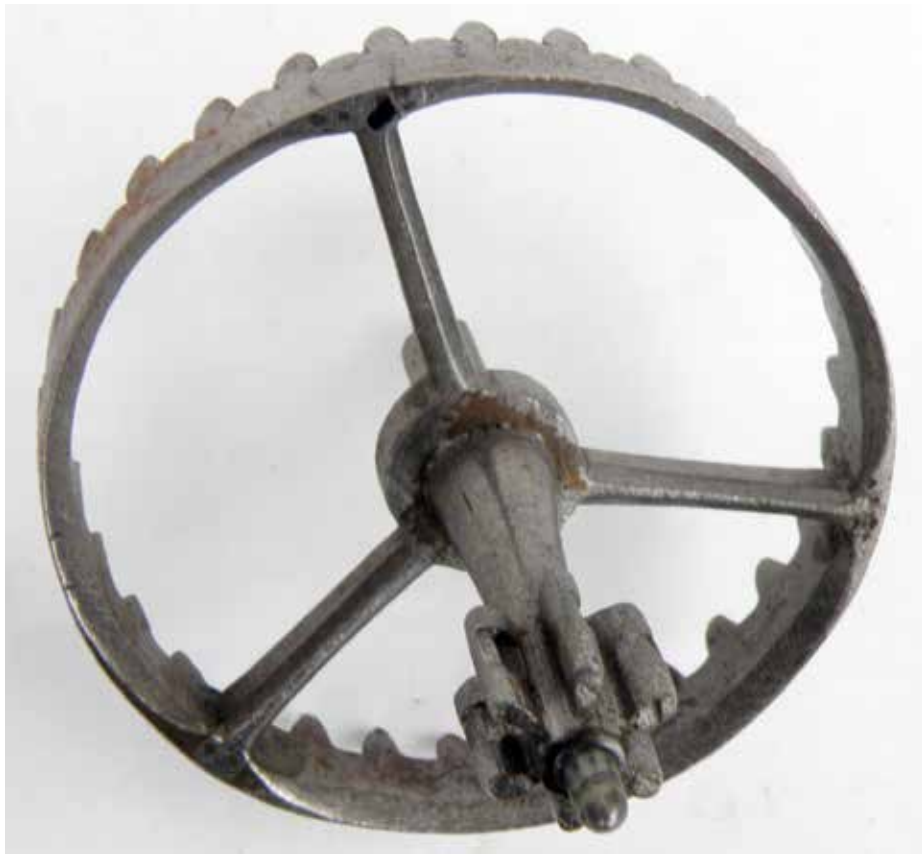
Like the clock in last month's article, all the wheels in both trains of this clock have just three crossings and separate rims, while the 'flat' wheels (that is, all except the contrate and crown wheels) on both trains have dots on the teeth, **figure 12**. This shows that they were marked out using a dividing plate and then slit by hand before being rounded up to give smooth meshing with the pinions. The crossings of the contrate and crown wheels have a rounded cross-section, **figures 13 and 14**. Each wheel and its pinion have marks to indicate correct meshing, not only on the striking train to ensure that locking, warning and the hammer tail are correctly set-up, but also on the going train. This is commonly found on iron wheels and this is to ensure that the wheels and pinions are assembled so that they mesh together in the same positions that the clockmaker decided gave smoothest running when rounding the teeth and pinions.

*Figure 12. Marking-out dots on the teeth of the going great wheel. Note the forged join between the crossing and the rim.*

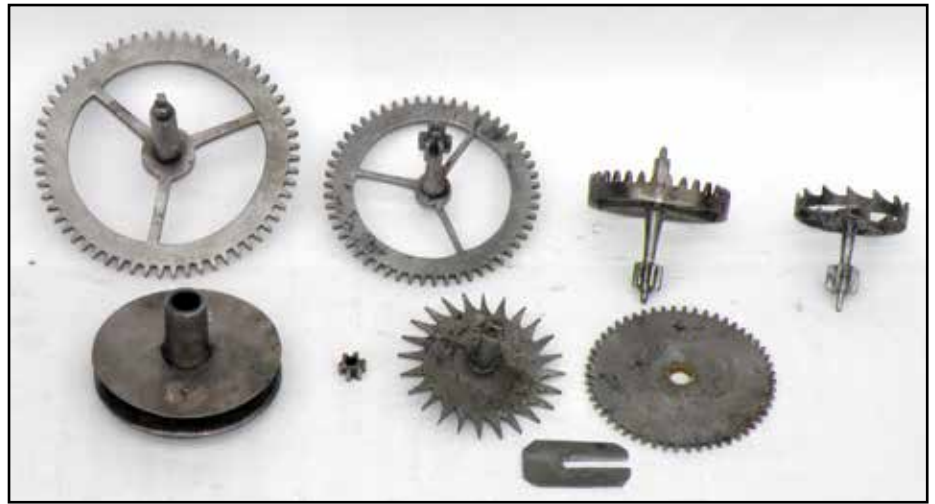
Since the escapement is a verge there are four wheels in the going train, **figure 15**. The counts give a pendulum that has a beat of just over half a second:

The starwheel or ratch for letting off the strike (included in **figure 15**) has 24 points rather than the more usual 12, indicating that not only does the clock strike every hour, but it sounds the half-hours as well. As received the countwheel was made of copper, which was clearly a later modification. I wondered why it had been necessary to change the countwheel, as they do not wear out and even if the narrow raised section at two o'clock had

*Figure 15. The going train. Note the starwheel with 24 points for the hour and half-hour strikes.*

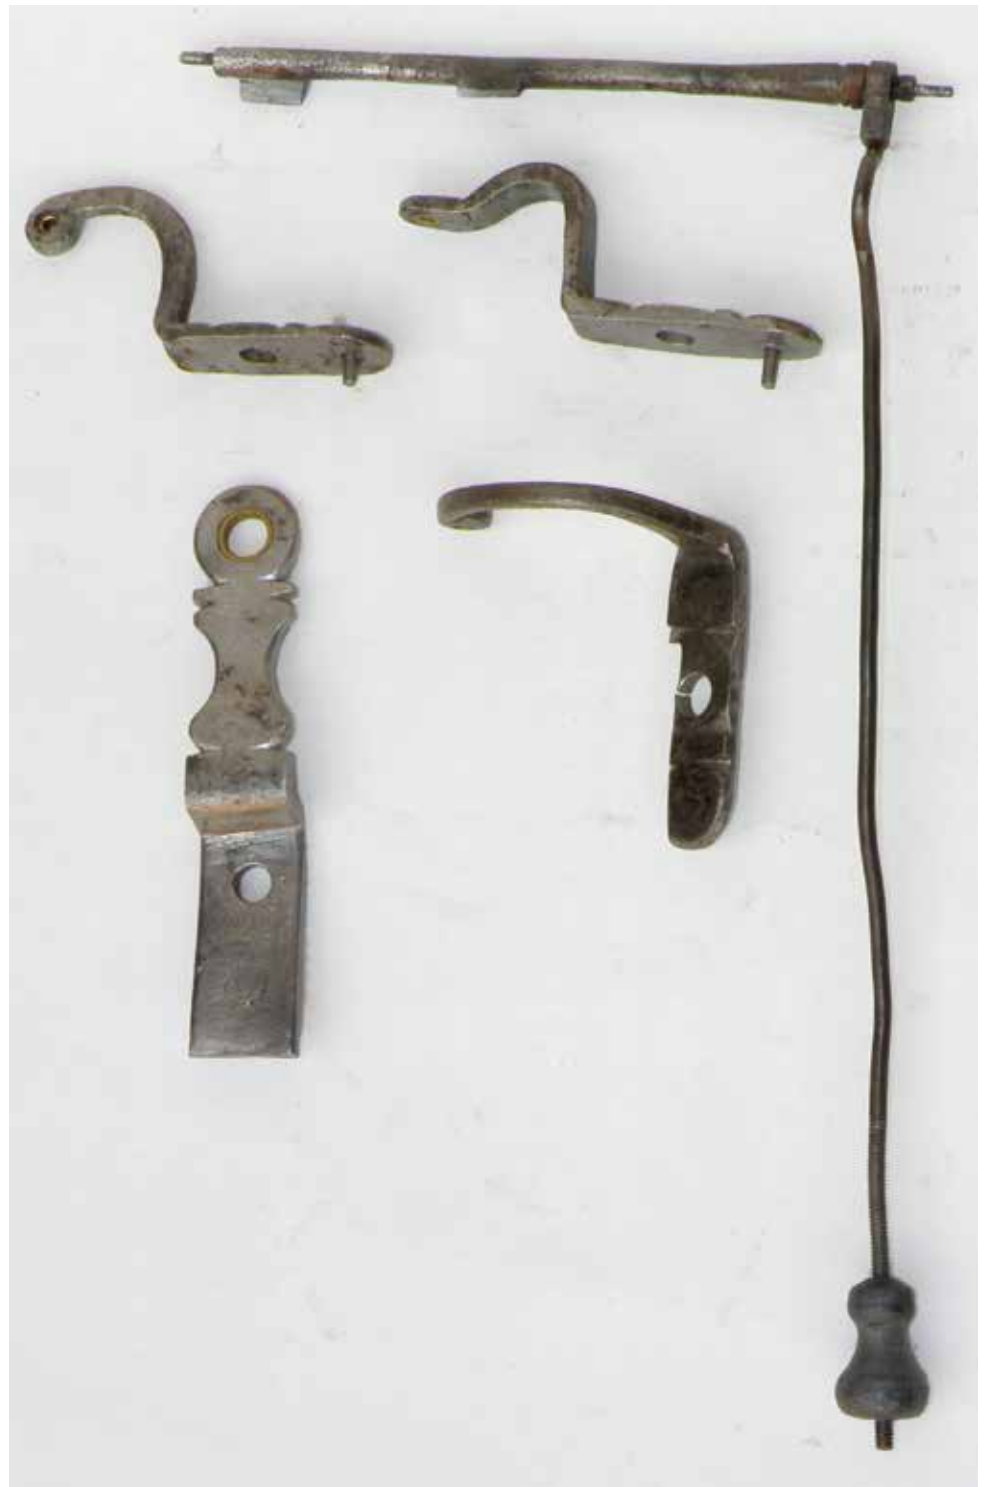
The ironwork of the escapement is shown in **figure 16**. This includes the verge and pendulum, the curved cocks

for the front and rear pivots of the verge, the cock for the top pivot of the crownwheel and a support for the front of the hour-hand arbor. Many 30-hour clocks with iron dials, including most British ones, pivot the hand arbors on a post, while those with brass dials, especially from Britain but rarely on Continental clocks, support the arbor of the hour hand in the centre hole of the dial itself. On this clock there is a decoratively-shaped iron bracket screwed to the front movement bar that provides support, not the dial itself nor a post. Some Normandy iron-framed lantern clocks have an additional movement bar just behind the dial for exactly the same purpose and the dial is screwed to it as well.

*Figure 16. The verge and pendulum, together with its cocks and the crownwheel top cock, also the support for the hand arbor.*

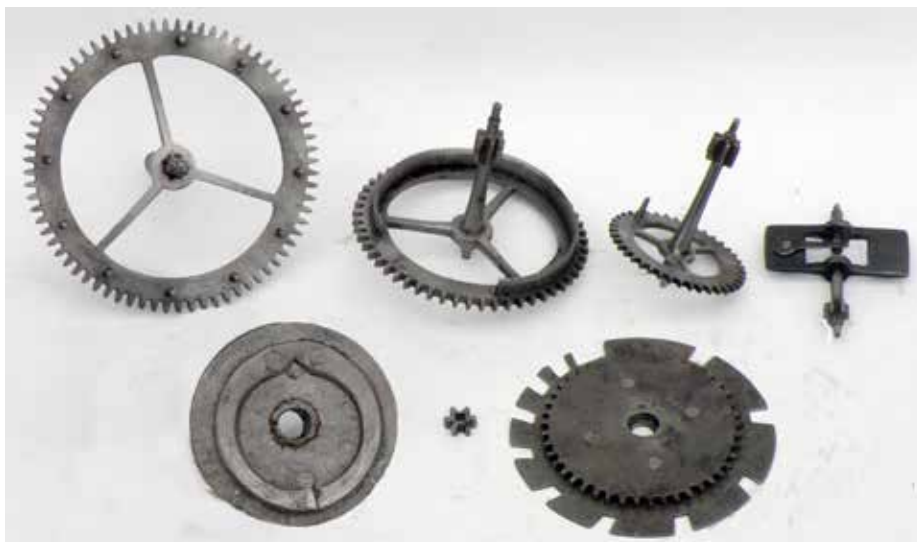
The wheels of the striking train, **figure 17**, are constructed in exactly the same way as the going train, the counts being:

fly	6
warn wheel	40 — 6
hoop wheel	54 — 6
greatwheel	72 — 6
	(12 hammer pins)
countwheel	45

Figure 17. The striking train.
