SWEDISH? S

Unsigned clock o

TRIP-FRAME

of uncertain origin

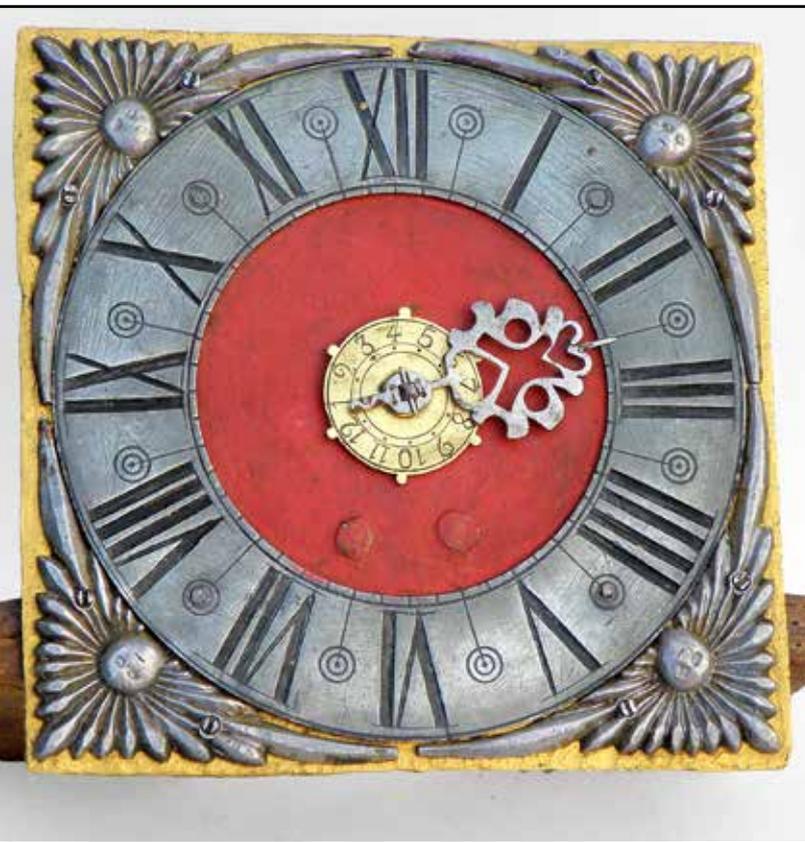
Figure 1. Iron dial with painted centre, re-gilded corners, pewter chapter ring and pewter spandrels.

The iron dial is quite small, being only 7in (180mm) square, with a pewter chapter ring, pewter spandrels and the centre painted red. While each spandrel is fixed to the dial sheet with two small iron screws, the chapter ring, which does not have the hour numerals filled with black wax, is held with pewter rivets through the centre of four of the circular half-hour markers. As received, the corners were dark and the spandrels had been painted black so that not much detail could be seen.

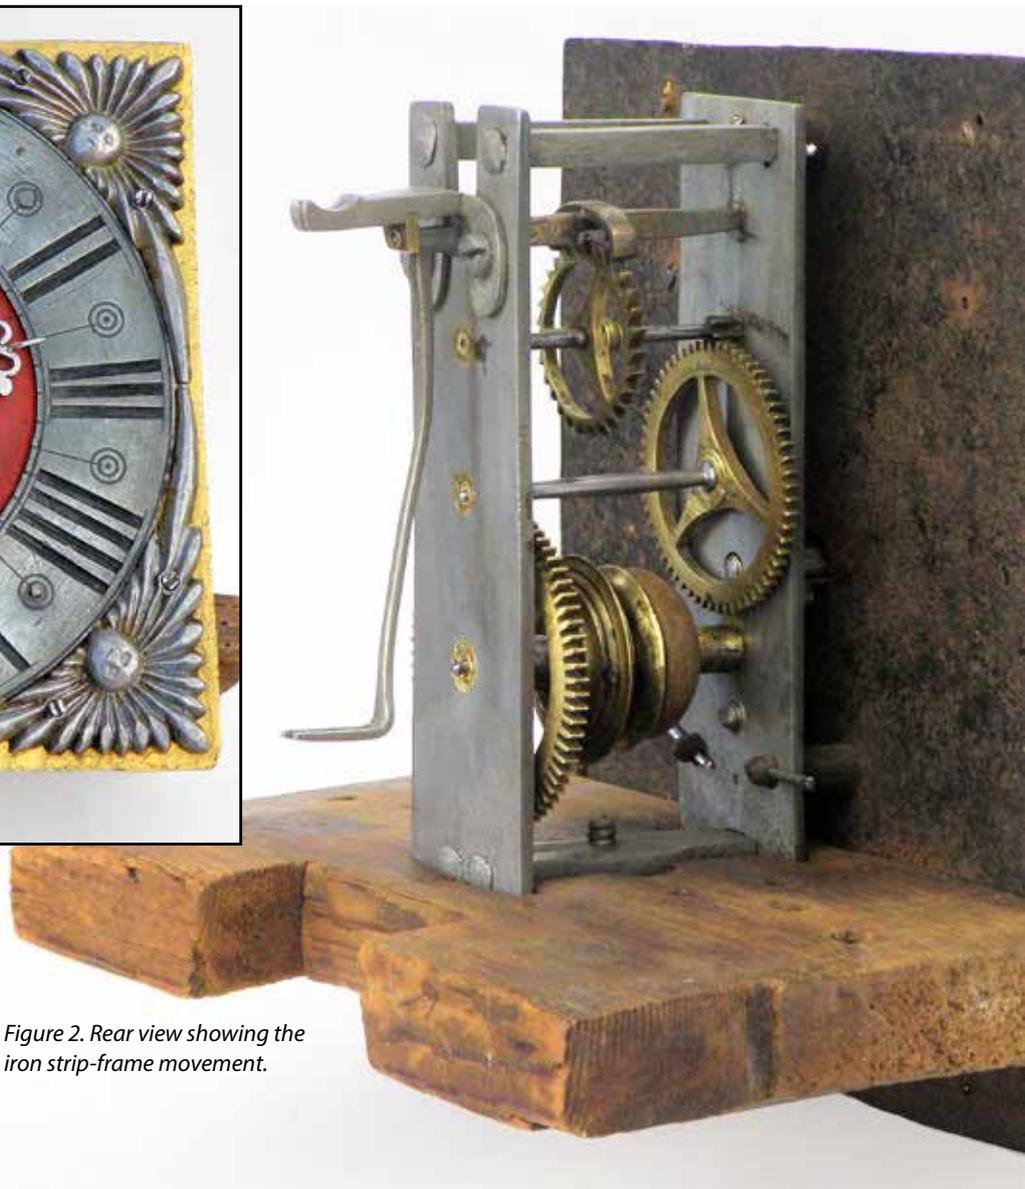
Figure 2. Rear view showing the iron strip-frame movement.

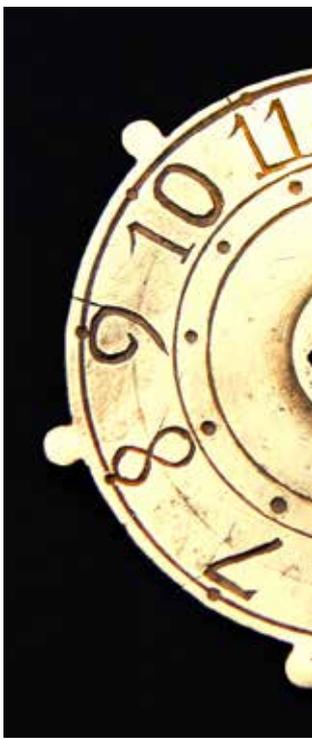
setting disc fits on its pipe by a pentagonal hole, **figure 8**.

Figure 8. The alarm disc.

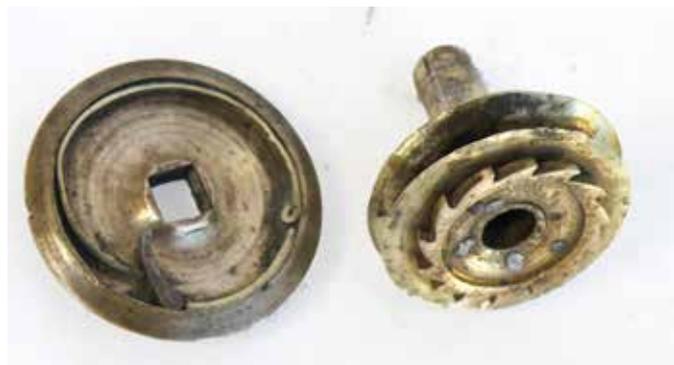
This timepiece has a variation on the latter system, but the click is on a separate removable disc that sits on a square section of the greatwheel arbor, while the ratchet is fixed to the pulley, **figures 13**

Figure 13. Greatwheel, click, pulley and wooden collar.

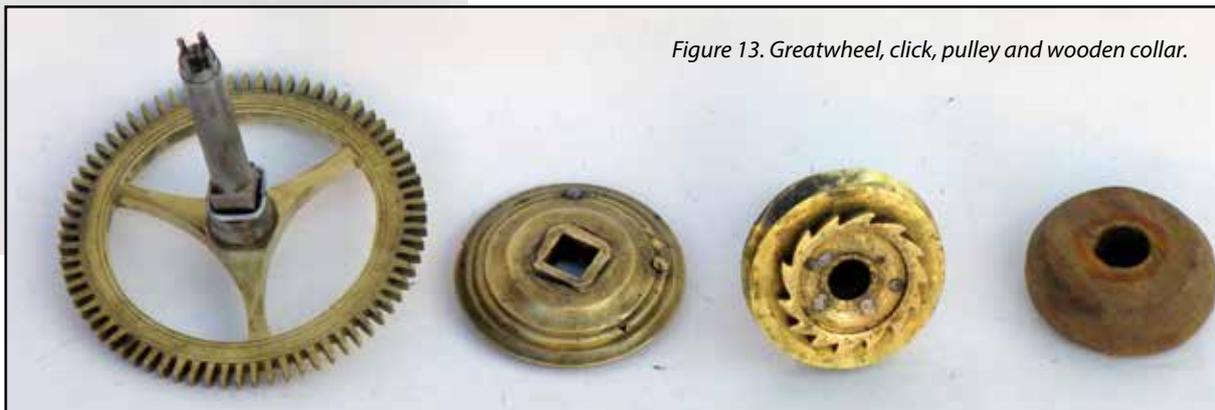
Figure 14. Alternative views of the click and ratchet.

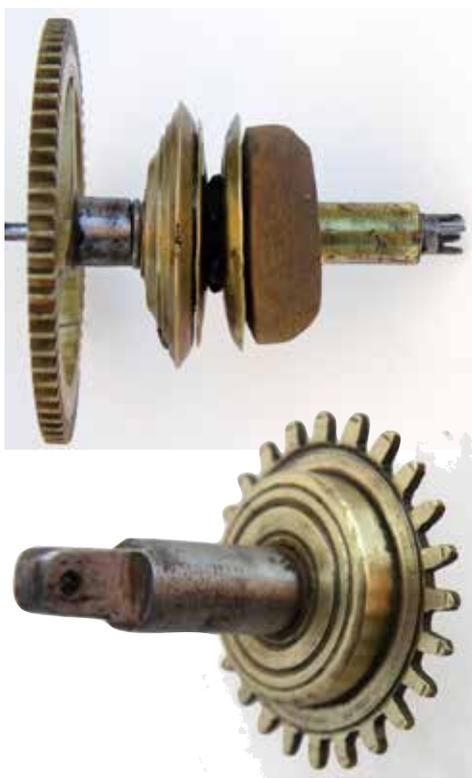
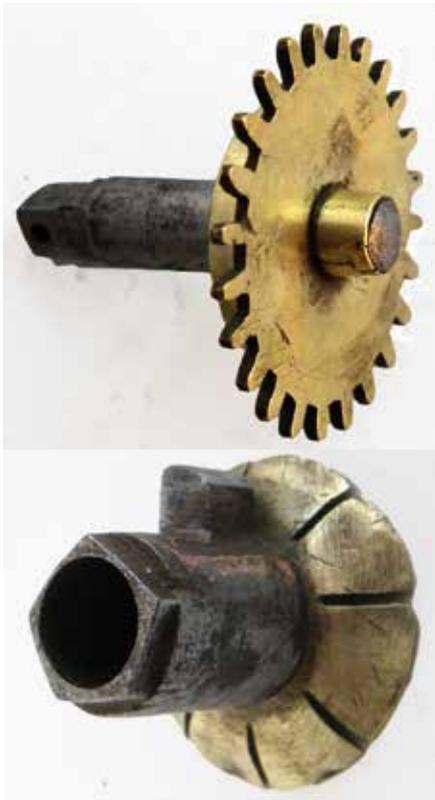
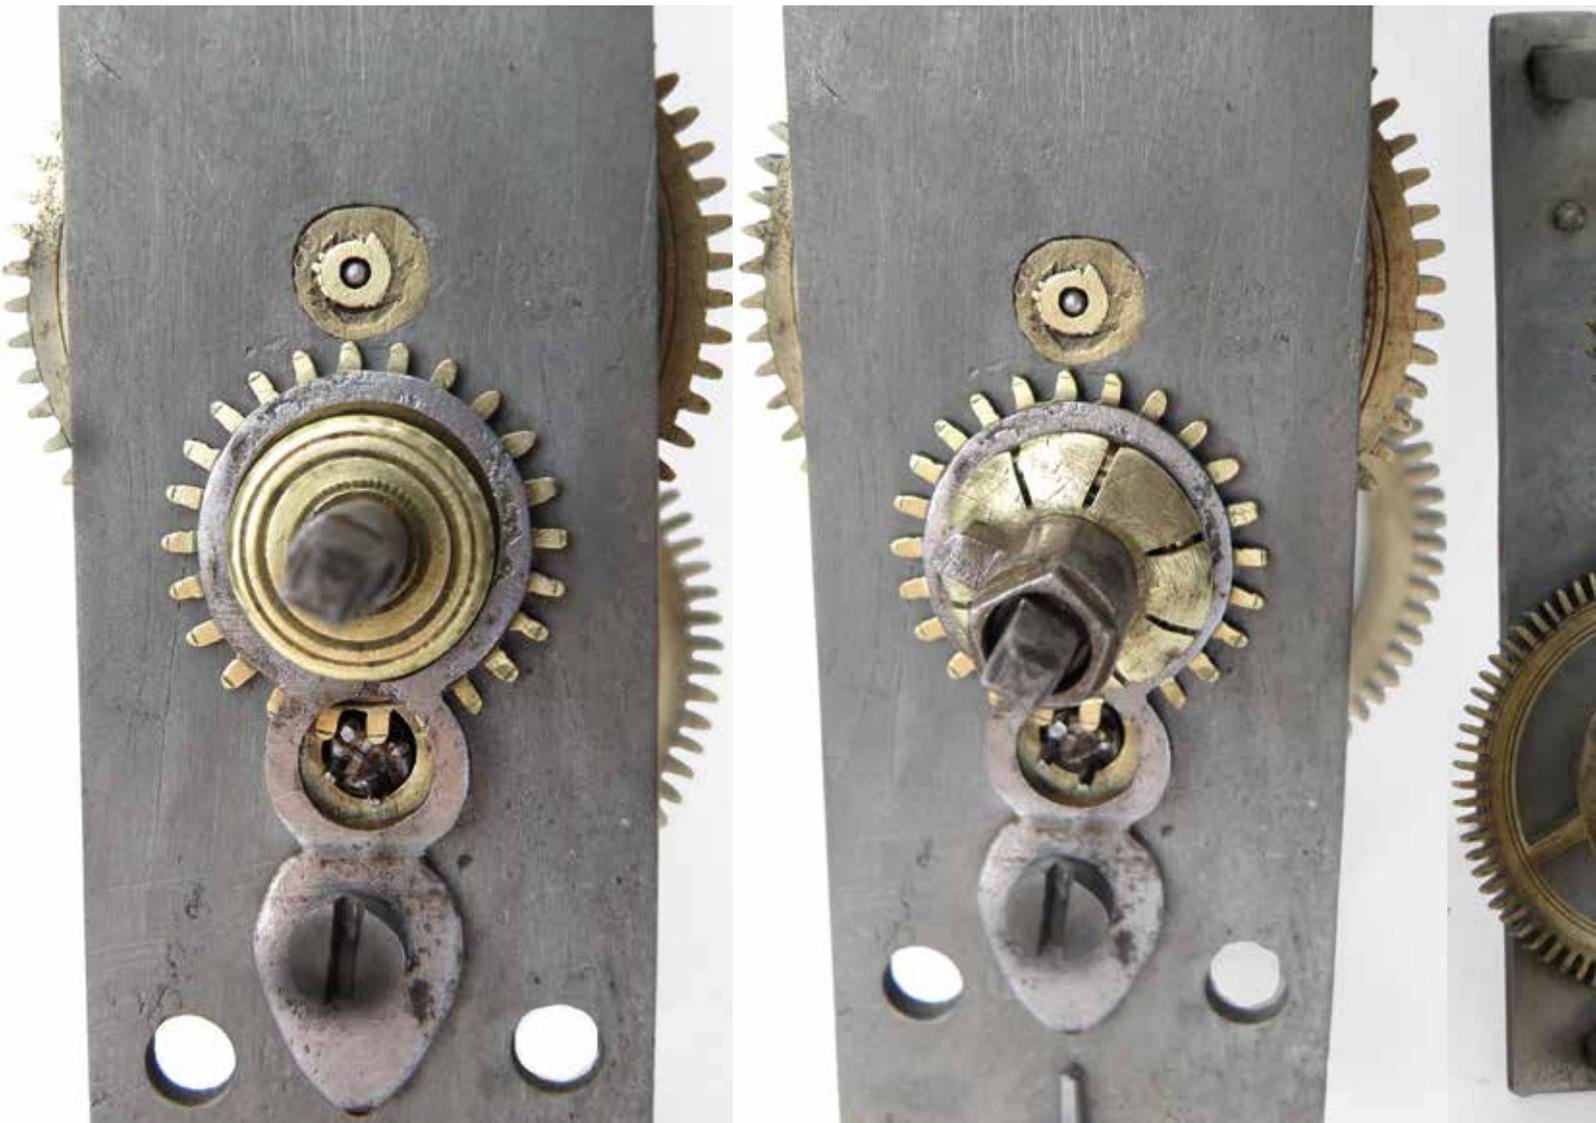
Figure 15 (top left). The pulley and click assembled on the greatwheel arbor. Figure 16 (above left). Hour wheel with brass friction disc. Figure 17 (top right). Brass bush holding the hour wheel against the friction disc. Figure 18 (above right). The alarm pipe, let-off flag and friction disc.

Figure 15 shows the assembled greatwheel click and pulley. Also shown is the wooden collar that sits firmly on the arbor close to the concave front shroud of the pulley. This collar serves no practical function and it may be there for purely cosmetic reasons. The rear side of the click housing is turned to form a series of decorative steps, while the front pulley shroud is attached to the pipe by a rather excessive amount of solder. This can be seen in figure 10, but if this is the work of the original clockmaker or a later repair is not easy to determine. The wooden collar hides the soldered joint and this may have been its sole purpose—just to make it look neat and tidy.

can be set to time. On English clocks a friction disc on the arbor is held against the wheel by a slotted retainer or a cross pin. On this clock a brass friction disc that is presumably hollow (it has not been dismantled) is held against the hour wheel by a brass bush forced on from the rear and also acts as a pivot, **figures 16 and 17**. The motionwork is completed by the alarm pipe with a let-off flag and a slotted and domed brass disc, **figure 18**.

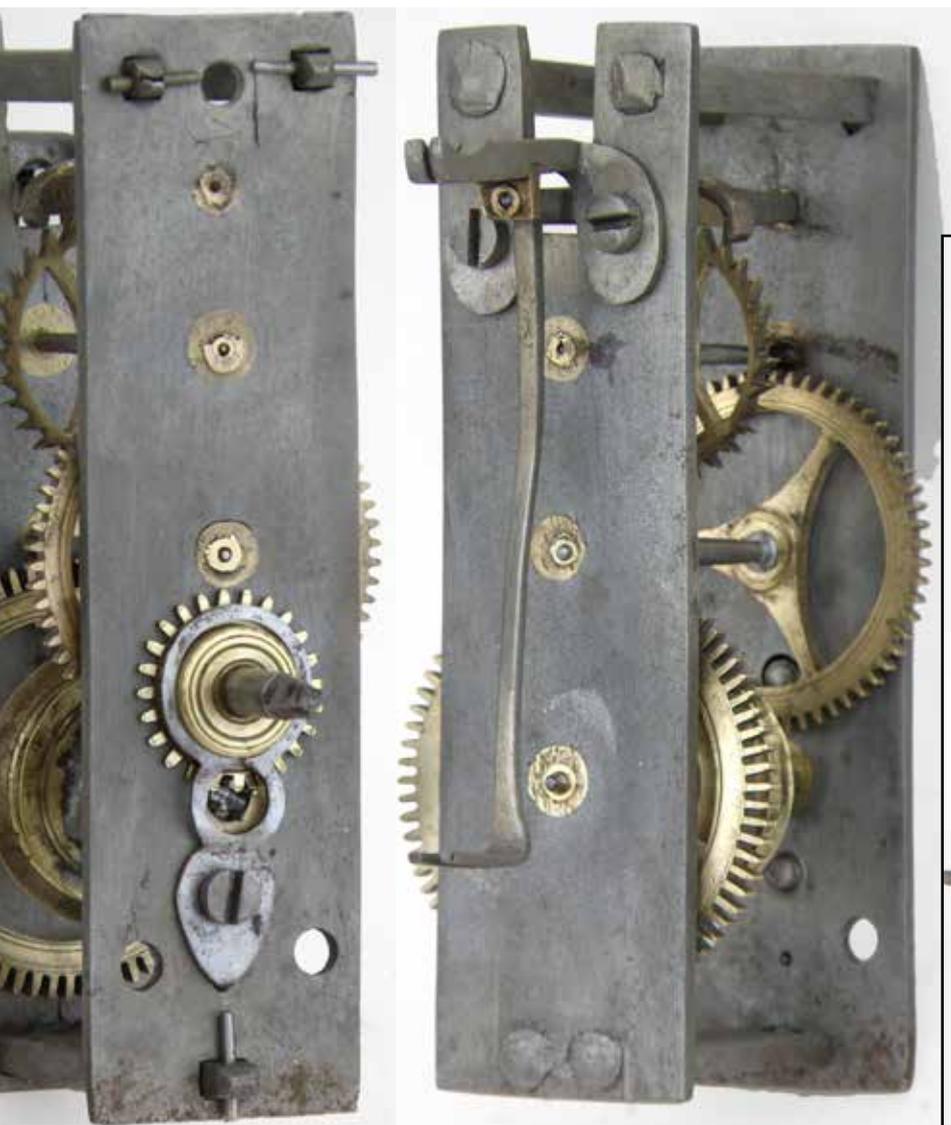
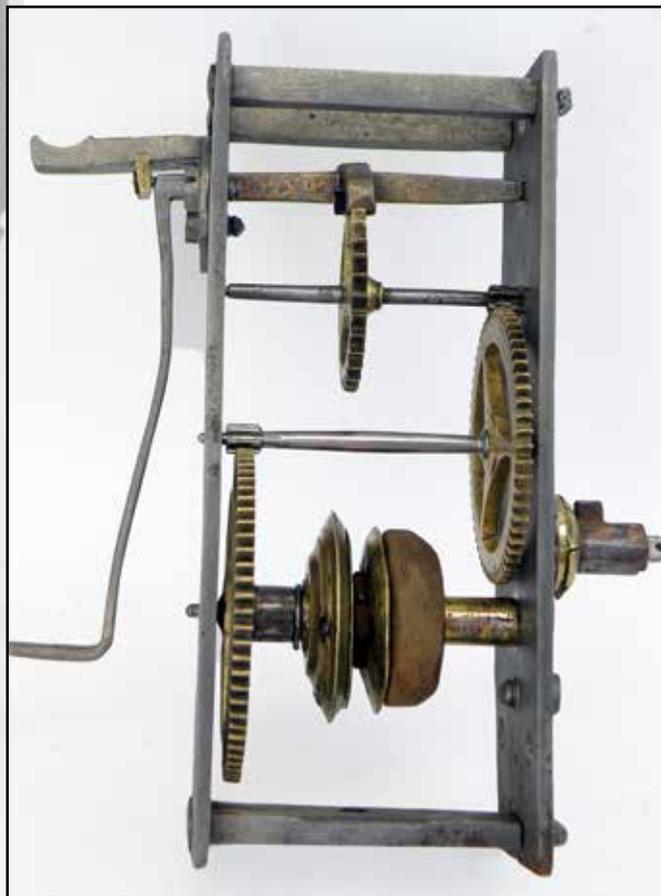
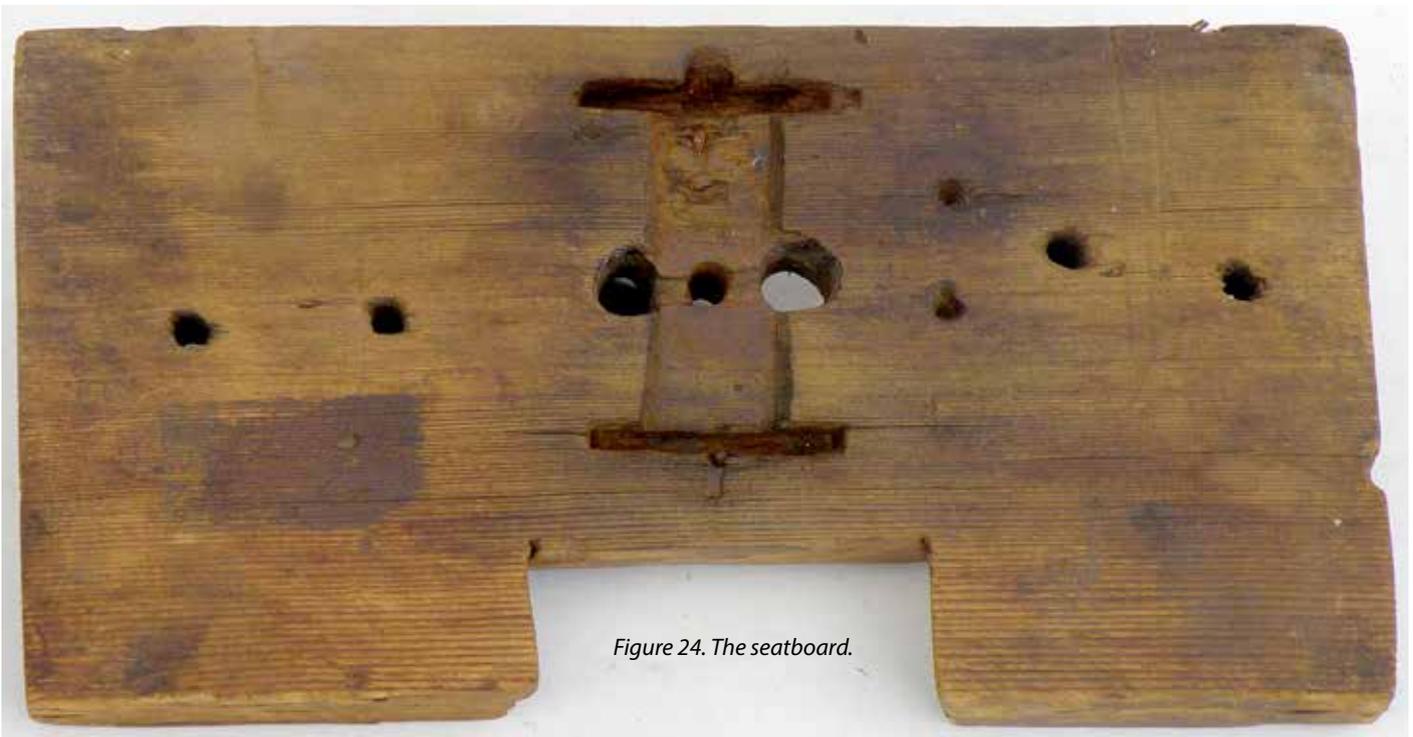
The hand arbor is retained by an iron supporting ring (with clearance for the pinion of report) screwed to the front plate, **figure 19**. The alarm pipe sits over the arbor, **figure 20**, while the alarm-setting disc is fitted on to the pentagonal spigot and the friction disc is compressed slightly when the taper pin securing the hand is pushed into place. This support is necessary to prevent the hour arbor from moving forward and allowing the hour wheel to disengage from the pinion-of-report. It is not necessary when the hour wheel is on a pipe rotating on a post fixed to the front plate. If there is not a step in the hand arbor or alarm pipe, then a calendar flag or pin performs this function, or if there is no calendar a long pin in the

Figures 21 to 23 show the assembled movement, but apart from the let-off tab there is no sign of where an alarm was fitted. The answer to this lies in the seatboard, **figure 24**, which has a couple of pairs of holes for an alarm rope. The pair of holes on the left (as viewed from the rear) do not have any associated holes for fixing screws. The alarm unit planned to be positioned here was moved to the right-hand side where there are two additional holes for wood screws. However, even here there is no depression or other mark to indicate that an alarm mechanism was ever fitted. It may well be that, though an alarm let-off flag and setting disc had been fitted, the customer decided not to proceed with adding the necessary crownwheel, verge, hammer and bell, instead using it as a basic timepiece. Since the hole in the dial had been made large enough to take the alarm pipe, this and the alarm disc was retained for purely aesthetic effect.

Figure 19. The hand arbor retained by a support screwed to the front plate.

Figure 20. The alarm pipe sits over the hand arbor.

Figure 21. Front of the movement.

Figure 22. Rear view.

Figure 23. Side view.

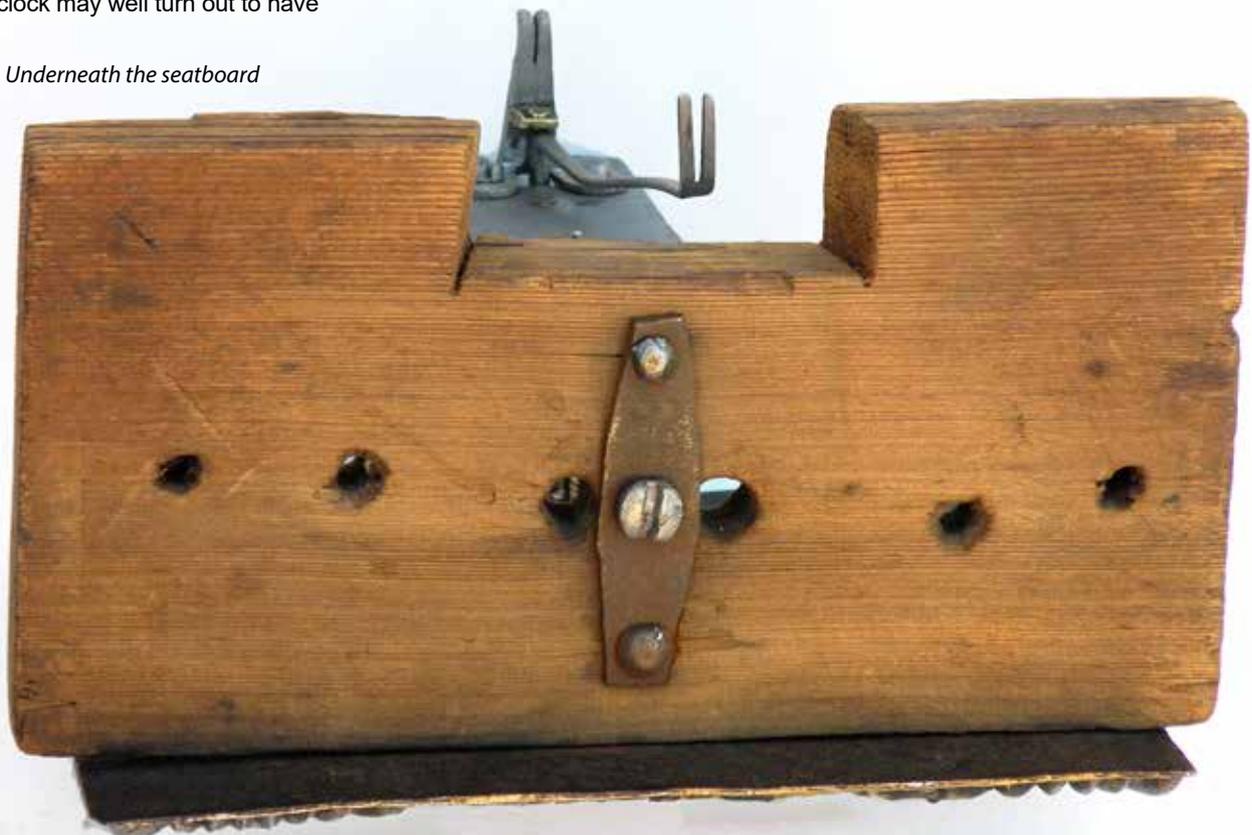
bottom pillar. They are very accurately and neatly cut so that the movement sits in exactly the correct position. Since the alarm mechanism (assuming that it had been fitted) needed to be precisely located in relation to the movement for the let-off linkage to work correctly, such a precise positioning of the movement was essential. The movement is fixed to the seatboard by a screw through a metal strap and into the lower pillar, **figure 25**.

Figure 25. Underneath the seatboard
